FACILITY CONDITION ASSESSMENT

Arcola Elementary School
1820 Franwall Avenue
Silver Spring, MD 20902

172559.25R000-001.354

April 10, 2026

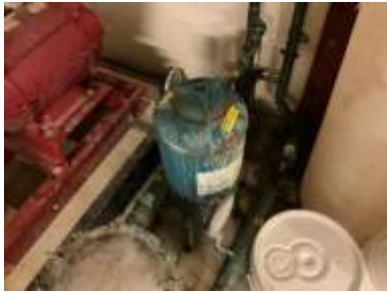
Boiler Supplemental Components in Poor condition.

Shot Feed Tank
Main Building Arcola Elementary School 055

The tank is covered in corrosion on the exterior and in need of replacement. - AssetCALC ID: 10050797

Uniformat Code: D3020
Recommendation: **Replace in 2027**

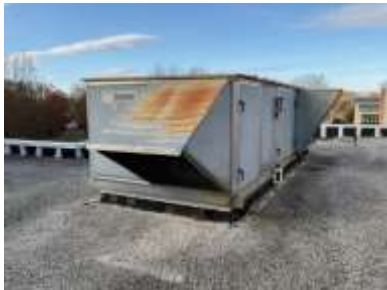
Furnace in Poor condition.

Gas
Main Building Arcola Elementary School Roof

Unit was reported to have issues heating parts of the building. - AssetCALC ID: 10050886

Uniformat Code: D3020
Recommendation: **Replace in 2027**

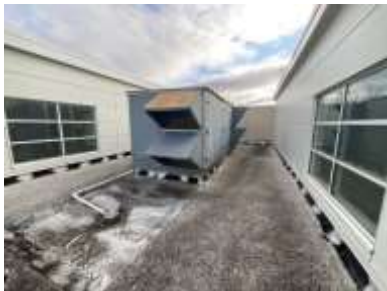
Air Handler in Poor condition.

Outside Air Intake Energy Recovery Unit (ERU)
Main Building Arcola Elementary School Roof

Unit is noted to have issues cooling parts of the building. - AssetCALC ID: 10050745

Uniformat Code: D3060
Recommendation: **Replace in 2027**

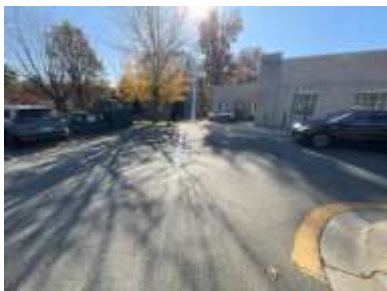
Recommended Follow-up Study: Civil, Site Drainage

Civil, Site Drainage
Arcola Elementary School Trash loading area in parking lot

Poor drainage in front of trash loading dock where asphalt slopes down - AssetCALC ID: 10051583

Uniformat Code: P2030
Recommendation: **Evaluate/Report in 2026**

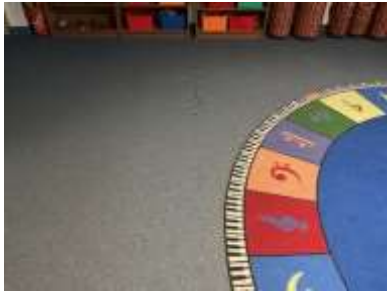
Flooring in Poor condition.

Carpet, Commercial Standard
Main Building Arcola Elementary School 176

Uniformat Code: C2030
Recommendation: **Replace in 2027**
