# FACILITY CONDITION ASSESSMENT

## Montgomery County Public Schools

Bannockburn Elementary School  
6520 Dalroy Lane  
Bethesda, MD 20817

*January 26, 2026*

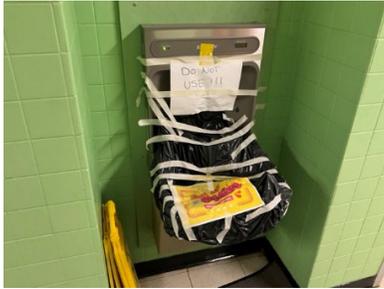
#### Drinking Fountain in Failed condition.

Wall-Mounted, Single-Level  
Main Building Bannockburn Elementary School  
Green Hallway

Uniformat Code: D2010  
Recommendation: **Replace in 2025**

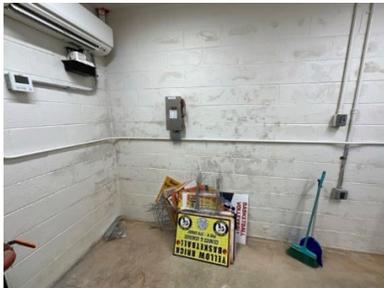
#### Recommended Follow-up Study: Environmental, Analysis of Suspect Fungal Growth

Environmental, Analysis of Suspect Fungal Growth  
Main Building Bannockburn Elementary School  
Room 41, 42, Elevator Room

There is suspected fungal growth in Room 41, 42, and the Elevator Room. A professional consultant must be retained to determine the cause of the growth, provide recommendations and, if necessary, estimate the scope and cost of any required repairs. - AssetCALC ID: 9975423

Uniformat Code: P2030  
Recommendation: **Evaluate/Report in 2025**

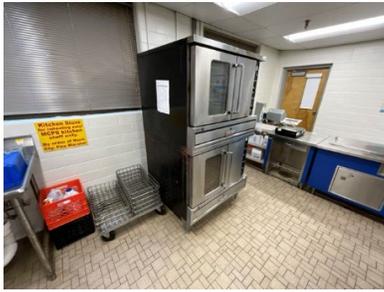
**Foodservice Equipment in Poor condition.**

Convection Oven, Double  
Main Building Bannockburn Elementary School  
Kitchen

Damaged lining and rusted - AssetCALC ID: 9971210

Uniformat Code: E1030  
Recommendation: **Replace in 2026**

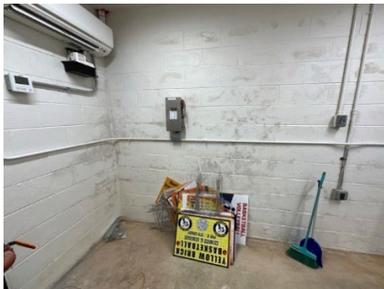
**Recommended Follow-up Study: Environmental, Remediation of Suspect Fungal Growth**

Environmental, Remediation of Suspect Fungal Growth  
Main Building Bannockburn Elementary School  
Room 41, 42, Elevator Room

There is suspected fungal growth in Room 41, 42, and the Elevator Room. This cost provides for remediation. - AssetCALC ID: 9899528

Uniformat Code: P2030  
Recommendation: **Remove in 2025**

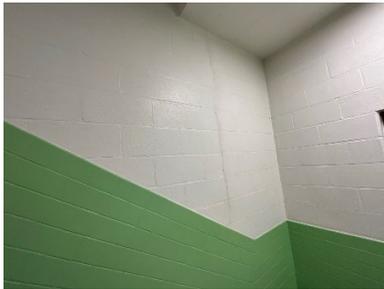
The building has significant structural cracking observed near the green staircase and slight cracking in some classrooms. It is recommended to bring in a professional to evaluate, more information can be found in the additional studies section. Overall, the exterior envelope systems and components were observed to be performing adequately. The VCT on the inside has generally become uneven over the years and is reportedly hard to seal and clean due to its unevenness. Apart from this, interior finishes have generally been replaced as needed and are anticipated for lifecycle replacement based on useful life and normal wear.

**Recommended Follow-up Study: Structural, Superstructure**

Structural, Superstructure  
Main Building Bannockburn Elementary School  
Green Staircase

The walls are cracking especially near the green staircase and some classrooms. A professional engineer must be retained to analyze the existing condition, provide recommendations and, if necessary, estimate the scope and cost of any required repairs. - AssetCALC ID: 9899530

The walls are cracking especially near the green staircase and some classrooms. A professional engineer must be retained to analyze the existing condition, provide recommendations and, if necessary, estimate the scope and cost of any required repairs. The cost of this study is included in the cost tables. Due to the ambiguity of the required repair scope at the time of this assessment, the cost for any possible subsequent repairs is not included.

Uniformat Code: P2030  
Recommendation: **Evaluate/Report in 2025**

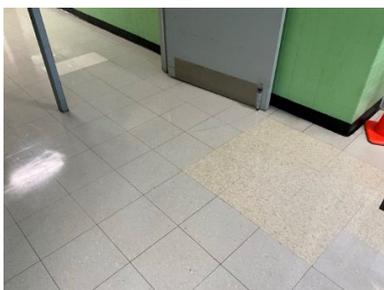
**Flooring in Poor condition.**

Vinyl Tile (VCT)  
Main Building Bannockburn Elementary School  
Throughout Building

The VCT is reportedly generally uneven throughout which can cause issues with sealing etc. Also tiles are mismatched and aged in several locations - AssetCALC ID: 9971158

Uniformat Code: C2030  
Recommendation: **Replace in 2027**

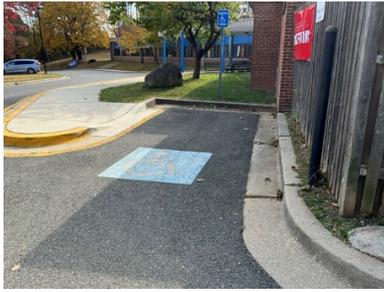
### ADA Parking

No van accessible parking spots were observed, it is recommended to add one or adjust another lot space. - AssetCALC ID: 10188691

Uniformat Code: Y1010  
Recommendation: **Install in 2025**

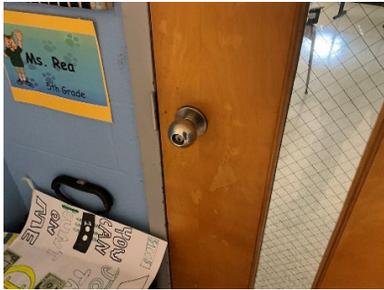
### ADA Entrances & Doors

Many door handles have twist knobs. It is recommended to change them to levers on doors that may need to be opened by disabled students. - AssetCALC ID: 10188692

Uniformat Code: Y1030  
Recommendation: **Install in 2025**

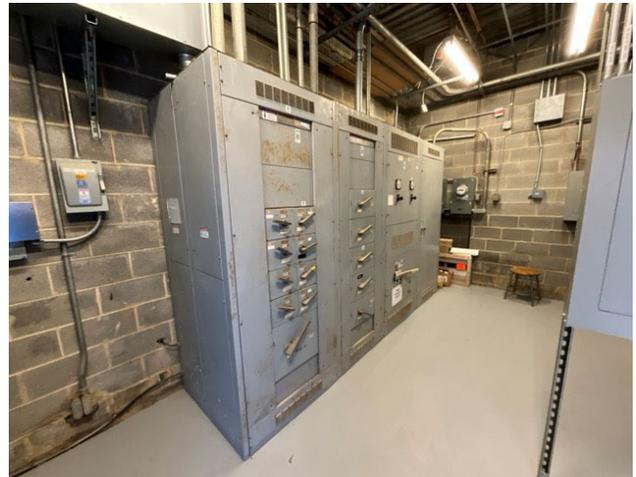
16 - SWITCHBOARD

Electrical service equipment and systems appear generally adequate. A 1987 switchboard provides power throughout. This is functional, although it is reaching the end of its expected lifespan. It is recommended to monitor and replace it in the coming years.
