FACILITY CONDITION ASSESSMENT

Montgomery County Public Schools
45 West Gude Drive, Suite 4000
Rockville, MD 20850

Lucy V. Barnsley Elementary School
14516 Nadine Drive
Rockville, MD 20853

April 10, 2026

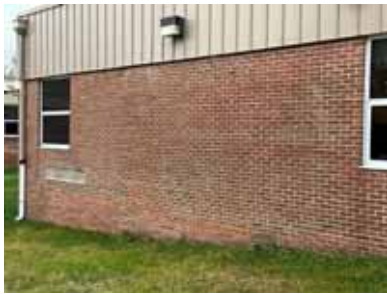
Exterior Walls in Poor condition.

Brick/Masonry/Stone, Clean and Seal
Main Building Lucy V. Barnesley Elementary
School Building Exterior

Most of the building exterior was observed to have staining. - AssetCALC ID: 10036015

Uniformat Code: B2010
Recommendation: **Maintain in 2026**

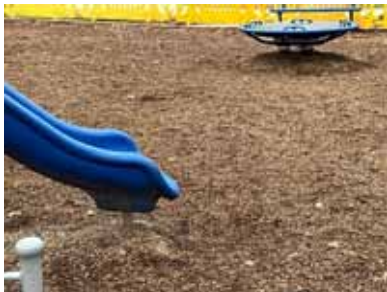
Playground Surfaces in Poor condition.

Chips Wood, 6" Depth
Site Lucy V. Barnesley Elementary School Site
Playground Areas

Appears to be washed out from rain events - AssetCALC ID: 10036010

Uniformat Code: G2050
Recommendation: **Replace in 2026**

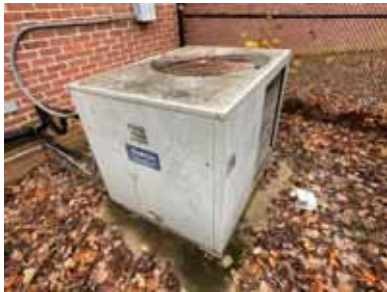
Split System in Poor condition.

Condensing Unit/Heat Pump, 8 to 10 TON
Main Building Lucy V. Barnesley Elementary
School Site Utility Areas

Uniformat Code: D3030
Recommendation: **Replace in 2027**
