FACILITY CONDITION ASSESSMENT

Montgomery County Public Schools
45 West Gude Drive, Suite 4000
Rockville, MD 20850

Beall Elementary School
451 Beall Avenue
Rockville, MD 20850

April 10, 2026

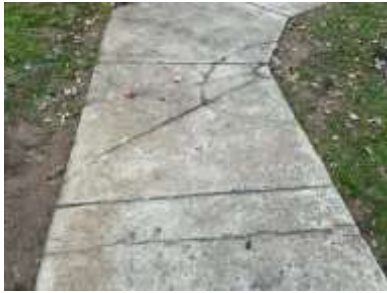
Concrete, Large Areas
Site Beall Elementary School Site Walkways

Sidewalk in Poor condition.

Walkways have cracks and heaving in several areas - AssetCALC ID: 10035588

Uniformat Code: G2030
Recommendation: **Replace in 2026**

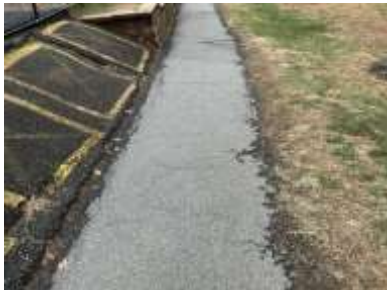
Asphalt
Site Beall Elementary School Playground
Walkway

Sidewalk in Poor condition.

Several large cracks and crumbling edges throughout - AssetCALC ID: 10035573

Uniformat Code: G2030
Recommendation: **Replace in 2027**

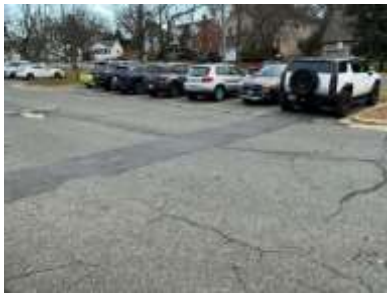
Pavement, Asphalt
Site Beall Elementary School Bus Loop /
Loading Area

Parking Lots in Poor condition.

Large cracks throughout - AssetCALC ID: 10035592

Uniformat Code: G2020
Recommendation: **Seal and Stripe in 2026**

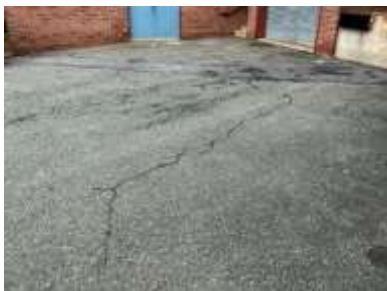
Pavement, Asphalt
Site Beall Elementary School Bus Loop /
Loading Area

Parking Lots in Poor condition.

Alligator and large cracks throughout - AssetCALC ID: 10035585

Uniformat Code: G2020
Recommendation: **Mill and Overlay in 2026**

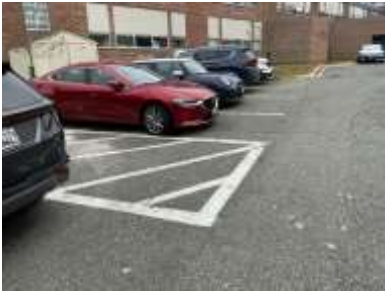
Pavement, Asphalt
Site Beall Elementary School Rear Parking Lot

Parking Lots in Poor condition.

Large cracks throughout - AssetCALC ID: 10035602

Uniformat Code: G2020
Recommendation: **Seal and Stripe in 2026**

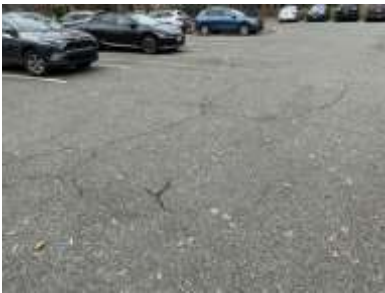
Pavement, Asphalt
Site Beall Elementary School Rear Parking Lot

Parking Lots in Poor condition.

Large cracks throughout - AssetCALC ID: 10035580

Uniformat Code: G2020
Recommendation: **Mill and Overlay in 2027**

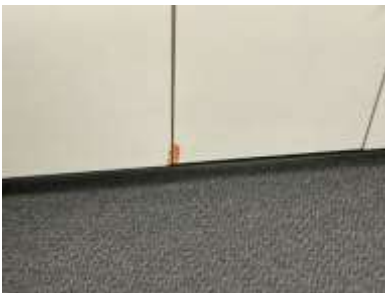
Cabinetry, High-End or Laboratory
Main Building Beall Elementary School
Reception

Casework in Poor condition.

Chipped and broken laminate throughout - AssetCALC ID: 10035453

Uniformat Code: E2010
Recommendation: **Replace in 2026**

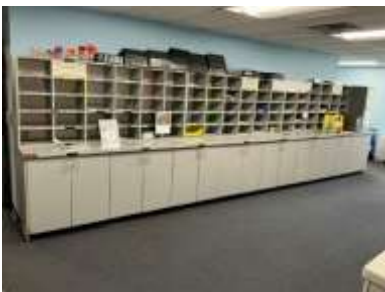
Cabinetry, Standard
Main Building Beall Elementary School
Teacher Workroom

Casework in Poor condition.

Cabinet is delaminating and missing door - AssetCALC ID: 10035369

Uniformat Code: E2010
Recommendation: **Replace in 2026**

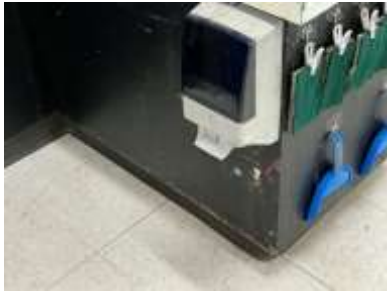
Cabinetry, Economy
Main Building Beall Elementary School
Classrooms Art

Casework in Poor condition.

Broken and cracked wood panels - AssetCALC ID: 10035364

Uniformat Code: E2010
Recommendation: **Replace in 2026**

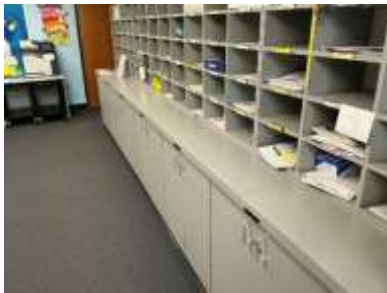
Countertop, Plastic Laminate
Main Building Beall Elementary School
Teacher Workroom

Casework in Poor condition.

Broken and missing laminate at edges - AssetCALC ID: 10035366

Uniformat Code: E2010
Recommendation: **Replace in 2026**

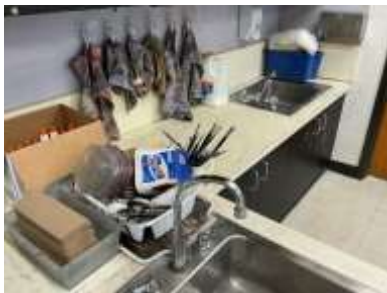
Countertop, Plastic Laminate
Main Building Beall Elementary School
Classrooms Art

Casework in Poor condition.

Broken and missing laminate - AssetCALC ID: 10035336

Uniformat Code: E2010
Recommendation: **Replace in 2026**

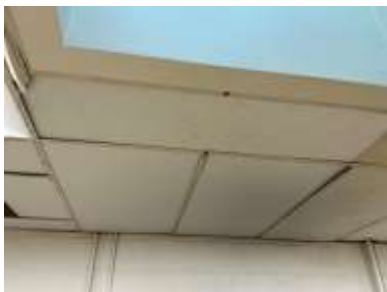
Acoustical Tile (ACT)
Main Building Beall Elementary School Kitchen

Suspended Ceilings in Poor condition.

Discolored panels and rusting grid - AssetCALC ID: 10035422

Uniformat Code: C1070
Recommendation: **Replace in 2026**

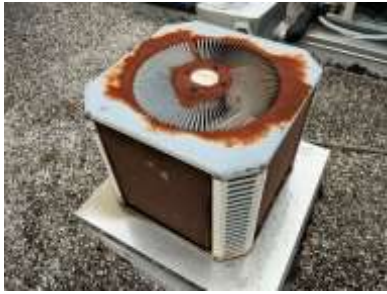
Interior and Exterior Component Pairing, 1 TON
Main Building Beall Elementary School Roof

Split System in Poor condition.

Unit rusted throughout - AssetCALC ID: 10035480

Uniformat Code: D3030
Recommendation: **Replace in 2026**

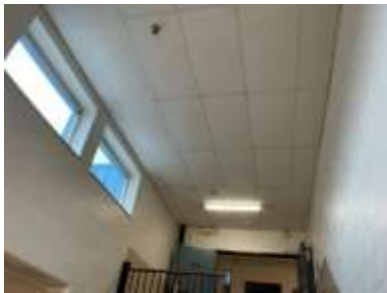
Acoustical Tile (ACT)
Main Building Beall Elementary School
Throughout Building

Suspended Ceilings in Poor condition.

Tiles bowed and discolored throughout - AssetCALC ID: 10035447

Uniformat Code: C1070
Recommendation: **Replace in 2027**

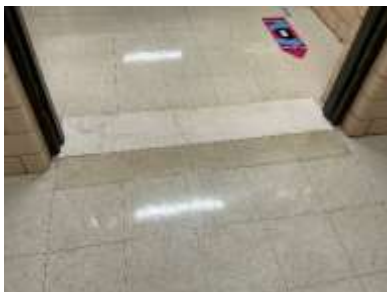
Vinyl Tile (VCT)
Main Building Beall Elementary School
Throughout Building

Flooring in Poor condition.

Uniformat Code: C2030
Recommendation: **Replace in 2027**
