# FACILITY CONDITION ASSESSMENT

**Montgomery County Public Schools**  
45 West Gude Drive, Suite 4000  
Rockville, MD 20850

Belmont Elementary School  
19528 Olney Mill Road  
Olney, MD, 20832

August 12, 2025

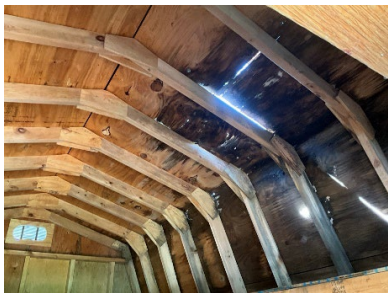
<p><b>Shed/Gazebo/Shade Structure in Poor condition.</b></p> <p>Wood or Metal-Framed, Basic/Minimal Site Belmont Elementary School Site General</p> <p>Uniformat Code: F1020 Recommendation: <b>Replace in 2025</b></p>	<p>Priority Score: <b>81.9</b></p> <p>Plan Type: Performance/Integrity</p> <p>Cost Estimate: \$5,000</p> <p>\$\$\$\$</p>
<p>Wood framed shed was observed to be damaged and deteriorated. Replacement is recommended in the short term. - AssetCALC ID: 9301027</p>

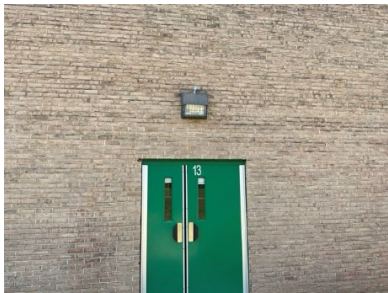
<p><b>Exterior Light in Poor condition.</b></p> <p>Building-Mounted, Higher-Lumen for Large Areas Main Building Belmont Elementary School Building Exterior</p> <p>Uniformat Code: D5040 Recommendation: <b>Replace in 2026</b></p>	<p>Priority Score: <b>81.8</b></p> <p>Plan Type: Performance/Integrity</p> <p>Cost Estimate: \$9,600</p> <p>\$\$\$\$</p>
<p>Exterior lighting was observed to be in poor condition and inadequate for the building. Upgrades are scheduled for the short term. - AssetCALC ID: 9301022</p>
