FACILITY CONDITION ASSESSMENT

Montgomery County Public Schools
45 West Gude Drive, Suite 4000
Rockville, MD 20850

Bethesda Elementary School
7600 Arlington Road
Bethesda, MD 20814

April 10, 2026

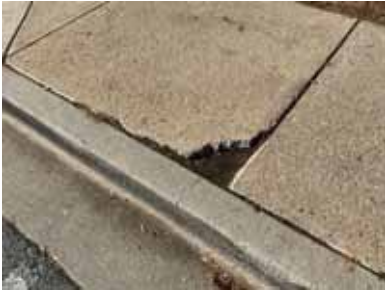
Sidewalk in Poor condition.

any pavement type, Sectional Repairs (per Man-Day)
Site Bethesda Elementary School Site

Cost allowance for sidewalk repairs - AssetCALC ID: 10206830

Uniformat Code: G2030
Recommendation: **Repair in 2026**

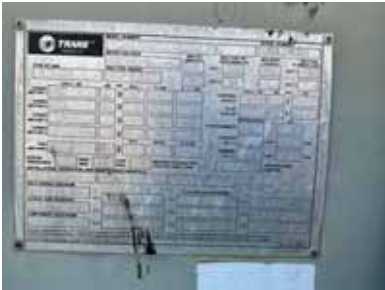
Chiller in Poor condition.

Air-Cooled
Main Building Bethesda Elementary School
Building Exterior

Unit has exceeded EUL and uses phased out refrigerant 22 - AssetCALC ID: 10204243

Uniformat Code: D3030
Recommendation: **Replace in 2027**

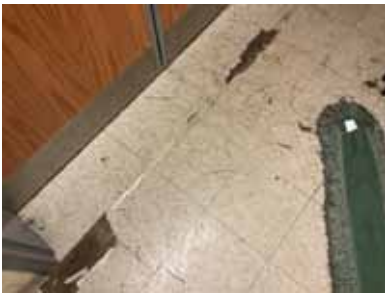
Interior Construction in Poor condition.

any type, Repairs per Man-Day
Main Building Bethesda Elementary School
125E

Cost allowance to repair broken tiles - AssetCALC ID: 10204192

Uniformat Code: C1010
Recommendation: **Repair in 2026**

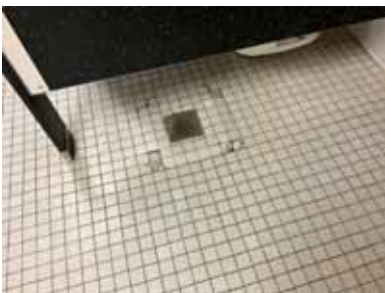
Interior Construction in Poor condition.

any type, Repairs per Man-Day
Main Building Bethesda Elementary School 1st
floor boys restroom

Cost allowance for crack floor repairs - AssetCALC ID: 10204239

Uniformat Code: C1010
Recommendation: **Repair in 2027**

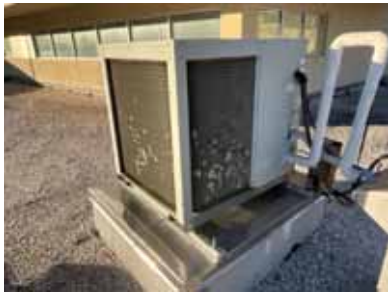
Split System in Poor condition.

Condensing Unit/Heat Pump
Main Building Bethesda Elementary School
Roof

Unit is exceedingly aged, has crushed fins, and uses phased out R22 refrigerant. - AssetCALC ID: 10204112

Uniformat Code: D3030
Recommendation: **Replace in 2026**

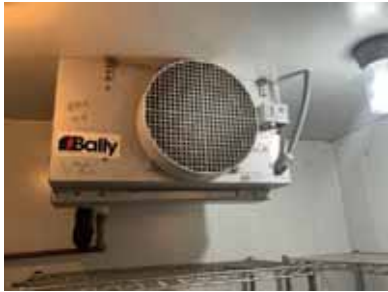
Foodservice Equipment in Poor condition.

Walk-In, Refrigerator
Main Building Bethesda Elementary School
Kitchen

The unit requires a phased out refrigerant R-22 - AssetCALC ID: 10204113

Uniformat Code: E1030
Recommendation: **Replace in 2027**

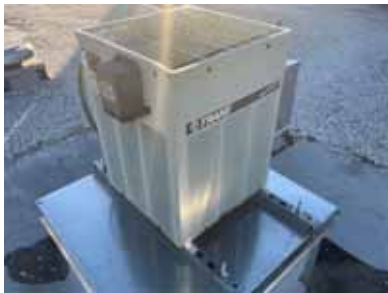
Split System in Poor condition.

Interior and Exterior Component Pairing
Main Building Bethesda Elementary School
Roof

Unit is exceedingly aged and used phased out R22 refrigerant. - AssetCALC ID: 10204230

Uniformat Code: D3030
Recommendation: **Replace in 2027**

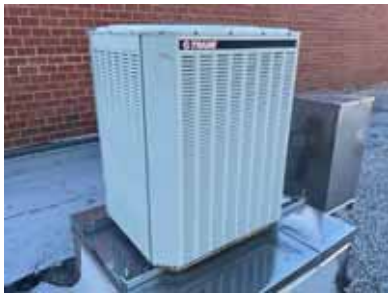
Split System in Poor condition.

Condensing Unit/Heat Pump
Main Building Bethesda Elementary School
Roof

Unit is exceedingly aged and used phased out R22 refrigerant. - AssetCALC ID: 10204218

Uniformat Code: D3030
Recommendation: **Replace in 2027**

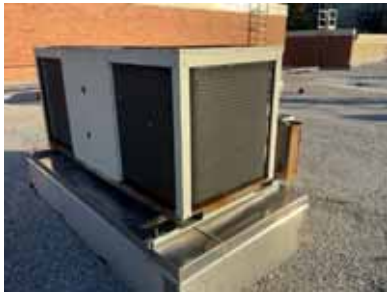
Split System in Poor condition.

Condensing Unit/Heat Pump
Main Building Bethesda Elementary School
Roof

Unit is exceedingly aged and used phased out R22 refrigerant. - AssetCALC ID: 10204179

Uniformat Code: D3030
Recommendation: **Replace in 2027**

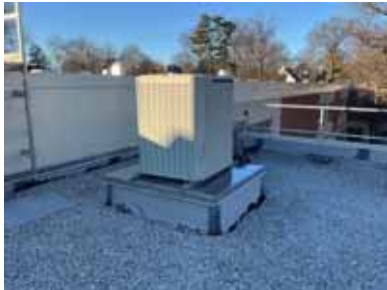
Split System in Poor condition.

Condensing Unit/Heat Pump
Main Building Bethesda Elementary School
Roof

Unit is exceedingly aged and used phased out R22 refrigerant. - AssetCALC ID: 10204106

Uniformat Code: D3030
Recommendation: **Replace in 2027**

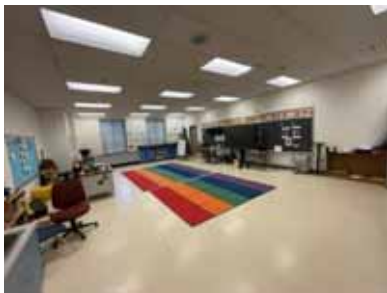
**Recommended Follow-up Study:
Environmental, Analysis of
Suspect Fungal Growth**

Environmental, Analysis of Suspect Fungal
Growth
Main Building Bethesda Elementary School
Classrooms

Additional Studies	Poor indoor air quality and mold was reported in rooms 141,144,145,146,148, 213,224,226, and 228. A consultant must be retained to analyze the existing condition, provide recommendations and, if necessary, estimate the scope and cost of any required repairs. The cost of this study is included in the cost tables. Due to the ambiguity of the required repair scope at the time of this assessment, the cost for any possible subsequent repairs is not included.	
Areas Observed	Most of the interior spaces were observed to gain a clear understanding of the facility's overall condition. Other areas accessed and assessed included the exterior equipment and assets directly serving the building, the exterior walls of the facility, and the roofs.	
Key Spaces Not Observed	All key areas of the facility were accessible and observed.

Uniformat Code: P2030
Recommendation: **Evaluate/Report in 2026**
