# FACILITY CONDITION ASSESSMENT

**Montgomery County Public Schools**  
45 West Gude Drive, Suite 4000  
Rockville, MD 20850

Bradley Hills Elementary School  
8701 Hartsdale Avenue  
Bethesda, MD 20817

*October 13, 2025*

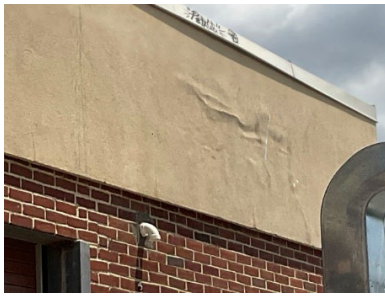
### Exterior Walls in Poor condition.

Isolated area of damaged EIFS wall on the exterior of the commercial kitchen. - AssetCALC ID: 9618825

Uniformat Code: B2010  
Recommendation: **Repair in 2025**

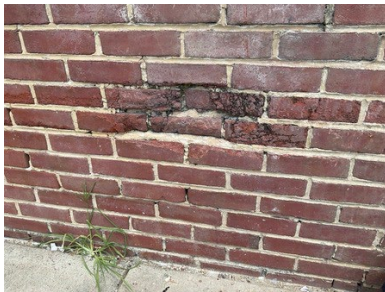
### Exterior Walls in Poor condition.

Exterior bricks/mortar joints damage along lower walls at the loading dock area. - AssetCALC ID: 9618902

Uniformat Code: B2010  
Recommendation: **Repair in 2026**

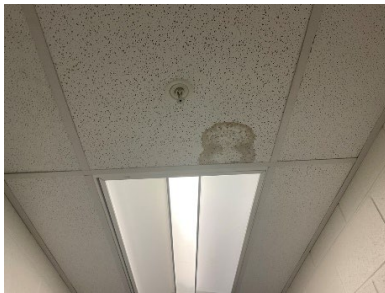
### Roofing in Poor condition.

Active roof leaks reportedly above the main office area and in classroom 204. Both roof leak areas are below the green roof system. - AssetCALC ID: 9618827

Uniformat Code: B3010  
Recommendation: **Repair in 2025**

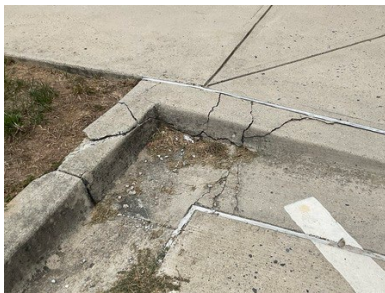
### Sidewalk in Poor condition.

Isolated areas of crack and spalled concrete sidewalks on the rear and sides of the building, as well as in the courtyard area. Portions of the adjacent concrete curb also have cracked concrete. - AssetCALC ID: 9618965

Uniformat Code: G2030  
Recommendation: **Repair in 2025**

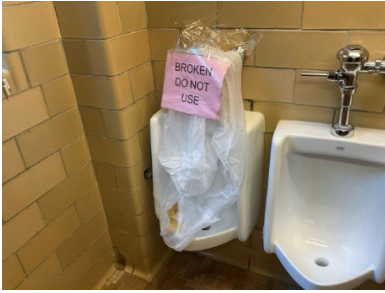
### Urinal in Failed condition.

There is one broken wall-mounted urinal in the boy's restroom by the lobby. - AssetCALC ID: 9618936

Uniformat Code: D2010  
Recommendation: **Replace in 2025**

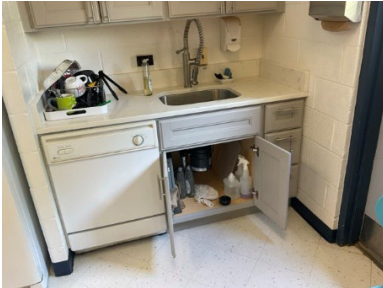
ADA Restroom sinks, some are missing wraps - AssetCALC ID: 9618926

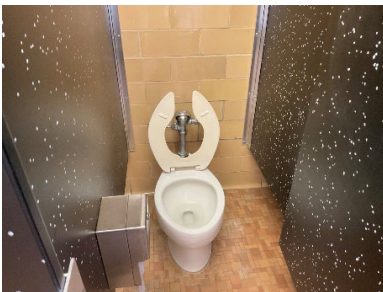
Potential moderate/major issues have been identified at this building and a detailed accessibility study is recommended. See the appendix for associated photos and additional information. - AssetCALC ID: 9618939

Uniformat Code: Y1090  
Recommendation: **Evaluate/Report in 2025**
