FACILITY CONDITION ASSESSMENT

Brooke Grove Elementary School
2700 Spartan Road
Olney, MD 20832

172559.25R000-012.354

May 1, 2026

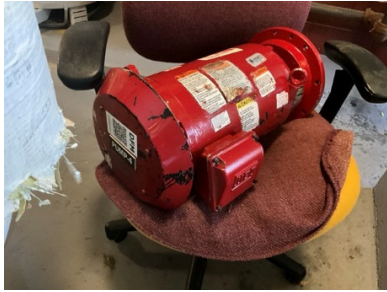
Pump in Failed condition.

Distribution, HVAC Chilled or Condenser Water
Main Building Brooke Grove Elementary
School Boiler Room

The pump is out of service waiting repairs - AssetCALC ID: 10265580

Uniformat Code: D3050
Recommendation: **Replace in 2026**

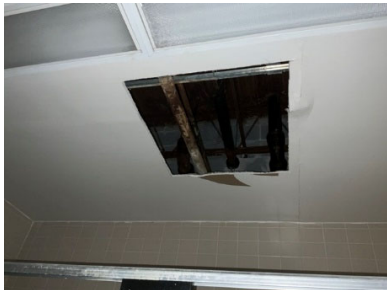
Interior Construction in Poor condition.

any type, Repairs per Man-Day
Main Building Brooke Grove Elementary
School Boys restroom

Cost allowance for dry wall repairs - AssetCALC ID: 10265610

Uniformat Code: C1010
Recommendation: **Repair in 2026**

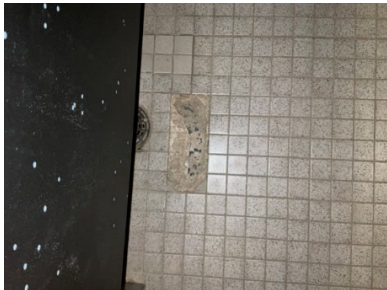
Interior Construction in Poor condition.

any type, Repairs per Man-Day
Main Building Brooke Grove Elementary
School Boys restroom near gym

Cost allowance to repair lifting tiles - AssetCALC ID: 10265590

Uniformat Code: C1010
Recommendation: **Repair in 2026**

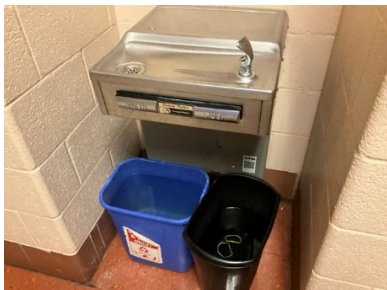
Drinking Fountain in Poor condition.

Wall-Mounted, Single-Level
Main Building Brooke Grove Elementary
School Across from room 10

Fountain has leaking issue - AssetCALC ID: 10265645

Uniformat Code: D2010
Recommendation: **Replace in 2027**

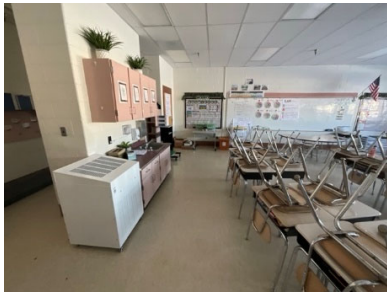
Environmental, Analysis of Suspect Fungal Growth
Main Building Brooke Grove Elementary
School Rooms 11H/18 and other areas

There are reported indoor air quality issues that could potentially be fungal growth - AssetCALC ID: 10265643

**Recommended Follow-up Study:
Environmental, Analysis of
Suspect Fungal Growth**

Uniformat Code: P2030
Recommendation: **Evaluate/Report in 2026**

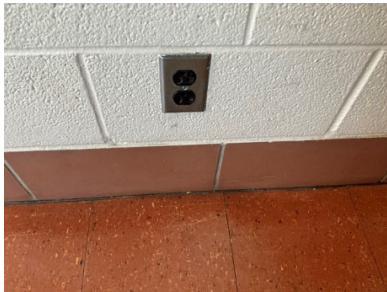
Electrical, General Design
Main Building Brooke Grove Elementary
School Throughout Building

It was reported that corridor receptacle are inadequate to manage multiple large cleaning equipment at once. - AssetCALC ID: 10265644

**Recommended Follow-up Study:
Electrical, General Design**

Uniformat Code: P2030
Recommendation: **Design in 2026**

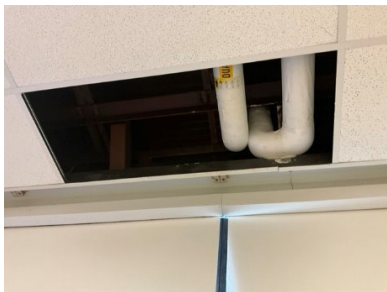
Mechanical, General Design
Main Building Brooke Grove Elementary
School Room 9/ and adjoining classrooms

It was reported that the back wall along the windows of the first floor classrooms have leaking issues from 2nd floor. - AssetCALC ID: 10265561

**Recommended Follow-up Study:
Mechanical, General Design**

Uniformat Code: P2030
Recommendation: **Design in 2027**

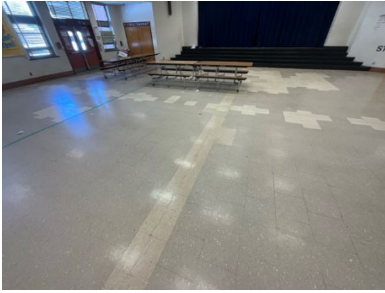
Flooring in Poor condition.

Vinyl Tile (VCT)
Main Building Brooke Grove Elementary
School Cafeteria

The floor has several patches and cracks throughout. - AssetCALC ID: 10265575

Uniformat Code: C2030
Recommendation: **Replace in 2027**

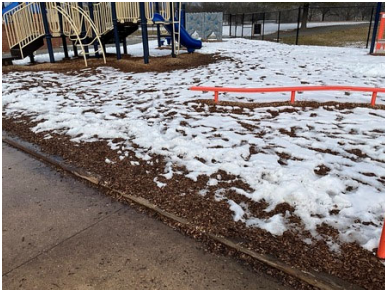
Site maintenance appeared to be adequate. The asphalt pavement and concrete sidewalk appeared to be in fair condition. It was reported that mulch from the playground surface was clogging the drain, causing a drainage issue. Replacement with pour-in-place rubber is recommended to mitigate the problem.

Playfield Surfaces in Poor condition.

Rubber, Poured-in-Place
Site Brooke Grove Elementary School Site

Uniformat Code: G2050
Recommendation: **Replace in 2027**
