FACILITY CONDITION ASSESSMENT

Burnt Mills Elementary School
415 Prelude Drive
Silver Spring, MD 20901

172559.25R000-016.354

May 1, 2026

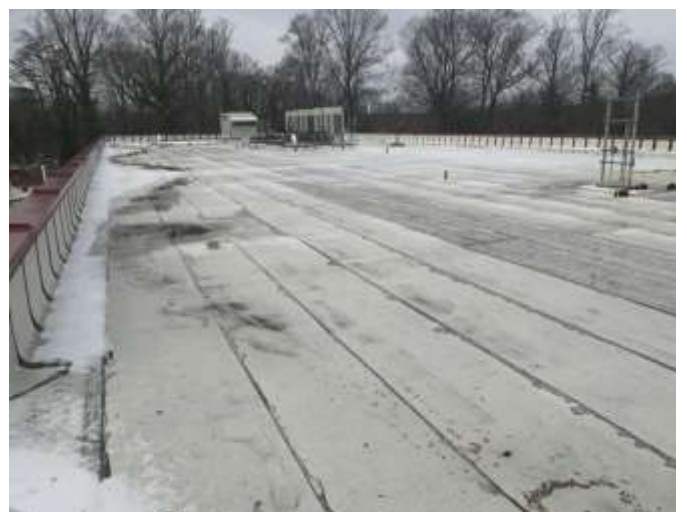
6 - MODIFIED BITUMEN ROOFING

The two-story building generally appears structurally sound, with no visible evidence of cracking or settlement. The structure is primarily open web steel joist supporting metal deck roof structure and all supported by structural steel framing and CMU bearing walls with brick and stone veneer. The roof coverings appear to be modified bitumen membrane for upper and lower sections. Lifecycle replacement of the roof coverings is not anticipated until very late in the reserve term.

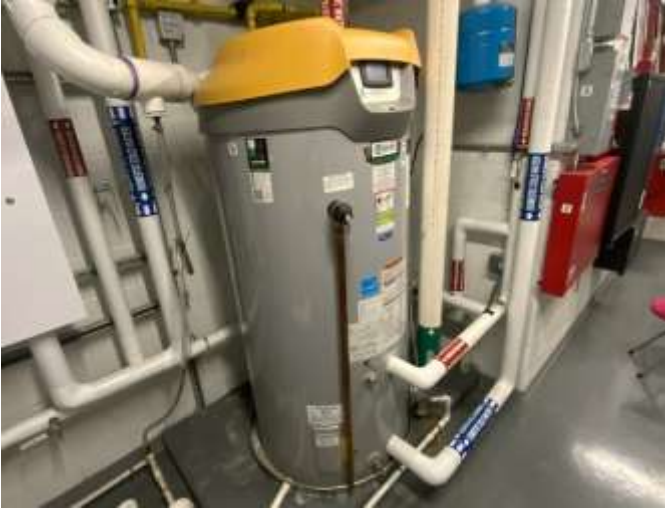
13 - WATER HEATER

Hot water for plumbing is provided by a gas fired condensing water heater which is in the main mechanical room. Water heater appears to be in good condition.

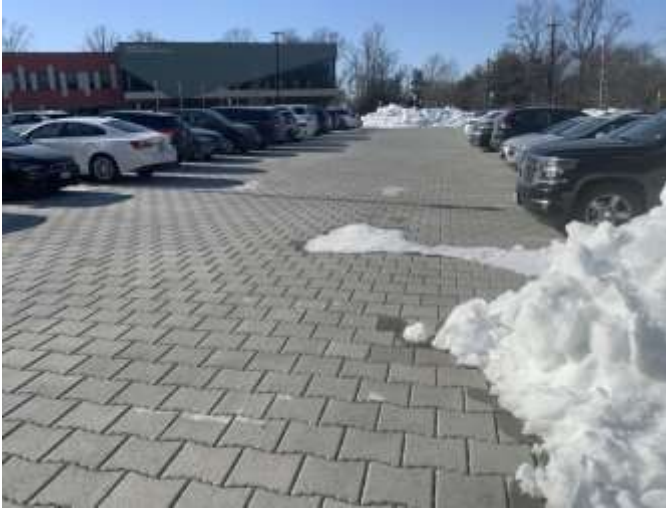
25 - PARKING AREA OVERVIEW

The new concrete paver parking lots are verified to be a 2023 installation and are in good condition as are the asphalt paved driveways. Pavement striping is beginning to fade and will require reinstallation within three years. Concrete sidewalk pavement is generally in good condition throughout the site. Site lighting is with pole-mounted LED for some fixtures and wall packs on the building exterior. Lifecycle replacement for site components including athletic courts and playground equipment is not anticipated within the reserve term.
