FACILITY CONDITION ASSESSMENT

Cabin Branch Elementary School
14129 Dunlin Street
Clarksburg, MD 20841

172559.25R000-018.354

May 26, 2026

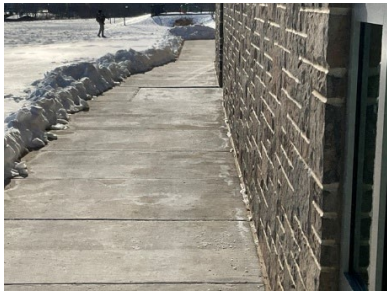
Sidewalk in Poor condition.

any pavement type, Sectional Repairs (per Man-Day)
 Site Cabin Branch Elementary School Building exits

All exterior doors have sinking concrete pad in front of them - AssetCALC ID: 10724982

Uniformat Code: G2030
 Recommendation: **Repair in 2026**

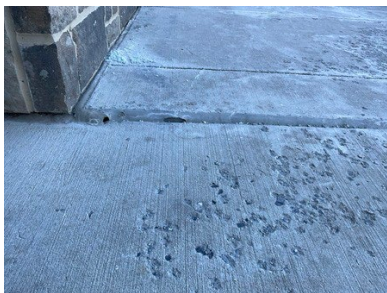
Sidewalk in Poor condition.

any pavement type, Sectional Repairs (per Man-Day)
 Site Cabin Branch Elementary School Site

Concrete chipping and spalling around overhead dock door - AssetCALC ID: 10393343

Uniformat Code: G2030
 Recommendation: **Repair in 2026**

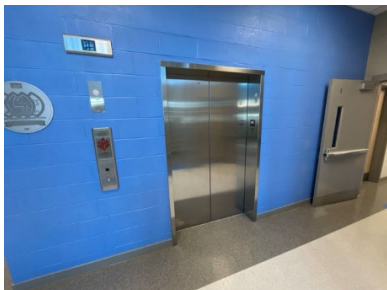
Passenger Elevator in Poor condition.

Hydraulic, 2 Floors
 Main Building Cabin Branch Elementary School Lobby

Elevator had been out of service for 2 weeks at time of assessment. There are no other ADA accessible means of access to the second floor of the building. - AssetCALC ID: 10393362

Uniformat Code: D1010
 Recommendation: **Renovate in 2027**

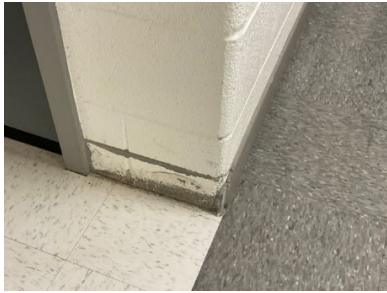
Interior Construction in Poor condition.

Any Type, Repairs per Worker-Day
Main Building Cabin Branch Elementary School
Near Boiler Room

Uniformat Code: C1010
Recommendation: **Repair in 2026**
