FACILITY CONDITION ASSESSMENT

Montgomery County Public Schools
45 West Gude Drive, Suite 4000
Rockville, MD 20850

Cannon Road Elementary School
901 Cannon Road
Silver Spring, MD 20904

February 26, 2026

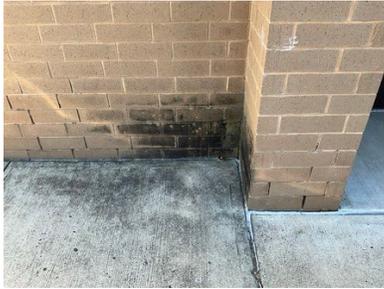
Exterior Walls in Poor Condition.

Brick/Masonry/Stone, Clean & Seal
Main Building Cannon Road Elementary
School Building Exterior

Several areas of staining observed on all sides of the building - AssetCALC ID: 9959030

Uniformat Code: B2010
Recommendation: **Maintain in 2026**

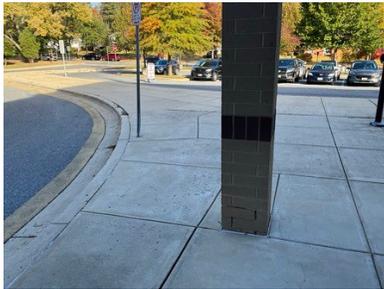
Sidewalk in Poor Condition.

Concrete, Large Areas
Site Cannon Road Elementary School Site

Spalling and pocking observed on concrete walkways. - AssetCALC ID: 9959021

Uniformat Code: G2030
Recommendation: **Replace in 2027**

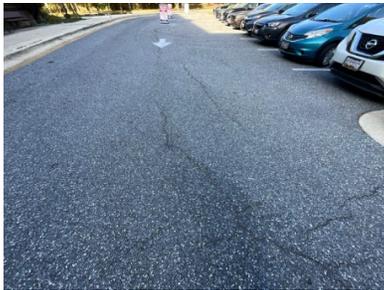
Parking Lots in Poor Condition.

Pavement, Asphalt
Site Cannon Road Elementary School Site

Alligator cracking observed, large cracks several areas of depression observed as well - AssetCALC ID: 9959063

Uniformat Code: G2020
Recommendation: **Mill & Overlay in 2027**

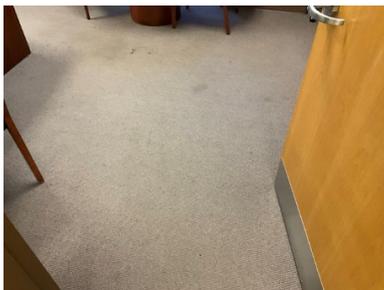
Flooring in Poor Condition.

Carpet, Commercial Standard
Main Building Cannon Road Elementary
School Office Areas and Library

Stained and worn carpet - AssetCALC ID: 9958938

Uniformat Code: C2030
Recommendation: **Replace in 2026**
