# FACILITY CONDITION ASSESSMENT

## **Montgomery County Public Schools**

Carderock Springs Elementary School

*May 1, 2026*

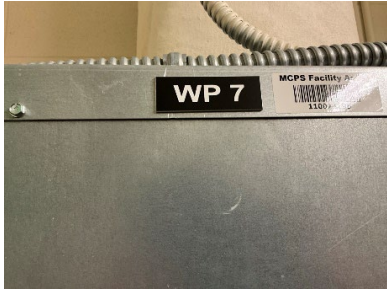
### Heat Pump in Poor condition.

Water Source, Interior Unit, 5 TON  
Main Building Carderock Springs Elementary  
School 18

Uniformat Code: D3030  
Recommendation: **Replace in 2026**
