FACILITY CONDITION ASSESSMENT

Montgomery County Public Schools

Rachel Carson Elementary School
100 Tschiffely Square Road
Gaithersburg, MD 20878

February 26, 2026

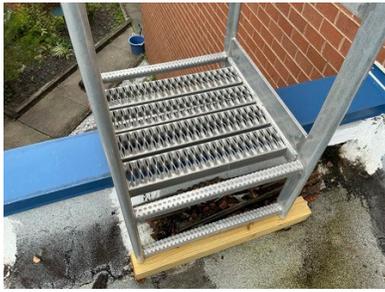
Roof Appurtenances in Poor condition.

Roof Access Ladder, Steel
Main Building Rachel Carson Elementary
School Roof Ladder

Roof ladder loose at top platform - AssetCALC ID: 9853237

Uniformat Code: B3020
Recommendation: **Replace in 2025**

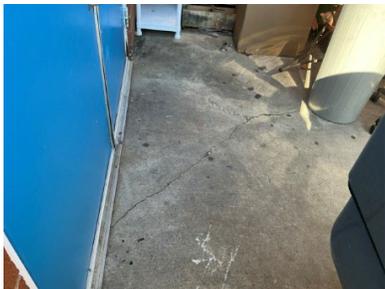
Loading Dock in Poor condition.

Concrete
Main Building Rachel Carson Elementary
School Building Exterior

Several large cracks throughout - AssetCALC ID: 9853145

Uniformat Code: B1010
Recommendation: **Replace in 2027**

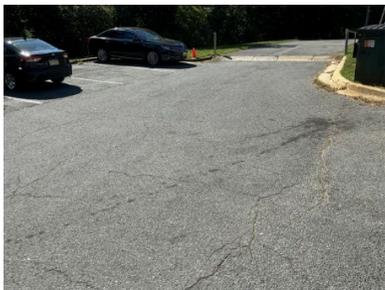
Parking Lots in Poor condition.

Pavement, Asphalt
Site Rachel Carson Elementary School Site
Parking Areas Left

Alligator and large cracks throughout - AssetCALC ID: 9863082

Uniformat Code: G2020
Recommendation: **Mill & Overlay in 2026**

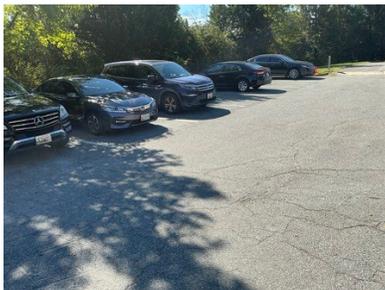
Parking Lots in Poor condition.

Pavement, Asphalt
Site Rachel Carson Elementary School Site
Parking Areas Left

Alligator and large cracks throughout - AssetCALC ID: 9863088

Uniformat Code: G2020
Recommendation: **Seal & Stripe in 2026**

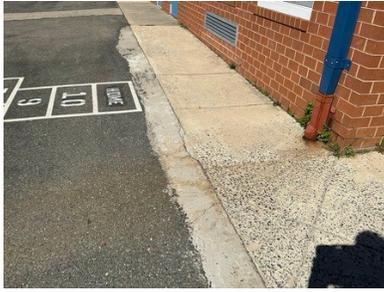
Parking Lots in Poor condition.

Pavement, Concrete
 Site Rachel Carson Elementary School Site Rear

Several cracks throughout - AssetCALC ID: 9863101

Uniformat Code: G2020
 Recommendation: **Replace in 2026**

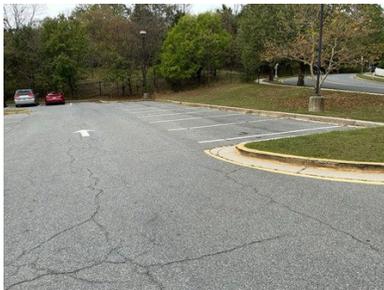
Parking Lots in Poor condition.

Pavement, Asphalt
 Site Rachel Carson Elementary School Right Parking Lot

Several cracks throughout - AssetCALC ID: 9863092

Uniformat Code: G2020
 Recommendation: **Seal & Stripe in 2026**

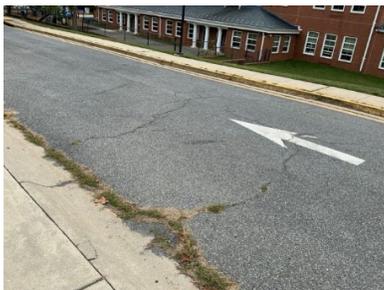
Parking Lots in Poor condition.

Pavement, Asphalt
 Site Rachel Carson Elementary School Right Parking Lot

Several large cracks throughout - AssetCALC ID: 9863097

Uniformat Code: G2020
 Recommendation: **Mill & Overlay in 2027**

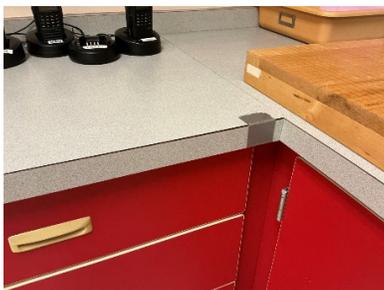
Casework in Failed condition.

Countertop, Plastic Laminate
 Main Building Rachel Carson Elementary School Workroom 103

Broken corners, delaminating and raised joints - AssetCALC ID: 9853193

Uniformat Code: E2010
 Recommendation: **Replace in 2025**

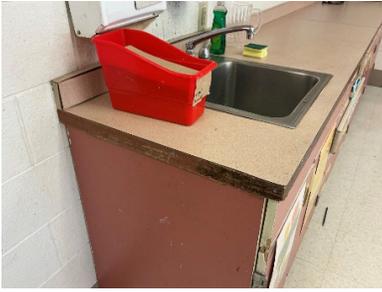
Casework in Poor condition.

Countertop, Plastic Laminate
Main Building Rachel Carson Elementary
School Art Room 120

Laminate missing at countertop edges. Laminate buckled at backflash - AssetCALC ID: 9853187

Uniformat Code: E2010
Recommendation: **Replace in 2025**

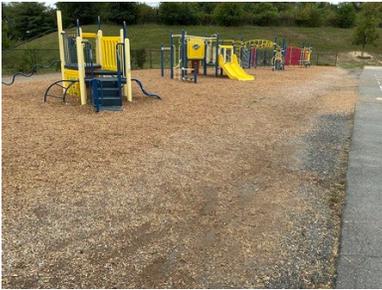
Playground Surfaces in Poor condition.

Chips Wood, 6" Depth
Site Rachel Carson Elementary School
Playgrounds

Asphalt below showing through - AssetCALC ID: 9863076

Uniformat Code: G2050
Recommendation: **Replace in 2026**

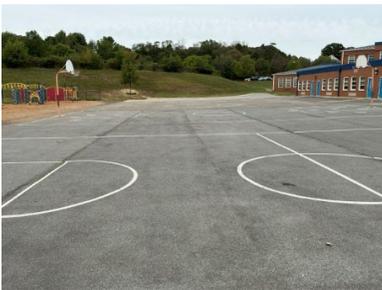
Athletic Surfaces & Courts in Poor condition.

Basketball/General, Asphalt Pavement
Site Rachel Carson Elementary School Rear
Play Area / Driveway

Large long cracks - AssetCALC ID: 9863099

Uniformat Code: G2050
Recommendation: **Replace in 2027**

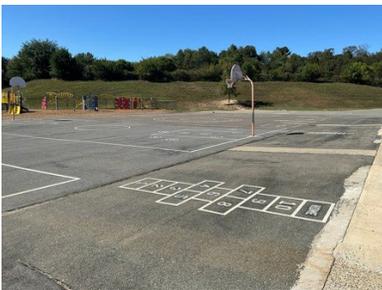
Athletic Surfaces & Courts in Poor condition.

Basketball/General, Asphalt Pavement
Site Rachel Carson Elementary School Rear
Play Area / Driveway

Large cracks throughout - AssetCALC ID: 9863087

Uniformat Code: G2050
Recommendation: **Seal & Stripe in 2027**

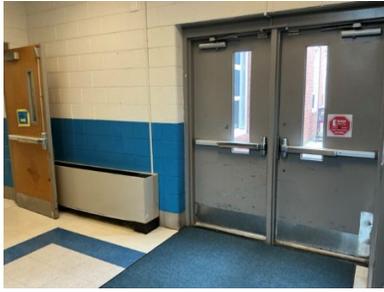
Exterior Door in Poor condition.

Steel, Commercial
 Main Building Rachel Carson Elementary
 School Building Exterior Doors 12

Doors not latching and weatherstripping bent - AssetCALC ID: 9853218

Uniformat Code: B2050
 Recommendation: **Replace in 2026**

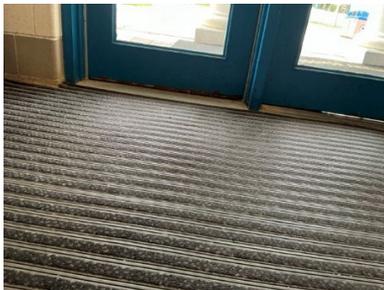
Exterior Door in Poor condition.

Aluminum-Framed & Glazed, Standard Swing
 Main Building Rachel Carson Elementary
 School Building Exterior

Large gap below doors. Missing weatherstripping and aged. - AssetCALC ID: 9853258

Uniformat Code: B2050
 Recommendation: **Replace in 2026**

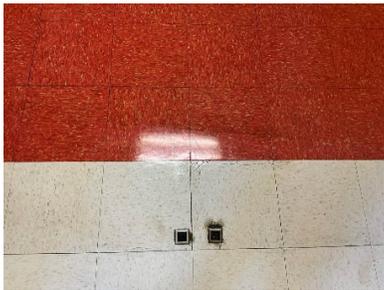
Flooring in Poor condition.

Vinyl Tile (VCT)
 Main Building Rachel Carson Elementary
 School Upper Lobby

Cracked and buckling tile - AssetCALC ID: 9853160

Uniformat Code: C2030
 Recommendation: **Replace in 2026**

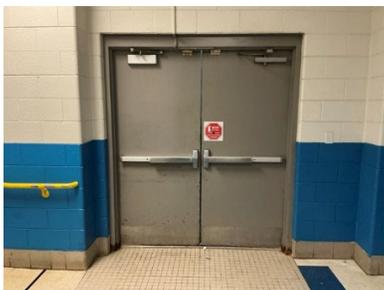
Exterior Door in Poor condition.

Steel, Commercial
 Main Building Rachel Carson Elementary
 School Loading Dock Door 2

Door frame badly rusted and doors weatherstripping bent causing a gap - AssetCALC ID: 9853214

Uniformat Code: B2050
 Recommendation: **Replace in 2026**

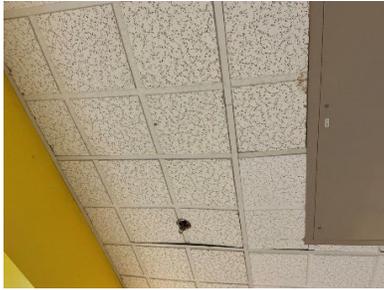
Suspended Ceilings in Poor condition.

Acoustical Tile (ACT)
Main Building Rachel Carson Elementary School Lobby

Broken and damaged tile throughout - AssetCALC ID: 9853183

Uniformat Code: C1070
Recommendation: **Replace in 2026**

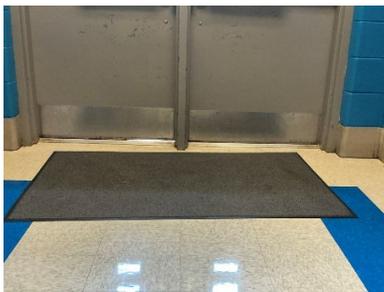
Exterior Door in Poor condition.

Steel, Commercial
Main Building Rachel Carson Elementary School Building Exterior

Missing weatherstripping and large gap below doors - AssetCALC ID: 9853174

Uniformat Code: B2050
Recommendation: **Replace in 2026**

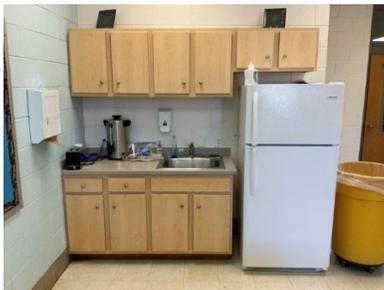
ADA Kitchen & Laundry Areas

Sink/Counter/Maneuverability, Full Reconfiguration
Main Building Rachel Carson Elementary School Staff Lounge 112

Uniformat Code: Y1060
Recommendation: **Renovate in 2025**
