# FACILITY CONDITION ASSESSMENT

**Montgomery County Public Schools**  
45 West Gude Drive, Suite 4000  
Rockville, MD 20850

Cashell Elementary School  
17101 Cashell Road  
Rockville, MD 20853

May 1, 2026

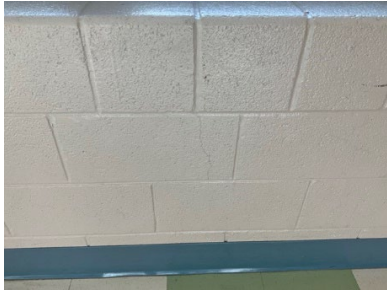
Building Envelope, Façade  
Main Building Cashell Elementary School  
Across from 164A

### Recommended Follow-up Study: Building Envelope, Façade

The wall has a crack which is a potential sign of settlement - AssetCALC ID: 10283212

Uniformat Code: P2030  
Recommendation: **Evaluate/Report in 2026**

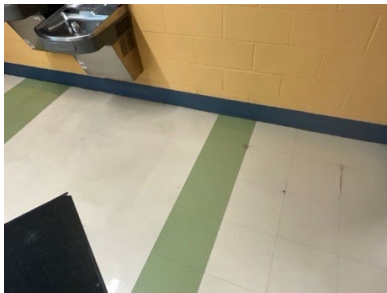
Vinyl Tile (VCT)  
Main Building Cashell Elementary School  
Throughout Building

### Flooring in Poor Condition.

The VCT flooring is lifting in localized areas. - AssetCALC ID: 10283199

Uniformat Code: C2030  
Recommendation: **Replace in 2027**

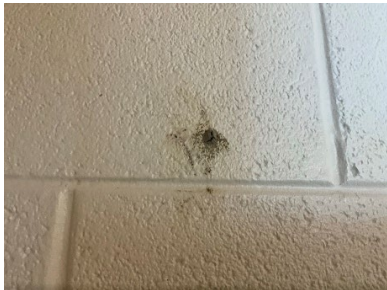
Building Envelope, Façade  
Main Building Cashell Elementary School 2nd  
floor

### Recommended Follow-up Study: Building Envelope, Façade

| <b>Additional Studies</b> | <p>The interior wall on the 2<sup>nd</sup> floor has holes forming from the inside of the wall. A professional architect must be retained to analyze the existing condition, provide recommendations and, if necessary, estimate the scope and cost of any required repairs. The cost of this study is included in the cost tables. Due to the ambiguity of the required repair scope at the time of this assessment, the cost for any possible subsequent repairs is not included.</p> <p>The wall is in poor condition. The wall on first floor across from 164A has a crack which could be a possible sign of settlement. A professional architect must be retained to analyze the existing condition, provide recommendations and, if necessary, estimate the scope and cost of any required repairs. The cost of this study is included in the cost tables. Due to the ambiguity of the required repair scope at the time of this assessment, the cost for any possible subsequent repairs is not included.</p> | |

Uniformat Code: P2030  
Recommendation: **Evaluate/Report in 2027**
