# FACILITY CONDITION ASSESSMENT

**Montgomery County Public Schools**  
45 West Gude Drive, Suite 4000  
Rockville, MD 20850

Clopper Mill Elementary School  
18501 Cinnamon Drive  
Germantown, MD 20874

*August 13, 2025*

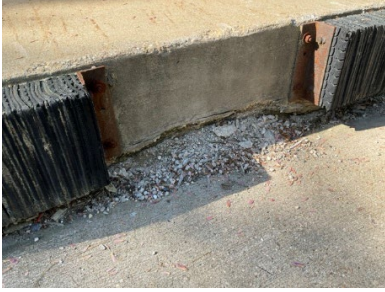
### Structural Flooring/Decking in Poor Condition.

Concrete  
Main Building Clopper Mill Elementary School  
Loading Dock

Isolated areas of cracked and spalled concrete loading dock (north side of building). - AssetCALC ID: 9273734

Uniformat Code: B1010  
Recommendation: **Repair in 2025**

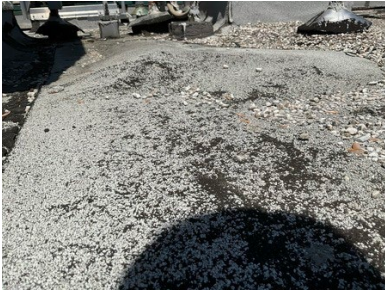
### Roofing in Poor Condition.

Any type, Repairs per Man-Day  
Main Building Clopper Mill Elementary School  
Roof

Isolated areas of blistering of the roof membrane around some of the rooftop HVAC equipment, with reported active leaks into the boiler room below. - AssetCALC ID: 9273837

Uniformat Code: B3010  
Recommendation: **Repair in 2025**

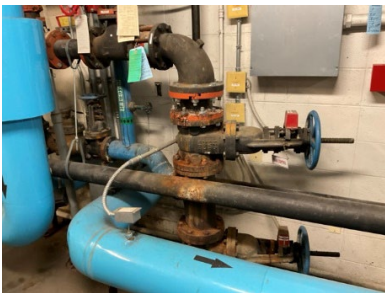
### Piping & Valves in Poor Condition.

Gate Valve, Fire Suppression  
Main Building Clopper Mill Elementary School  
Boiler Room

Fire suppression system has two gate valves that exhibit significant corrosion and leaks. - AssetCALC ID: 9273887

Uniformat Code: D4010  
Recommendation: **Replace in 2025**

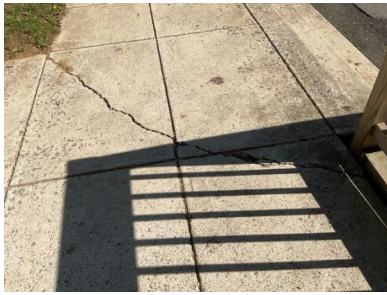
### Sidewalk in Poor Condition.

There are isolated areas of cracking and spalling concrete sidewalks on the north, west, and south sides of the building, with portions of deteriorated asphalt walkways by the portable classrooms. - AssetCALC ID: 9273715

Uniformat Code: G2030  
Recommendation: **Repair in 2025**

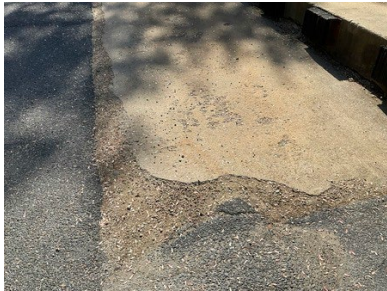
### Parking Lots in Poor Condition.

There are isolated areas of cracking and spalling concrete in-front of the loading dock (north side of building). - AssetCALC ID: 9273704

Uniformat Code: G2020  
Recommendation: **Repair in 2025**

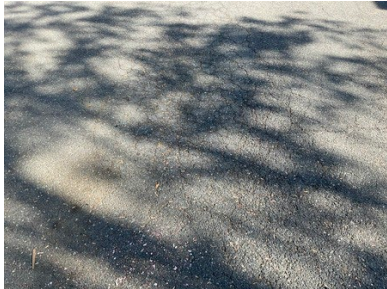
### Parking Lots in Poor Condition.

There are significant areas of alligator cracking and potholes along the drive aisles and secondary parking area on the north side of the property. - AssetCALC ID: 9273674

Uniformat Code: G2020  
Recommendation: **Cut & Patch in 2025**

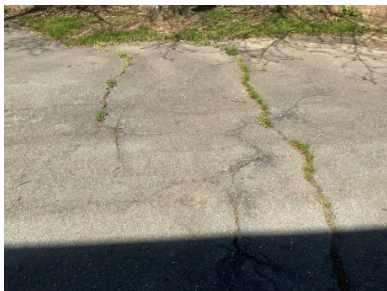
### Athletic Surfaces & Courts in Poor Condition.

There are significant areas of worn, cracking, and vertically displaced asphalt pavement due to mature tree root growth at the front play court (west side of building). - AssetCALC ID: 9273679

Uniformat Code: G2050  
Recommendation: **Mill & Overlay in 2025**

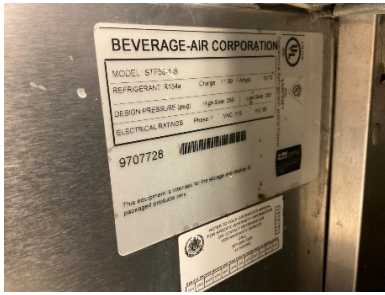
## Food Service Equipment in Failed Condition.

Refrigerator, Chest  
Main Building Clopper Mill Elementary School  
Commercial Kitchen

The chest refrigerator used for milk storage was reportedly non-functional; according to kitchen staff, the milk is stored in the walk-in and they must load and unload the milk for each lunch period. - AssetCALC ID: 9273752

Uniformat Code: E1030  
Recommendation: **Replace in 2025**

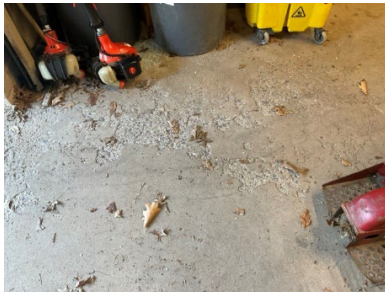
## Recommended Follow-up Study: Structural Superstructure

The concrete slab floor has portions in poor condition. The interior floors were observed with some cracked VCT floors, including the common area hallways along the main large hallway, and also cracked VCT floors at the service hallway, and other various common hallways in the building. The cracking at these locations' spans across the hallway between the CMU walls, however, no cracking of CMU walls noted. Additionally, the tractor garage concrete floor exhibits areas of spalling and the trash room has an area of deteriorated concrete with dip in the floor. A professional engineer must be retained to analyze the existing condition, provide recommendations and, if necessary, estimate the scope and cost of any required repairs. The cost of this study is included in the cost tables. A budgetary cost allowance to repair the floors is also included. - AssetCALC ID: 9309528

Uniformat Code: P2030  
Recommendation: **Evaluate/Report in 2025**

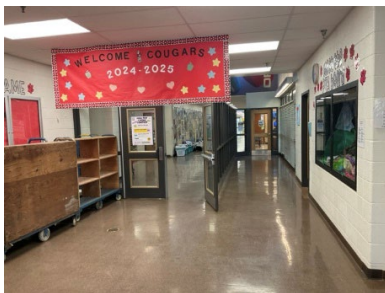
## Recommended Follow-up Study: Mechanical, General Design

The heating lamp; cooling of the school lobby area is inadequate, as it reportedly stays too cold during winter or too hot during warmer months. A professional engineer must be retained to analyze the existing condition, provide recommendations and, if necessary, estimate the scope and cost of any required repairs. The cost of this study is included in the cost tables. The cost of any HVAC upgrades cannot be accurately determined without the recommended study; however, costs are included for replacement of the existing HVAC system equipment. - AssetCALC ID: 9273735

Uniformat Code: P2030  
Recommendation: **Design in 2025**

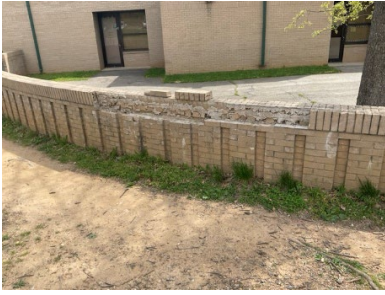
### Masonry Wall Fencing in Poor Condition.

There are damaged portions of the brick masonry wall fence on the front (west) side of the building. -  
AssetCALC ID: 9273678

Uniformat Code: G2060  
Recommendation: **Repair in 2025**

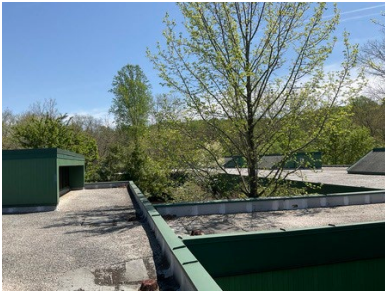
### Landscaping in Poor Condition.

There are overgrown trees overhanging the roof surfaces on the south side of the building and in the courtyard areas. - AssetCALC ID: 9273712

Uniformat Code: G2080  
Recommendation: **Repair in 2025**

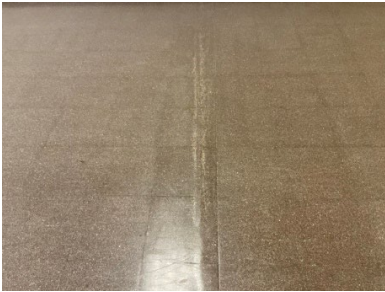
### Flooring in Poor Condition.

The concrete slab floor has portions in poor condition. The interior floors were observed with some cracked VCT floors, including the common area hallways along the main large hallway, and also cracked VCT floors at the service hallway, and other various common hallways in the building. The cracking at these locations' spans across the hallway between the CMU walls, however, no cracking of CMU walls noted. Additionally, the tractor garage concrete floor exhibits areas of spalling and the trash room has an area of deteriorated concrete with dip in the floor. A professional engineer must be retained to analyze the existing condition, provide recommendations and, if necessary, estimate the scope and cost of any required repairs. The cost of this study is included in the cost tables. A budgetary cost allowance to repair the floors are also included. -

Uniformat Code: C2030  
Recommendation: **Repair in 2025**

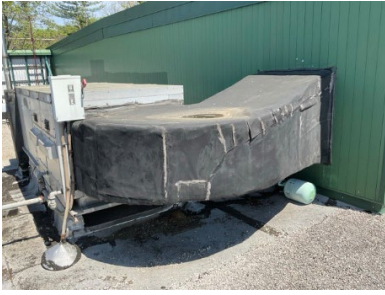
### HVAC System in Poor Condition.

The rubber membrane covering the rooftop ducts is worn and has open seams at MAU-1. - AssetCALC ID: 9273888

Uniformat Code: D3050  
Recommendation: **Replace in 2025**

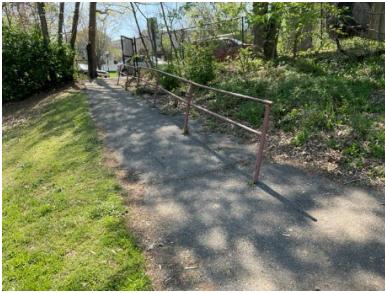
### Site Ramp in Poor Condition.

Cracking and sloping asphalt ramp with missing and bent metal guardrail - southwest side of sports field - AssetCALC ID: 9273701

Uniformat Code: G2030  
Recommendation: **Replace in 2025**

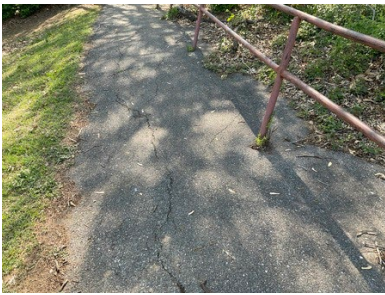
### Site Ramp in Poor Condition.

Cracking and sloping asphalt ramp with missing and bent metal guardrail - southwest side of sports field - AssetCALC ID: 9304811

Uniformat Code: G2030  
Recommendation: **Install in 2025**

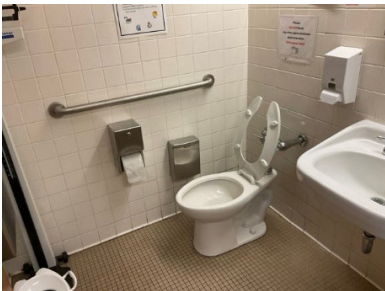
### ADA Restrooms

Grab Bars & Blocking, Height/Location  
Main Building Clopper Mill Elementary School  
ADA - Health room restroom

Uniformat Code: Y1050  
Recommendation: **Modify in 2025**
