# FACILITY CONDITION ASSESSMENT

**Montgomery County Public Schools**  
45 West Gude Drive, Suite 4000  
Rockville, MD 20850

Cold Spring Elementary School  
9201 Falls Chapel Way  
Potomac, MD 20854

*August 13, 2025*

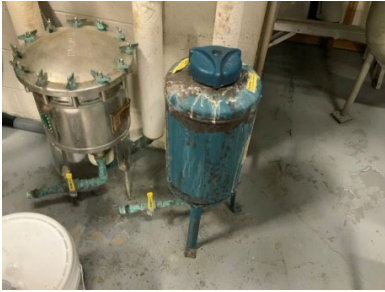
### Boiler Supplemental Components in Poor Condition.

Shot Feed Tank  
Main Building Cold Spring Elementary School  
Boiler Room

Tank is excessively corroded. - AssetCALC ID: 9208607

Uniformat Code: D3020  
Recommendation: **Replace in 2026**

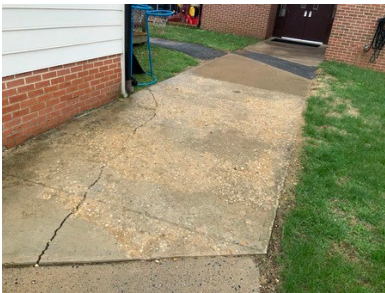
### Sidewalk in Poor Condition.

any pavement type, Sectional Repairs (per  
Man-Day)  
Site Cold Spring Elementary School Site

Cracked sidewalk, repairs recommended. - AssetCALC ID: 9208586

Uniformat Code: G2030  
Recommendation: **Repair in 2025**

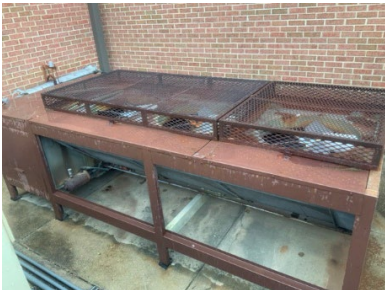
### Computer Room AC Unit in Poor Condition.

Air-Cooled, CRAC Drycooler/Condenser, 16 to  
20 TON  
Main Building Cold Spring Elementary School  
Building Exterior

Very outdated and corroded - AssetCALC ID: 9208528

Uniformat Code: D3030  
Recommendation: **Replace in 2026**

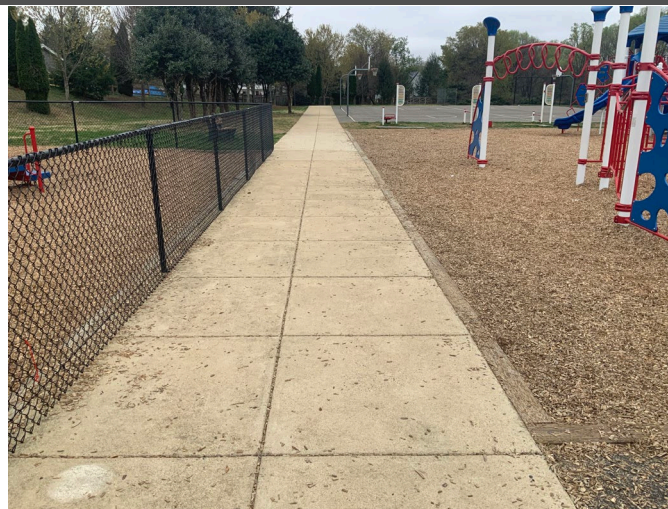
8 - SIDEWALK

Site maintenance appears to be excellent, and site improvements and landscaping are generally in good condition. Sidewalks have some areas of cracking, recommended to be repaired to prevent trip hazards. The playground and play structures are in fair condition. The chain link fencing is in good condition. Site lighting consists of HPS pole lights throughout.
