# FACILITY CONDITION ASSESSMENT

## **Montgomery County Public Schools**

Darnestown Elementary School  
15030 Turkey Foot Road  
Gaithersburg, MD 20878

*June 3, 2026*

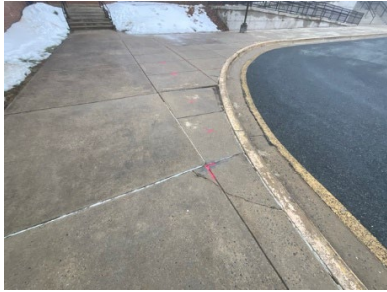
### Sidewalk in Poor condition.

Section of sidewalk near the stairs on the front of the building has sinking concrete creating a trip hazard. - AssetCALC ID: 10495185

Uniformat Code: G2030  
 Recommendation: **Repair in 2025**

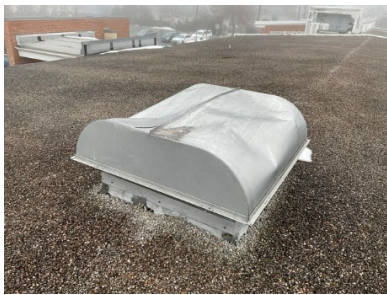
The vast majority of MEPF equipment was replaced in the 2013 renovation. There are a few older mechanical and electrical equipment but the oldest of them is from 2003. There are some older rooftop exhaust fans that appear to be functional, but one of the bigger ones has severe dents and damage to the housing.

### Exhaust Fan in Poor condition.

Fan housing is heavily dented and damaged. - AssetCALC ID: 10495089

Uniformat Code: D3060  
 Recommendation: **Replace in 2027**

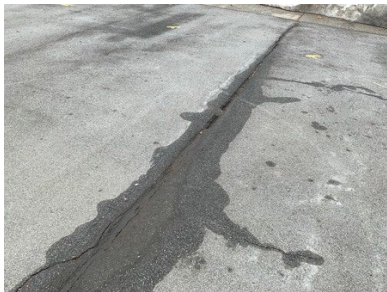
### Athletic Surfaces & Courts in Poor condition.

Large split running down the length of asphalt play surface directly adjacent to the school. - AssetCALC ID: 10495093

Uniformat Code: G2050  
 Recommendation: **Mill & overlay in 2027**

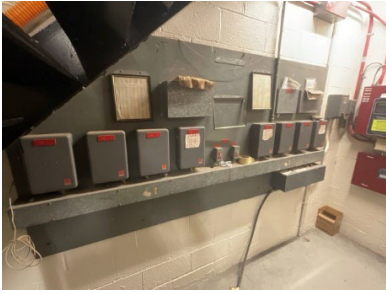
**BAS/HVAC Controls in Poor condition.**

The facility HVAC is controlled using an outdated pneumatic system supplied by an air compressor. For improved reliability and efficiency and increased control, full conversion to a web-based direct digital control (DDC) platform is highly recommended. The budgetary cost is included in the five-year plan. - AssetCALC ID: 10495103

Uniformat Code: D8010  
Recommendation: **Upgrade/Install in 2027**
