FACILITY CONDITION ASSESSMENT

Montgomery County Public Schools
45 West Gude Drive, Suite 4000
Rockville, MD 20850

DuFief Elementary School
15001 DuFief Drive
Gaithersburg, MD 20878

August 14, 2025

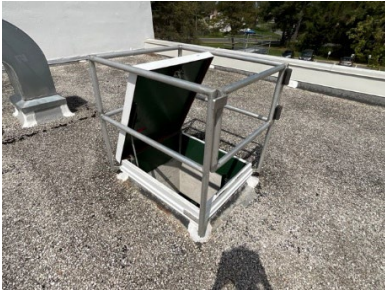
Roof Hatch in Poor condition.

The roof hatch has issues opening and closing which could be a safety concern for someone on a ladder - AssetCALC ID: 9222744

Uniformat Code: B3060
Recommendation: **Replace in 2025**

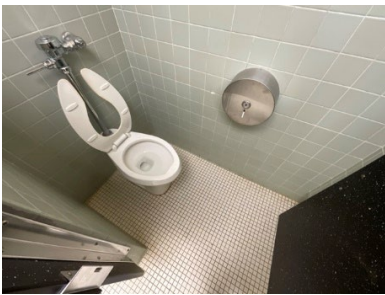
ADA Restrooms

Grab bars missing - AssetCALC ID: 9301760

Uniformat Code: Y1050
Recommendation: **Install in 2025**

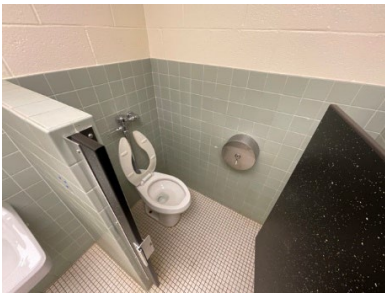
ADA Miscellaneous

Potential moderate/major issues have been identified at this building, and a detailed accessibility study is recommended. See the appendix for associated photos and additional information. - AssetCALC ID: 9222748

Uniformat Code: Y1090
Recommendation: **Evaluate/Report in 2025**

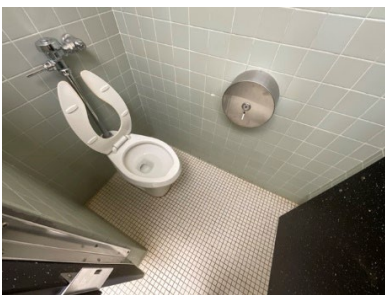
ADA Restrooms

Too small, not sufficient floor space - AssetCALC ID: 9301761

Uniformat Code: Y1050
Recommendation: **Modify in 2025**

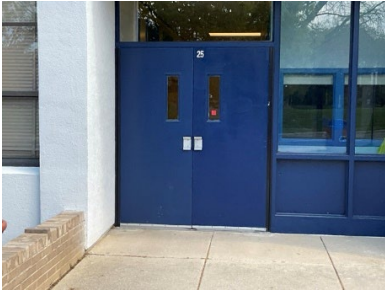
ADA Paths of Travel

No secondary signage observed - AssetCALC ID: 9301759

Uniformat Code: Y1020
Recommendation: **Install in 2025**

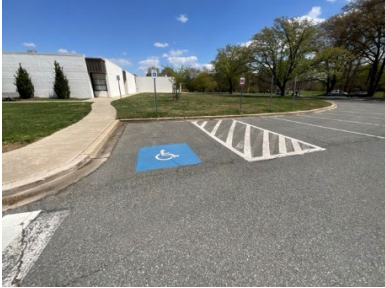
ADA Parking

No marked van accessible parking observed - AssetCALC ID: 9301762

Uniformat Code: Y1010
Recommendation: **Install in 2025**

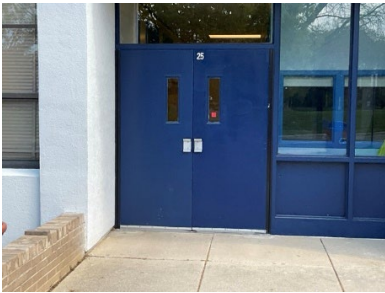
ADA Entrances and Doors

No secondary signage observed - AssetCALC ID: 9301757

Uniformat Code: Y1030
Recommendation: **Install in 2025**

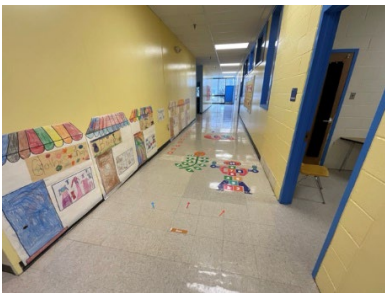
ADA Paths of Travel

No accessible area of refuge observed - AssetCALC ID: 9301758

Uniformat Code: Y1020
Recommendation: **Install in 2025**

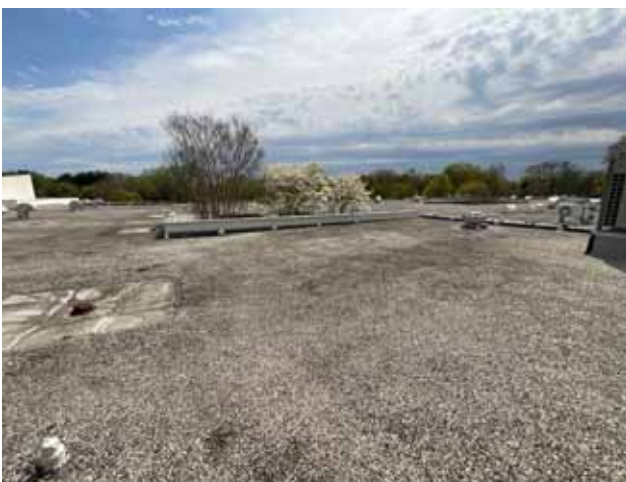
5 - ROOF

The building has masonry construction with a built-up roof. One leak was reported in the roof that is planned to be repaired in the near future. A majority of windows are aged but no major issues were reported. Although, they will likely need replacement in the coming years. Interior finishes were reportedly significantly renovated around five years ago and are anticipated for lifecycle replacement based on useful life and normal wear.

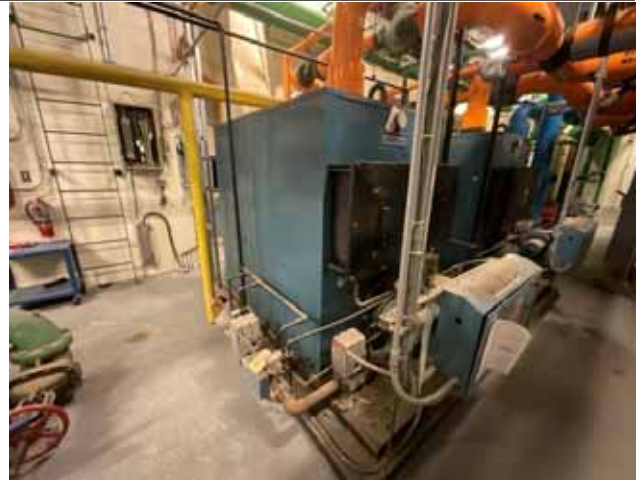
14 - BOILER

The building's HVAC is provided by boilers, chiller, and cooling tower with air handler and packaged units providing heating and cooling. Ventilation is provided by scattered exhaust fans on the roof. The boilers are nearing the end of their estimated useful life (EUL), but no major issues were reported or observed.

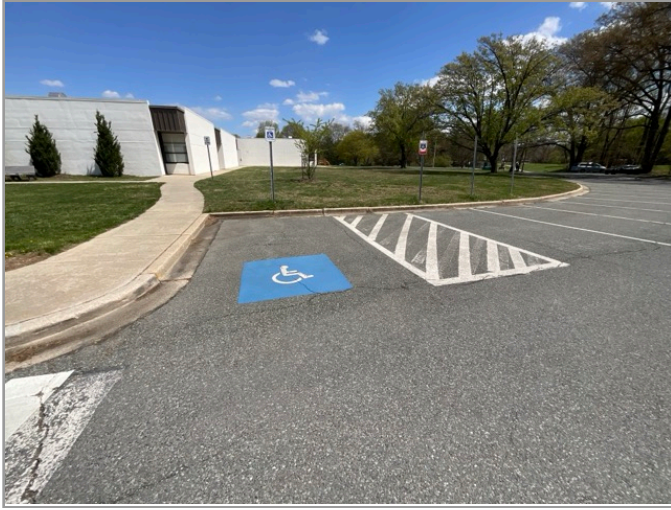
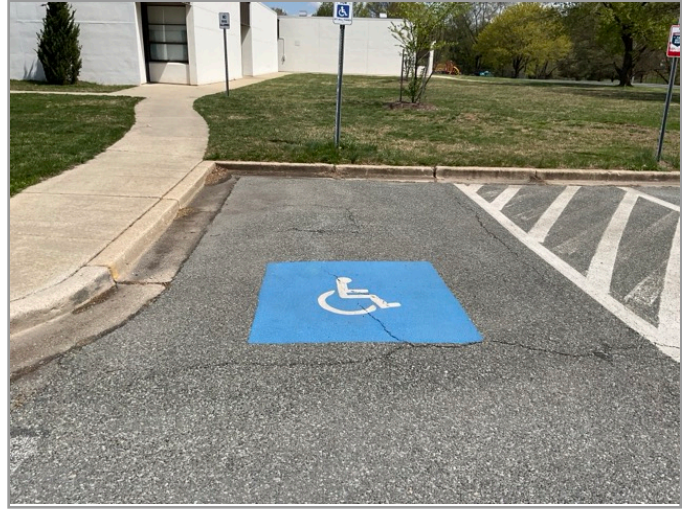
Question		Yes	No	NA	Comments
1	Does the required number of standard ADA designated spaces appear to be provided ?	✗			
2	Does the required number of van-accessible designated spaces appear to be provided ?		✗		No marked van accessible parking observed
3	Are accessible spaces on the shortest accessible route to an accessible building entrance ?	✗			
4	Does parking signage include the International Symbol of Accessibility ?	✗			
5	Does each accessible space have an adjacent access aisle ?	✗			
6	Do parking spaces and access aisles appear to be relatively level and without obstruction ?	✗

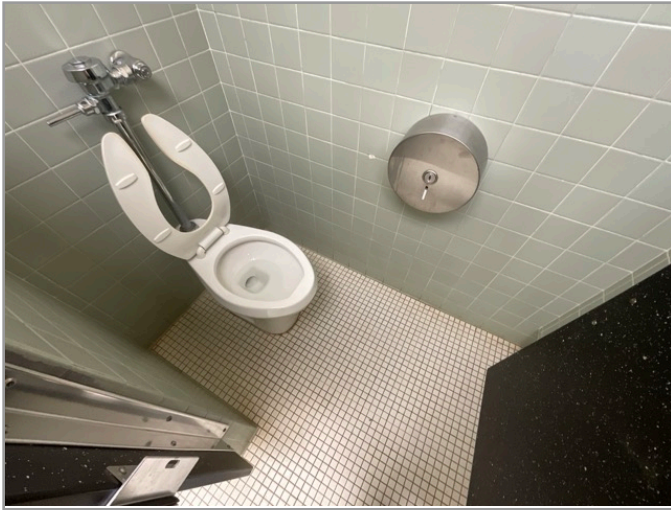
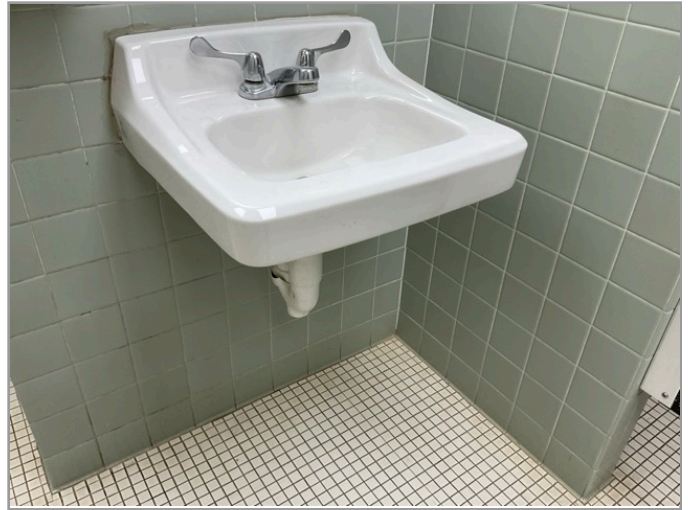
Question		Yes	No	NA	Comments
1	Do publicly accessible toilet rooms appear to have a minimum compliant floor area ?			✗	
2	Does the lavatory appear to be mounted at a compliant height and with compliant knee area ?	✗			
3	Does the lavatory faucet have compliant handles ?	✗			
4	Is the plumbing piping under lavatories configured to protect against contact ?	✗			
5	Are grab bars provided at compliant locations around the toilet ?		✗		Grab bars missing
6	Do toilet stall doors appear to provide the minimum compliant clear width ?		✗		Too small
