# FACILITY CONDITION ASSESSMENT

East Silver Spring Elementary School  
631 Silver Spring Avenue  
Silver Spring, MD 20910

172559.25R000-039.354

*August 20, 2025 (original)*  
*September 24, 2025 (revised)*

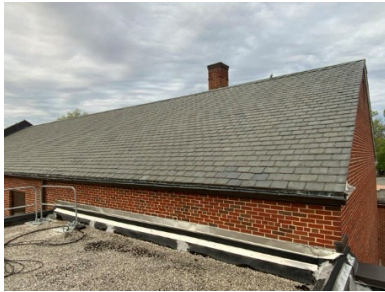
### Roofing in Poor condition.

Slate  
Main Building East Silver Spring Elementary  
School Cafeteria Roof

Many slate tiles are chipped and broken - AssetCALC ID: 9219169

Uniformat Code: B3010  
Recommendation: **Replace in 2027**

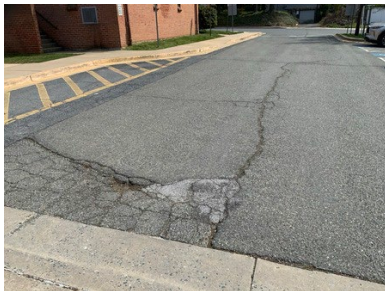
### Parking Lots in Failed condition.

Pavement, Asphalt  
Site East Silver Spring Elementary School Site  
Parking Areas

Severe alligator cracking observed in several locations - AssetCALC ID: 9219215

Uniformat Code: G2020  
Recommendation: **Cut & Patch in 2025**

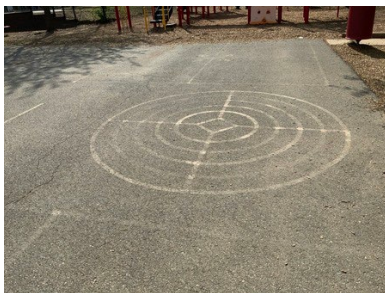
### Athletic Surfaces & Courts in Poor condition.

Basketball/General, Asphalt Pavement  
Site East Silver Spring Elementary School Site  
Playground Areas

Striping has not been redone since installation and has worn away - AssetCALC ID: 9219176

Uniformat Code: G2050  
Recommendation: **Seal & Stripe in 2025**

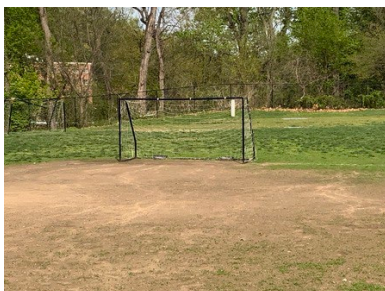
### Sports Apparatus in Poor condition.

Soccer, Movable Practice Goal  
Site East Silver Spring Elementary School Site  
Sports Fields & Courts

Goal frames damaged - AssetCALC ID: 9219189

Uniformat Code: G2050  
Recommendation: **Replace in 2026**

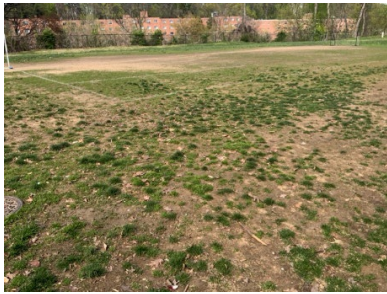
### Landscaping in Poor condition.

Turf/Sod  
Site East Silver Spring Elementary School Site  
Sports Fields & Courts

Grassy turf is worn away - AssetCALC ID: 9219089

Uniformat Code: G2080  
Recommendation: **Replace in 2026**

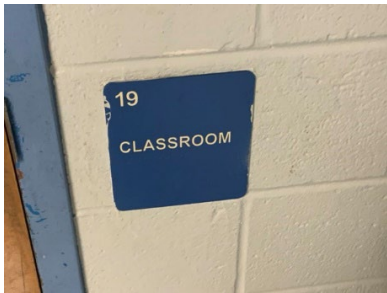
### Signage in Poor condition.

Wall-Mounted, Room Identification  
Main Building East Silver Spring Elementary  
School Throughout Building

Some of the interior room signage is missing or incorrect. The signage needs to be updated to match the most current FISH drawings. A budgetary cost is included. - AssetCALC ID: 9222547

Uniformat Code: C1090  
Recommendation: **Replace in 2026**

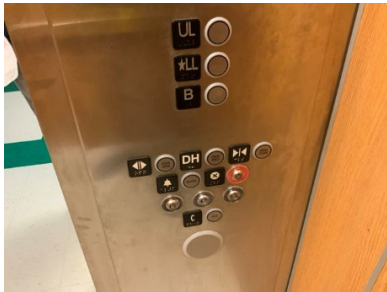
### ADA Elevators

Cabs, Control Panel (per Cab)  
Main Building East Silver Spring Elementary  
School

Missing tactile Braille characters mounted to the left of each elevator car control button. - AssetCALC ID: 9346645

Uniformat Code: Y1040  
Recommendation: **Renovate in 2025**

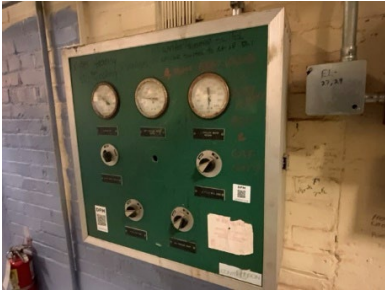
## BAS/HVAC Controls in Poor condition.

Basic System or Legacy Upgrades  
Main Building East Silver Spring Elementary  
School Boiler Room

The facility HVAC is controlled using an outdated pneumatic system supplied by an air compressor. For improved reliability and efficiency and increased control, full conversion to a web-based direct digital control (DDC) platform is highly recommended. A budgetary cost is included in the five-year plan. - AssetCALC ID: 9219132

Uniformat Code: D8010  
Recommendation: **Upgrade/Install in 2026**

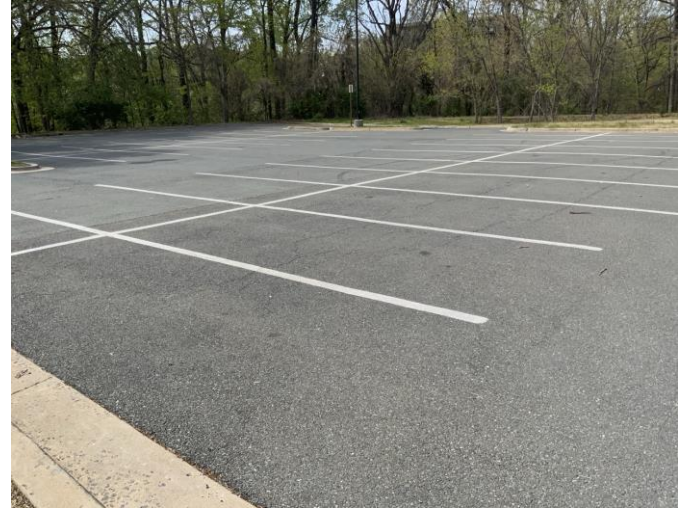
44 - ASPHALT PARKING LOTS

The asphalt parking lots are estimated to have been replaced in 2010 and exhibits signs of severe alligator cracking in several areas. Pavement striping is in good condition having been restriped recently. Site lighting is with pole-mounted LED fixtures and wall packs. Much of the playground equipment was installed in 2009 and lifecycle replacement is anticipated in the near term. It is recommended that the wood chip play surfaces be replaced in the near term with rubber play surfaces. Concrete sidewalks, for the most part, appear to be in fair condition having been installed in 1988.

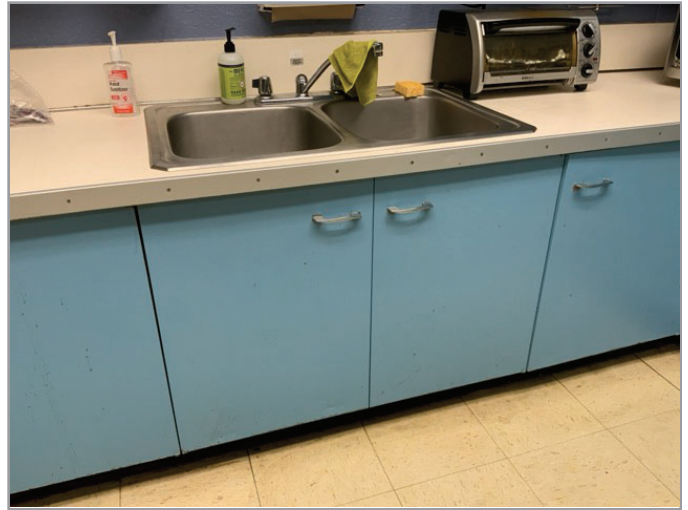
SINK CLEARANCE

Question		Yes	No	NA	Comments
1	Do kitchens/kitchenettes appear to have a minimum compliant path of travel or area of maneuverability ?	✗			
2	Are the appliances centered for a parallel or forward approach with adequate clear floor space ?	✗			
3	Is there an accessible countertop/preparation space of proper width and height ?	✗			
4	Is there an accessible sink space of proper width and height ?	✗			
5	Does the sink faucet have compliant handles ?	✗			
6	Is the plumbing piping under the sink configured to protect against contact ?		✗		No knee clearance under sink
