FACILITY CONDITION ASSESSMENT

Montgomery County Public Schools

Fallsmead Elementary School
1800 Greenplace Terrace
Rockville, MD 20850

April 10, 2026

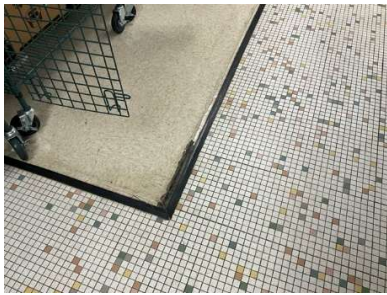
Interior Construction in Poor condition.

any type, Repairs per Man-Day
 Fallsmead Elementary School Fallsmead
 Elementary School Commercial Kitchen

Uniformat Code: C1010
 Recommendation: **Repair in 2026**

Cost allowance for broken VCT - AssetCALC ID: 10069786

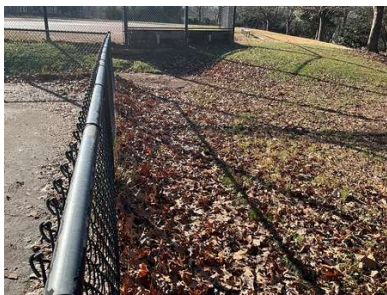
Recommended Follow-up Study: Civil, Site Drainage

Civil, Site Drainage
 Site Fallsmead Elementary School Site
 General

Uniformat Code: P2030
 Recommendation: **Evaluate/Report in 2026**

It was reported that the drain is continuously covered in dirt. - AssetCALC ID: 10069875

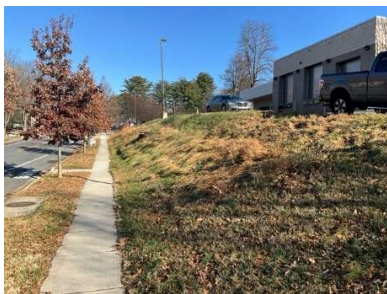
Landscaping in Poor condition.

Lawns & Grounds, Re-Establishment
 Site Fallsmead Elementary School Site

Uniformat Code: G2080
 Recommendation: **Repair in 2026**

It was reported that the hill is too steep to maintain. - AssetCALC ID: 10069884

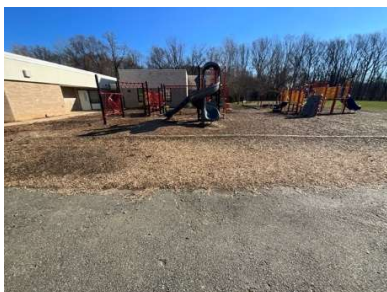
Playfield Surfaces

Rubber, Poured-in-Place
 Site Fallsmead Elementary School Site

Uniformat Code: G2050
 Recommendation: **Replace in 2027**
