FACILITY CONDITION ASSESSMENT

Flower Valley Elementary School
4615 Sunflower Drive
Rockville, MD 20853

172559.25R000-045.354

May 26, 2026

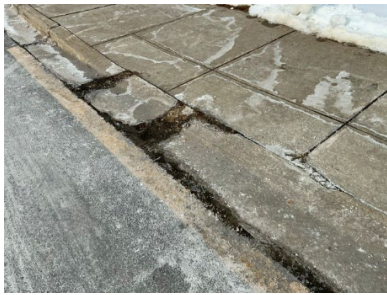
Parking Lots in Poor Condition.

Curb & Gutter, Concrete
 Site Flower Valley Elementary School Bus Loop

Broken and cracked curb - AssetCALC ID: 10294880

Uniformat Code: G2020
 Recommendation: **Replace in 2027**

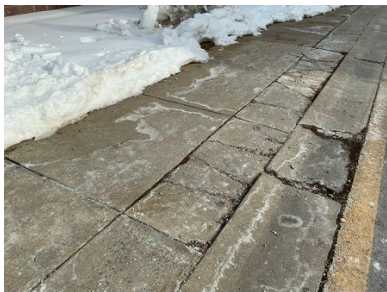
Sidewalk in Poor Condition.

Concrete, Small Areas/Sections
 Site Flower Valley Elementary School Bus Loop

Broken and cracked concrete sidewalk - AssetCALC ID: 10294881

Uniformat Code: G2030
 Recommendation: **Replace in 2027**

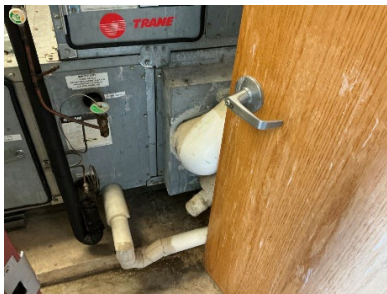
Interior Construction in Poor Condition.

Any type, Repairs per Man-Day
 Main Building Flower Valley Elementary School
 Mechanical Room 164

Door swings in and hits AHU piping. - AssetCALC ID: 10292034

Uniformat Code: C1010
 Recommendation: **Repair in 2026**

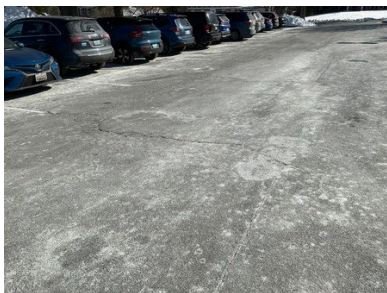
Parking Lots in Poor Condition.

Pavement, Asphalt
 Site Flower Valley Elementary School Site
 Parking Areas

Several alligator and large cracks. POC reports that parking lot floods continuously - AssetCALC ID: 10292111

Uniformat Code: G2020
 Recommendation: **Mill & Overlay in 2027**

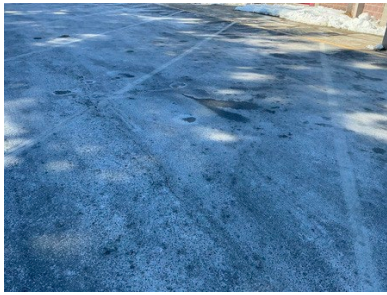
Parking Lots in Poor Condition.

Pavement, Asphalt
 Site Flower Valley Elementary School Bus Loop

POC reports that bus loop floods continuously - AssetCALC ID: 10292122

Uniformat Code: G2020
 Recommendation: **Mill & Overlay in 2027**

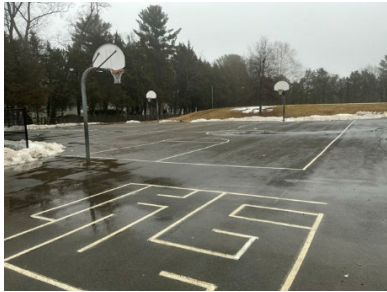
Athletic Surfaces & Courts in Poor Condition.

Basketball/General, Asphalt Pavement
 Site Flower Valley Elementary School Site Sports Court

Several large cracks and alligator cracking throughout - AssetCALC ID: 10292112

Uniformat Code: G2050
 Recommendation: **Mill & Overlay in 2027**

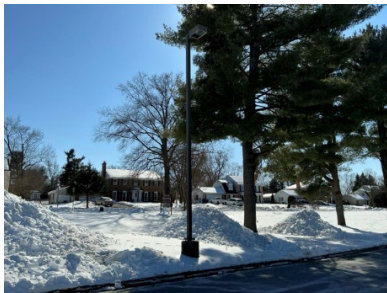
Pole Light Fixture with Lamps in Poor Condition.

Any type 20' High, with LED Replacement
 Site Flower Valley Elementary School Site Parking Areas

POC reports that lighting is dim and inadequate - AssetCALC ID: 10292107

Uniformat Code: G4050
 Recommendation: **Replace/Install in 2027**

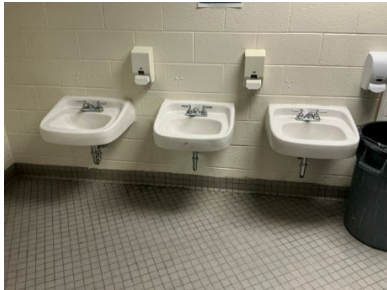
ADA Restrooms in Poor Condition.

Lavatory, Pipe Wraps/Insulation
Main Building Flower Valley Elementary School
Reception

Missing ADA pipe wrap at 6sinks in building - AssetCALC ID: 10292085

Uniformat Code: Y1050
Recommendation: **Install in 2026**

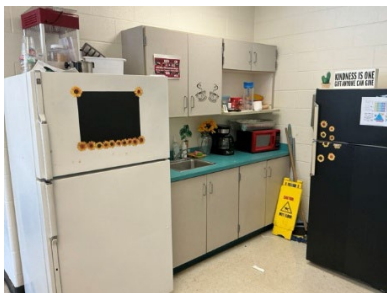
ADA Kitchen & Laundry Areas in Poor Condition.

Kitchen Sink & Counter, Full Reconfiguration
Main Building Flower Valley Elementary School
Staff Lounge 140

Uniformat Code: Y1060
Recommendation: **Renovate in 2027**
