FACILITY CONDITION ASSESSMENT

Montgomery County Public Schools

Galway Elementary School
12612 Galway Drive
Silver Spring, MD 20904

May 1, 2026

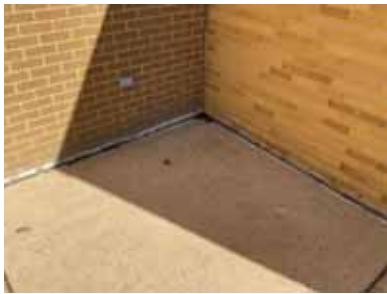
Sidewalk in Poor condition.

any pavement type, Sectional Repairs per Man-Day
 Site Galway Elementary School Site Parking Areas

Several areas where concrete is cracked or shifted to present trip hazards. Sealant around building and sidewalk is largely missing. - AssetCALC ID: 10050547

Uniformat Code: G2030
 Recommendation: **Repair in 2026**

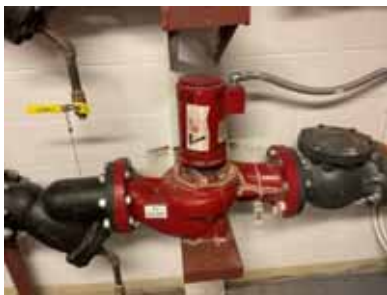
Pump in Poor condition.

Distribution, HVAC Heating Water
 Main Building Galway Elementary School Main Mechanical Room

Pump is heavily corroded around seams. - AssetCALC ID: 10048308

Uniformat Code: D3050
 Recommendation: **Replace in 2027**

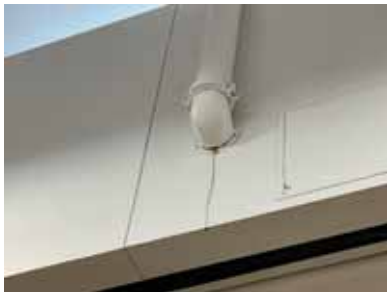
Plumbing System in Poor condition.

any type, Repairs per Man-Day
 Main Building Galway Elementary School Media Center

Pipe in media center has trail of leaking water. - AssetCALC ID: 10049870

Uniformat Code: D2010
 Recommendation: **Repair in 2025**

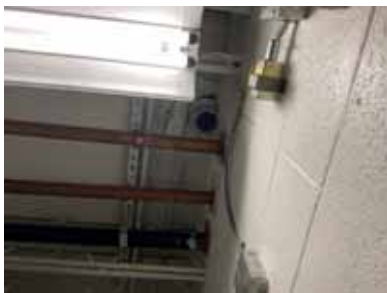
Plumbing System in Poor condition.

any type, Repairs per Man-Day
 Main Building Galway Elementary School 135

Drainpipe in ceiling is leaking onto the floor in mechanical room. - AssetCALC ID: 10049869

Uniformat Code: D2010
 Recommendation: **Repair in 2025**

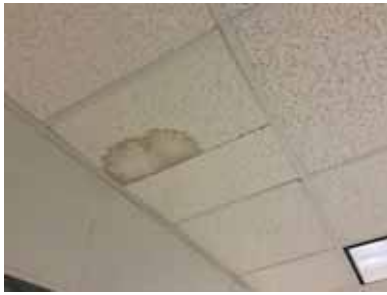
HVAC System in Poor condition.

any type, Repairs per Man-Day
 Main Building Galway Elementary School
 Hallway near room 167

Onsite contact noted major issues with this area leaking. Roofing company inspected and said it was an issue with HVAC or plumbing. - AssetCALC ID: 10049875

Uniformat Code: D3050
 Recommendation: **Repair in 2025**

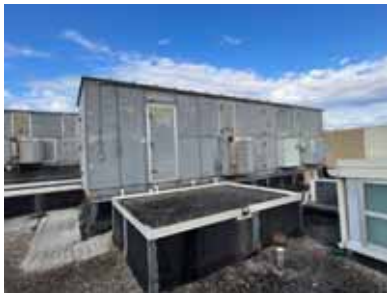
Air Handler in Poor condition.

Exterior AHU, 10001 to 15000 CFM
 Main Building Galway Elementary School Roof

Uniformat Code: D3050
 Recommendation: **Replace in 2027**
