# FACILITY CONDITION ASSESSMENT

**Montgomery County Public Schools**  
45 West Gude Drive, Suite 4000  
Rockville, MD 20850

Germantown Elementary School  
19110 Liberty Mill Road  
Germantown, MD 20874

*October 3, 2025*

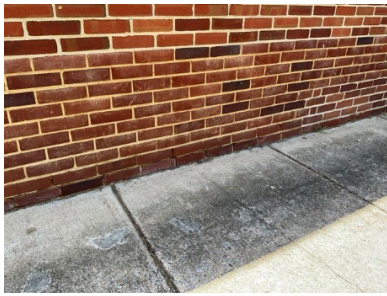
### Exterior Walls in Poor condition.

Brick or Brick Veneer, 1-2 Story Building  
Main Building Germantown Elementary School  
Building Exterior

Repoint brick where mortar has become deteriorated. - AssetCALC ID: 9714717

Recommendation: **Repair/Repoint in 2026**

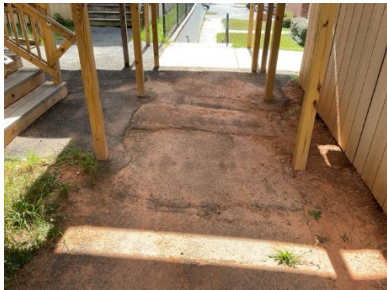
### Sidewalk in Poor condition.

Asphalt  
Site Germantown Elementary School Site  
General

The asphalt path by the modular units is cracked and uneven. - AssetCALC ID: 9712570

Recommendation: **Replace in 2026**

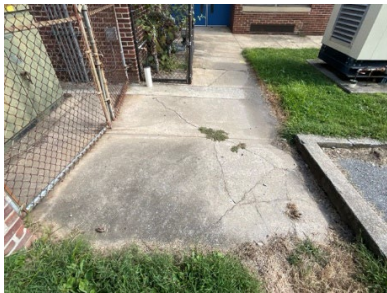
### Sidewalk in Poor condition.

Concrete, Small Areas/Sections  
Site Germantown Elementary School Site  
General

Cracking and deteriorated section of concrete walkways observed in various areas around the facility. - AssetCALC ID: 9712561

Recommendation: **Replace in 2027**

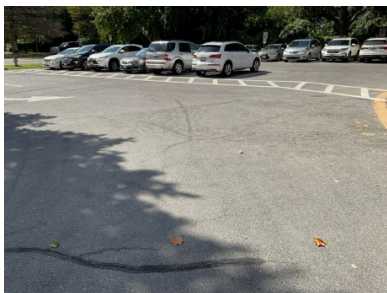
### Parking Lots in Poor condition.

Pavement, Asphalt  
Site Germantown Elementary School Site  
Parking Areas

Significant transverse cracking with alligator cracking in places to be sealed to maintain the overall integrity of the pavement system. - AssetCALC ID: 9712565

Recommendation: **Seal and Stripe in 2026**

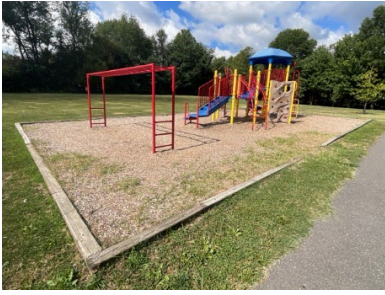
### Playground Surfaces in Poor condition.

Chips Wood, 6" Depth  
Site Germantown Elementary School Site  
Playground Areas

Wood chips have been overgrown with weeds and should be replaced. - AssetCALC ID: 9712560

Unifomat Code: G2050  
Recommendation: **Replace in 2026**

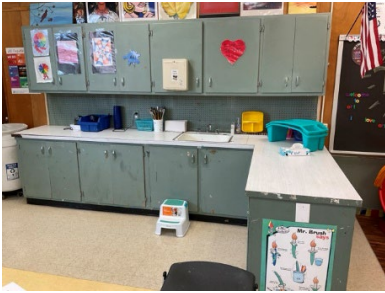
### Casework in Poor condition.

Countertop, Plastic Laminate  
Main Building Germantown Elementary School  
Art Classroom

Damaged on edges, replace with cabinetry. - AssetCALC ID: 9714691

Unifomat Code: E2010  
Recommendation: **Replace in 2027**

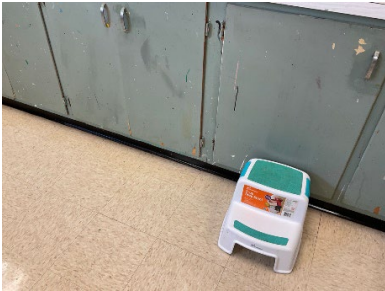
### Casework in Poor condition.

Cabinetry, Standard  
Main Building Germantown Elementary School  
Art Classroom

Cabinetry in art room is damaged with peeling paint and chipping wood. - AssetCALC ID: 9714764

Unifomat Code: E2010  
Recommendation: **Replace in 2027**

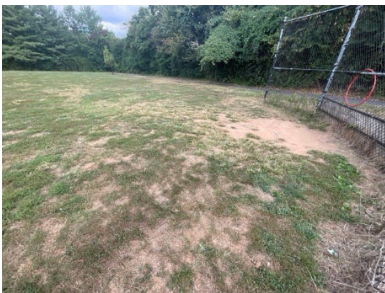
### Landscaping in Poor condition.

Eroded Areas, Sodding  
Site Germantown Elementary School Site  
Sports Fields and Courts

Eroded area of grass adjacent to field backstop. - AssetCALC ID: 9712567

Unifomat Code: G2080  
Recommendation: **Repair in 2025**

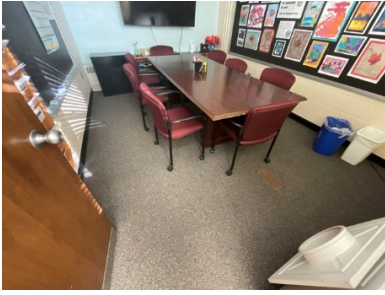
### Flooring in Poor condition.

Carpet, Commercial Standard  
Main Building Germantown Elementary School  
Main Office, Media Center

Aging carpet with areas of damage. - AssetCALC ID: 9714707

Uniformat Code: C2030  
Recommendation: **Replace in 2027**

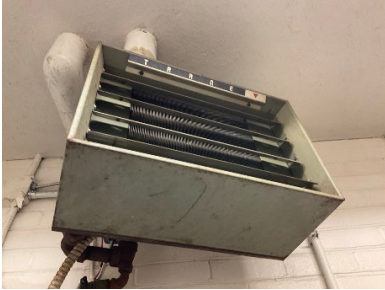
### Unit Heater in Poor condition.

Electric  
Main Building Germantown Elementary School  
Trash Room

Significant corrosion to unit. - AssetCALC ID: 9714714

Uniformat Code: D3020  
Recommendation: **Replace in 2027**

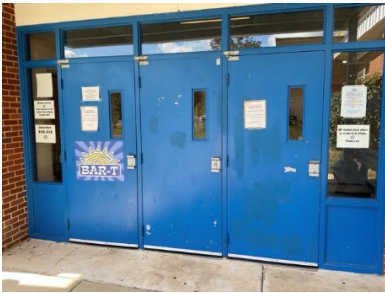
### Exterior Door in Poor condition.

Steel, any type  
Main Building Germantown Elementary School  
Building Exterior

Uniformat Code: B2050  
Recommendation: **Refinish in 2027**

Refinish all exterior doors. - AssetCALC ID: 9714780

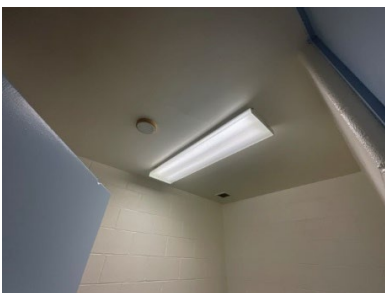
### Ceiling Finishes in Poor condition.

any flat surface  
Main Building Germantown Elementary School  
Restrooms

Uniformat Code: C2050  
Recommendation: **Prep and Paint in 2027**

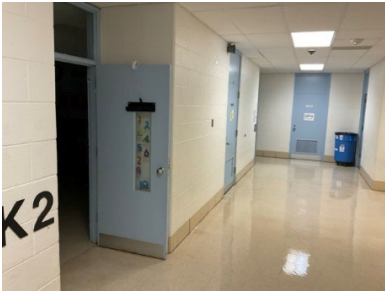
## ADA Entrances and Doors

Hardware, Lever Handle  
Main Building Germantown Elementary School  
Throughout Building

Doorknobs present throughout building. Replacement with lever handles is recommended. - AssetCALC ID: 9714771

Unifomat Code: Y1030  
Recommendation: **Install in 2025**

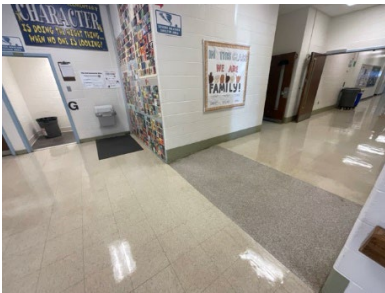
## ADA Paths of Travel

Ramp/Stair Handrails, Extensions  
Main Building Germantown Elementary School  
CR7-12 Hallway

Small section of ramp by CR7-12 does not have handrails. Installation of handrail extensions are recommended. - AssetCALC ID: 9714729

Unifomat Code: Y1020  
Recommendation: **Install in 2025**
