# FACILITY CONDITION ASSESSMENT

**Montgomery County Public Schools**  
45 West Gude Drive, Suite 4000  
Rockville, MD 20850

Glenallan Elementary School  
12520 Heurich Road  
Silver Spring, MD 20902

*May 4, 2026*

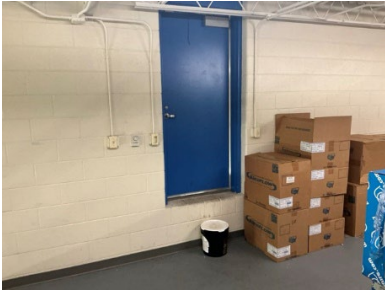
### Stairs in Poor Condition.

Metal or Pan-Filled, Interior  
Main Building Glenallan Elementary School  
Roof Access 247

No step to roof access door - AssetCALC ID: 10272039

Uniformat Code: B1080  
Recommendation: **Replace in 2026**

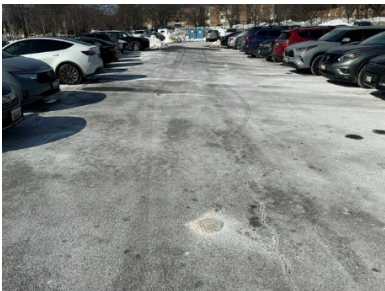
### Parking Lots in Poor Condition.

Pavement, Asphalt  
Site Glenallan Elementary School Site Parking  
Areas

Large cracks throughout - AssetCALC ID: 10272202

Uniformat Code: G2020  
Recommendation: **Seal & Stripe in 2027**

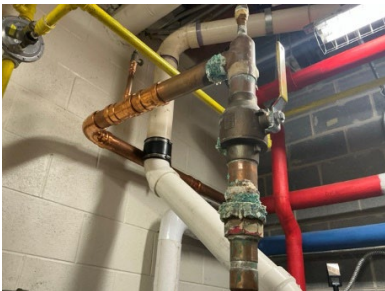
### Water Heater in Poor Condition.

Gas, High-Efficiency Condensing Style  
Main Building Glenallan Elementary School  
Mechanical Room 165

POC reports copper pipes are constantly leaking - AssetCALC ID: 10272004

Uniformat Code: D2010  
Recommendation: **Replace in 2026**

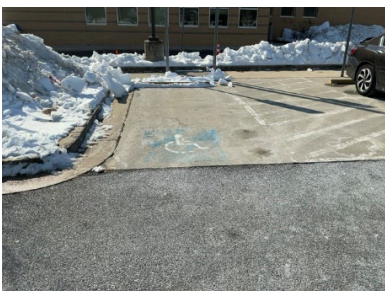
### ADA Parking in Poor Condition.

Designated Stall, Pavement Markings only  
Site Glenallan Elementary School Site Parking  
Areas

ADA stall markings and striping are worn off due to wear - AssetCALC ID: 10282676

Uniformat Code: Y1010  
Recommendation: **Install in 2026**

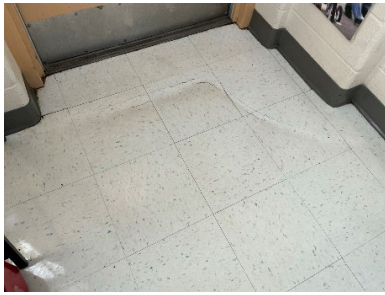
## Flooring in Poor Condition.

Concrete  
Main Building Glenallan Elementary School  
Classroom 119

Uniformat Code: C2030  
Recommendation: **Repair in 2027**
