FACILITY CONDITION ASSESSMENT

Greenwood Elementary School
3336 Gold Mine Road
Brookeville, MD 20833

172559.25R000-059.354

August 18, 2025

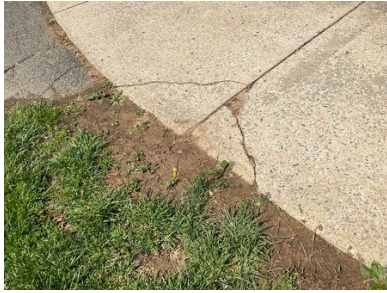
Sidewalk in Poor condition.

Concrete, Large Areas
Site Greenwood Elementary School Site
General

There are significant areas of spalling and cracking sidewalks on all sides of the school, with trip hazards along the front of the school between the sidewalk and curb. - AssetCALC ID: 9231334

Uniformat Code: G2030
Recommendation: **Replace in 2025**

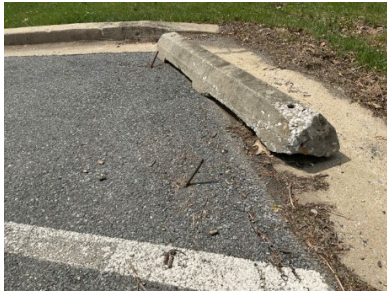
Parking Lots in Failed condition.

Wheel Stops, Concrete
Site Greenwood Elementary School Site ADA
Parking Areas

There are uplifted and misaligned concrete wheel stops, exposing sharp steel rebar, at the ADA parking areas. - AssetCALC ID: 9231352

Uniformat Code: G2020
Recommendation: **Replace/Install in 2025**

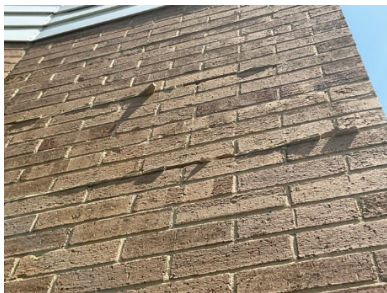
Exterior Walls in Poor condition.

Brick or Brick Veneer, 1-2 Story Building
Greenwood Elementary School Greenwood
Elementary School Building Exterior

The exterior brick masonry walls exhibit isolated areas of deteriorated bricks/mortar joints at various locations, including on the front, sides, and rear elevations of the building. - AssetCALC ID: 9230345

Uniformat Code: B2010
Recommendation: **Repair/Repoint in 2025**

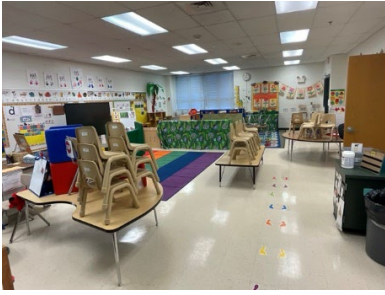
Roofing in Poor condition.

any type, Repairs per Man-Day
Greenwood Elementary School Greenwood
Elementary School Roof

There are active roof leaks reported above the Pre-K classroom 44- trash containers observed below the leak area in the classroom. - AssetCALC ID: 9230469

Uniformat Code: B3010
Recommendation: **Repair in 2025**

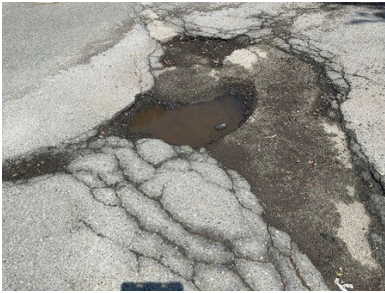
Parking Lots in Poor condition.

Pavement, Asphalt
Site Greenwood Elementary School Site
Parking Areas

There are significant areas of alligator cracking and potholes in the parking areas and drive lanes (north, northeast and northwest). - AssetCALC ID: 9231337

Uniformat Code: G2020
Recommendation: **Cut and Patch in 2025**

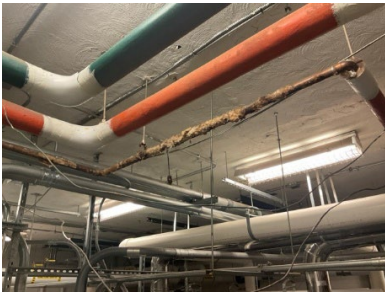
Piping and Valves in Poor condition.

Piping Copper, Domestic Water
Greenwood Elementary School Greenwood
Elementary School Boiler Room

There are active plumbing leaks in the boiler room that require replacement of copper piping due to corrosion and leaks. - AssetCALC ID: 9230404

Uniformat Code: D2010
Recommendation: **Replace in 2025**

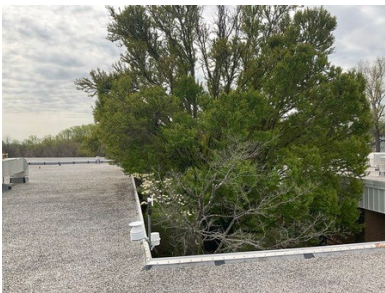
Landscaping in Poor condition.

Mature Trees, Removal/Trimming
Greenwood Elementary School Greenwood
Elementary School Roof

There are overgrown trees in courtyard areas overhang the roof surfaces. - AssetCALC ID: 9230435

Uniformat Code: G2080
Recommendation: **Repair in 2025**

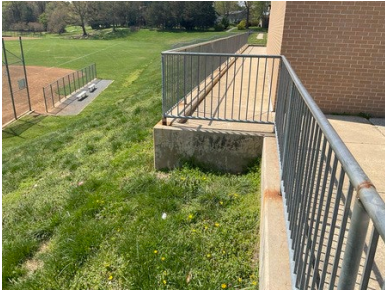
Retaining Wall in Poor condition.

Concrete Cast-in-Place
Site Greenwood Elementary School Site
General

There is an isolated areas of concrete deterioration at the rear concrete retaining wall. - AssetCALC ID: 9231327

Uniformat Code: G2060
Recommendation: **Repair in 2025**

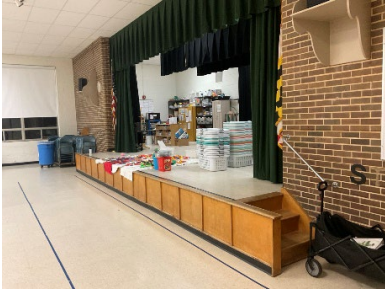
Vertical Lift

Wheelchair, 5' Rise
Greenwood Elementary School Greenwood
Elementary School ADA Stage

ADA Stage Vertical Lift - AssetCALC ID: 9230428

Uniformat Code: D1010
Recommendation: **Install in 2025**

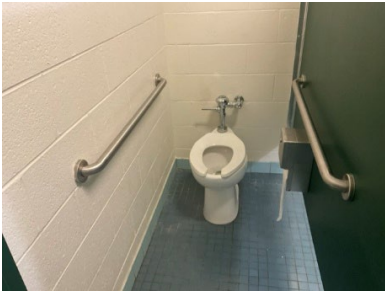
ADA Restrooms

Toilet Partitions, Location/Clearance
Greenwood Elementary School Greenwood
Elementary School ADA Restrooms

ADA Restrooms - Toilet Partitions - AssetCALC ID: 9230425

Uniformat Code: Y1050
Recommendation: **Modify in 2025**

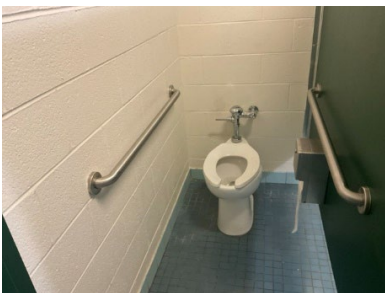
ADA Restrooms

Grab Bars and Blocking, Height/Location
Greenwood Elementary School Greenwood
Elementary School ADA Restrooms

ADA Restrooms - Toilet Stalls, Grab Bars and Blocking - AssetCALC ID: 9230476

Uniformat Code: Y1050
Recommendation: **Modify in 2025**

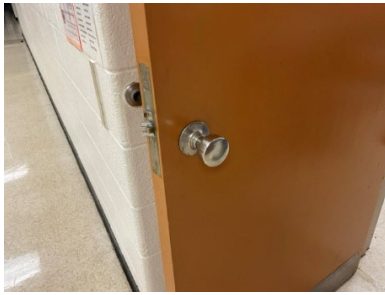
ADA Entrances and Doors

Hardware, Lever Handle
Greenwood Elementary School Greenwood
Elementary School ADA Doors

ADA Doors - Lever Handle Hardware (original building classrooms) - AssetCALC ID: 9230470

Uniformat Code: Y1030
Recommendation: **Install in 2025**

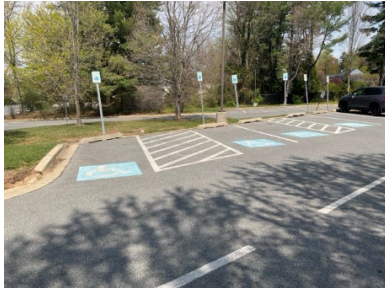
ADA Parking

Designated Stall, Pavement Markings and
Signage
Site Greenwood Elementary School ADA Site
Parking Areas
