FACILITY CONDITION ASSESSMENT

Montgomery County Public Schools
45 West Gude Drive, Suite 4000
Rockville, MD 20850

Jones Lane Elementary School
15110 Jones Lane
Gaithersburg, MD 20878

Bureau Veritas
6021 University Boulevard, Suite 200
Ellicott City, MD 21043
800.733.0660
www.bvna.com

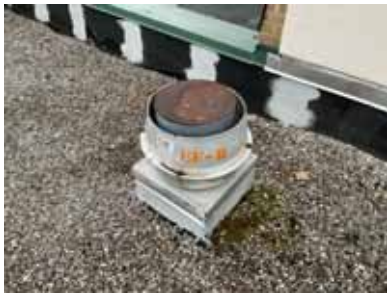
Exhaust Fan in Poor condition.

Roof or Wall-Mounted, 10" Damper
Main Building Jones Lane Elementary School
Roof

Unit housing is very rusted - AssetCALC ID: 10840196

Uniformat Code: D3060
Recommendation: **Replace in 2027**

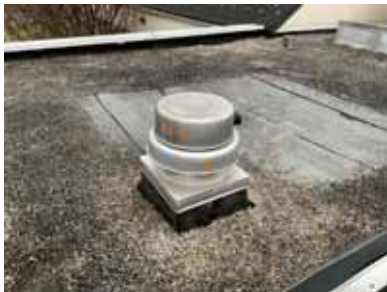
Exhaust Fan in Poor condition.

Roof or Wall-Mounted, 16" Damper
Main Building Jones Lane Elementary School
Roof

Unit was making loud clanging noises like a fan blade is damaged or off center - AssetCALC ID: 10840192

Uniformat Code: D3060
Recommendation: **Replace in 2027**

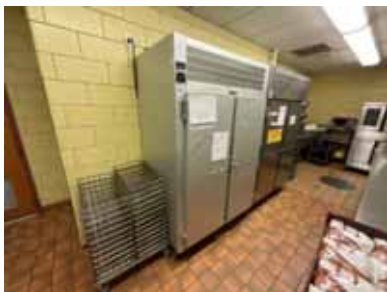
Foodservice Equipment in Poor condition.

Freezer, 2-Door Reach-In
Main Building Jones Lane Elementary School
Kitchen

Freezer is condemned and not used anymore - AssetCALC ID: 10840224

Uniformat Code: E1030
Recommendation: **Replace in 2027**

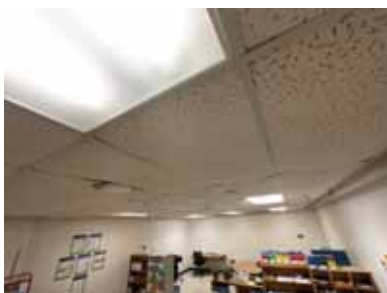
Suspended Ceilings in Poor condition.

Acoustical Tile (ACT)
Jones Lane Elementary School Classrooms
General

Classrooms towards the middle of the school have old md warped ceiling tiles that need to be replaced - AssetCALC ID: 10853561

Uniformat Code: C1070
Recommendation: **Replace in 2027**

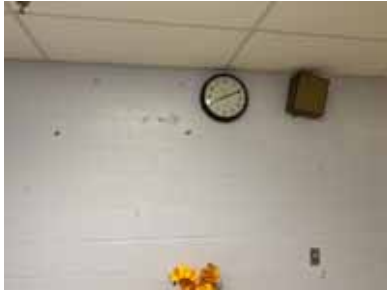
Wall Finishes in Poor condition.

any surface
Main Building Jones Lane Elementary School
Faculty Break Rooms

Uniformat Code: C2010
Recommendation: **Prep and Paint in 2027**
