# FACILITY CONDITION ASSESSMENT

**Montgomery County Public Schools**  
45 West Gude Drive, Suite 4000  
Rockville, MD 20850

Kemp Mill Elementary School  
411 Sisson Street  
Silver Spring, MD 20902

April 13, 2026

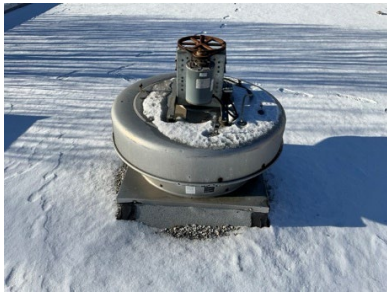
### Exhaust Fan in Poor condition.

Roof or Wall-Mounted, 24" Damper, 2001 to 5000 CFM  
Main Building Kemp Mill Elementary School Roof

Roof mounted exhaust fan is inoperable. - AssetCALC ID: 10188532

Uniformat Code: D3060  
Recommendation: **Replace in 2026**

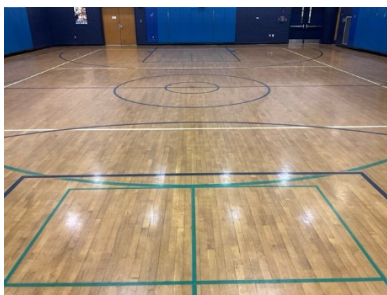
### Flooring in Poor condition.

Wood, Sports  
Main Building Kemp Mill Elementary School Gymnasium

The gymnasium floor is age damaged with several areas of lifted planks and protruding nails that could create a tripping hazard. - AssetCALC ID: 10188639

Uniformat Code: C2030  
Recommendation: **Replace in 2026**

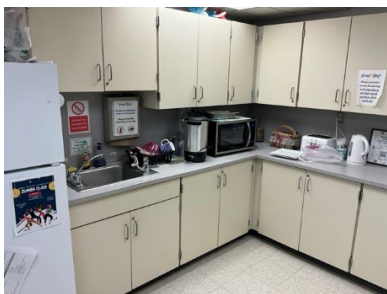
### ADA Kitchen and Laundry Areas

Sink/Counter/Maneuverability, Full Reconfiguration  
Kemp Mill Elementary School Staff Lounge

Kitchen area at the staff lounge was observed to not be ADA compliant. - AssetCALC ID: 10192808

Uniformat Code: Y1060  
Recommendation: **Renovate in 2025**

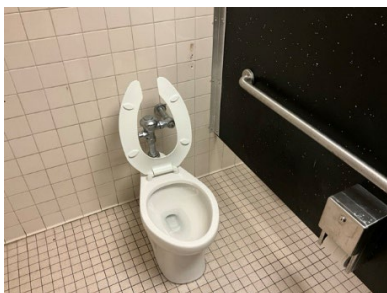
### ADA Restrooms

Grab Bars and Blocking  
Kemp Mill Elementary School Restroom

Missing grab bars were observed at the restrooms throughout the school. - AssetCALC ID: 10193622

Uniformat Code: Y1050  
Recommendation: **Install in 2025**

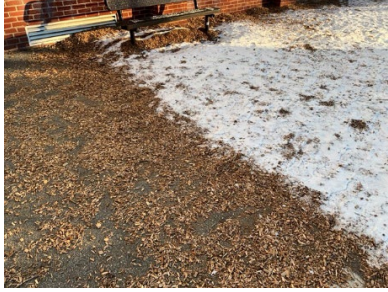
## Playground Surfaces

Rubber, Poured-in-Place  
Site Kemp Mill Elementary School Site  
Playground Areas

The play surface is currently wood chips, requiring frequent maintenance and creating an uneven surface that can be challenging to maneuver. Replacement with rubberized surfacing is recommended. - AssetCALC ID: 10188664

Uniformat Code: G2050  
Recommendation: **Replace in 2028**
