FACILITY CONDITION ASSESSMENT

Montgomery County Public Schools

Kensington-Parkwood Elementary School

June 3, 2026

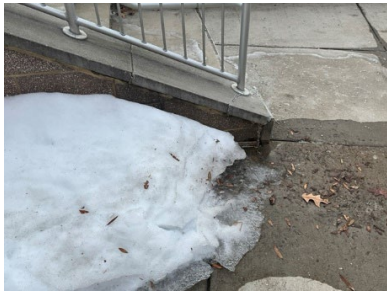
Exterior Walls in Failed condition.

any type, Repairs per Man-Day
 Site Kensington-Parkwood Elementary School
 Site General

Address damaged areas of staircase - AssetCALC ID: 10312430

Uniformat Code: B2010
 Recommendation: **Repair in 2025**

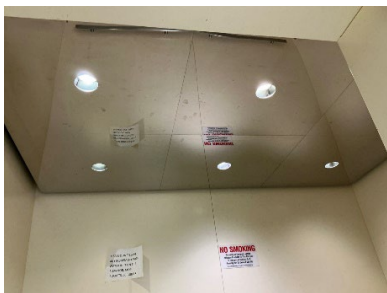
Elevator Cab Finishes in Poor condition.

Economy
 Main Building Kensington-Parkwood
 Elementary School Elevator #1

Mismatched tiles and scratched walls - AssetCALC ID: 10312645

Uniformat Code: D1010
 Recommendation: **Replace in 2027**

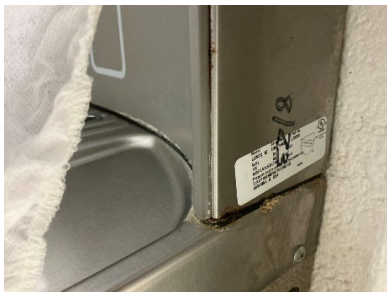
Drinking Fountain in Failed condition.

Wall-Mounted, Single-Level
 Main Building Kensington-Parkwood
 Elementary School

out of order, issue unknown, maintenance order submitted - AssetCALC ID: 10500340

Uniformat Code: D2010
 Recommendation: **Replace in 2025**

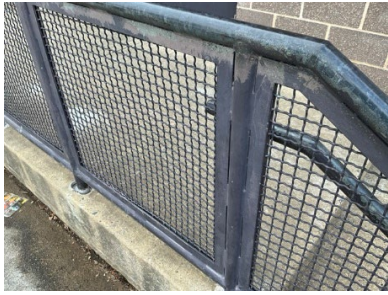
Stair/Ramp Rails in Poor condition.

Metal
Site Kensington-Parkwood Elementary School
Site General

Worn and faded paint - AssetCALC ID: 10312411

Uniformat Code: B1080
Recommendation: **Refinish in 2026**
