FACILITY CONDITION ASSESSMENT

Montgomery County Public Schools
45 West Gude Drive, Suite 4000
Rockville, MD 20850

Lakewood Elementary School
2534 Lindley Terrace
Rockville, MD 20850

April 13, 2026

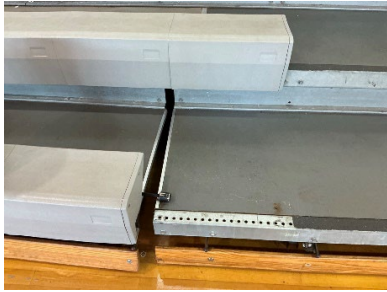
Bleachers in Failed condition.

Telescoping Manual, up to 15 Tier (per Seat)
Main Building Lakewood Elementary School
Gymnasium

Missing 3 seats and structure visible - AssetCALC ID: 10023132

Uniformat Code: E2010
Recommendation: **Replace in 2025**

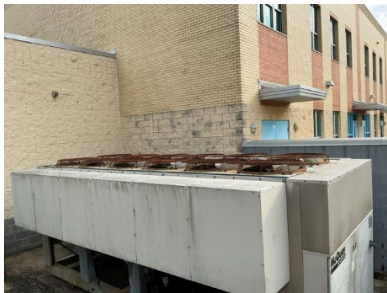
Chiller in Failed condition.

Air-Cooled
Main Building Lakewood Elementary School
Site Utility Areas

Chiller not working. Temporary truck mounted chiller operational - AssetCALC ID: 10023090

Uniformat Code: D3030
Recommendation: **Replace in 2025**

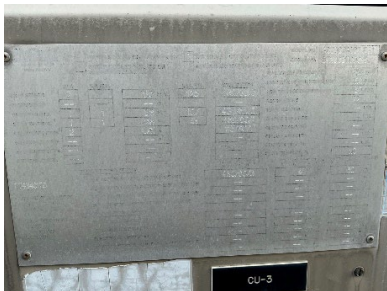
Chiller in Poor condition.

Air-Cooled
Main Building Lakewood Elementary School
Roof

Blades rusted - AssetCALC ID: 10027468

Uniformat Code: D3030
Recommendation: **Replace in 2027**

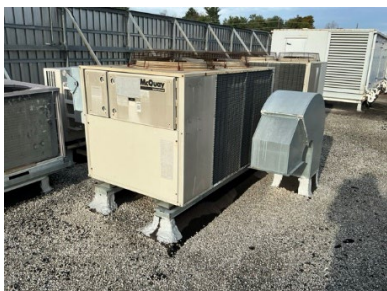
Chiller in Poor condition.

Air-Cooled
Main Building Lakewood Elementary School
Roof

Blades rusted throughout and insulation frayed and falling off - AssetCALC ID: 10027441

Uniformat Code: D3030
Recommendation: **Replace in 2027**

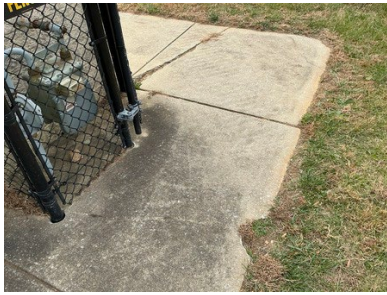
Parking Lots in Poor condition.

Pavement, Concrete
Site Lakewood Elementary School Utility Areas

Cracks throughout - AssetCALC ID: 10027520

Uniformat Code: G2020
Recommendation: **Replace in 2026**

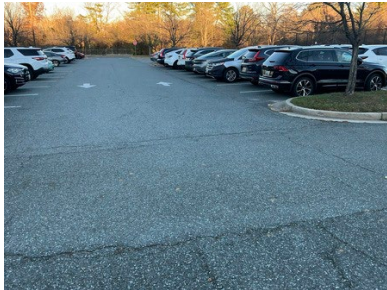
Parking Lots in Poor condition.

Pavement, Asphalt
Site Lakewood Elementary School Front
Parking Lot

Several large cracks throughout - AssetCALC ID: 10023257

Uniformat Code: G2020
Recommendation: **Seal & Stripe in 2026**

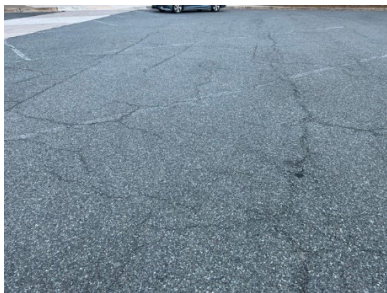
Parking Lots in Poor condition.

Pavement, Asphalt
Site Lakewood Elementary School Bus Loop

Large cracks throughout - AssetCALC ID: 10023274

Uniformat Code: G2020
Recommendation: **Seal & Stripe in 2026**

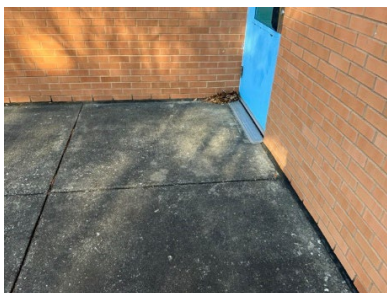
Parking Lots in Poor condition.

Pavement, Concrete
Site Lakewood Elementary School Gymnasium
Patio

Concrete patio at rear of gym has excessive settlement, is heaving and has gap of 2 inches from gym wall -
AssetCALC ID: 10023259

Uniformat Code: G2020
Recommendation: **Replace in 2027**

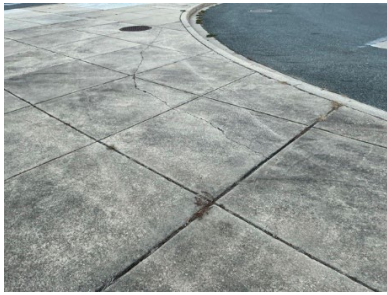
Parking Lots in Poor condition.

Pavement, Concrete
 Site Lakewood Elementary School Front Walkways

Cracks and missing pieces of concrete throughout - AssetCALC ID: 10027518

Uniformat Code: G2020
 Recommendation: **Replace in 2027**

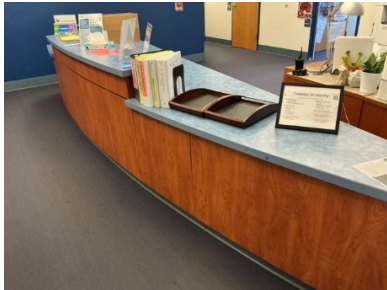
Casework in Poor condition.

Cabinetry, High-End or Laboratory
 Main Building Lakewood Elementary School Reception

Broken and loose laminate at face and sides of reception desk - AssetCALC ID: 10023129

Uniformat Code: E2010
 Recommendation: **Replace in 2026**

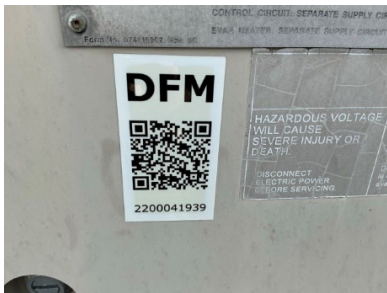
Split System in Failed condition.

Condensing Unit, 16 to 20 TON
 Main Building Lakewood Elementary School Roof

Rust damaged throughout and refrigeration pipe insulation frayed and missing. Uses outdated R22 refrigerant. - AssetCALC ID: 10027451

Uniformat Code: D3030
 Recommendation: **Replace in 2025**

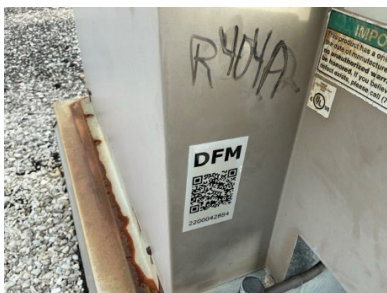
Foodservice Equipment in Poor condition.

Walk-In, Condenser for Refrigerator/Freezer
 Main Building Lakewood Elementary School Roof

Insulation frayed and missing - AssetCALC ID: 10027463

Uniformat Code: E1030
 Recommendation: **Replace in 2026**

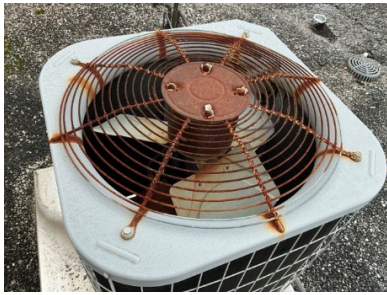
Split System in Poor condition.

Interior & Exterior Component Pairing
Main Building Lakewood Elementary School
Roof

Unit has exceeded EUL and rusted damaged. System uses outdated R22 refrigerant. - AssetCALC ID: 10027449

Uniformat Code: D3030
Recommendation: **Replace in 2026**

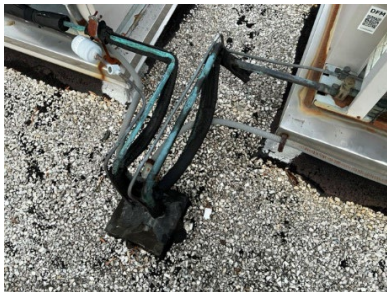
Foodservice Equipment in Poor condition.

Walk-In, Condenser for Refrigerator/Freezer
Main Building Lakewood Elementary School
Roof

Piping insulation frayed and missing - AssetCALC ID: 10027457

Uniformat Code: E1030
Recommendation: **Replace in 2026**

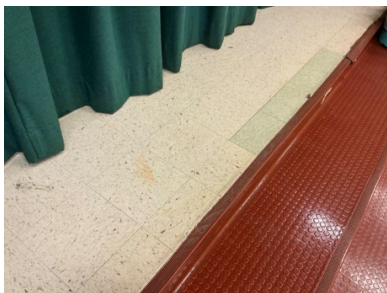
Flooring in Poor condition.

Vinyl Tile (VCT)
Main Building Lakewood Elementary School
Stage

Broken tiles along first step to stage - AssetCALC ID: 10023128

Uniformat Code: C2030
Recommendation: **Replace in 2026**

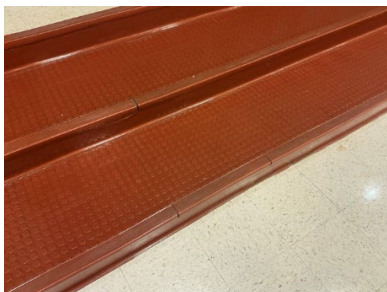
Stair Treads in Poor condition.

Raised Rubber Tile
Main Building Lakewood Elementary School
Stage

Rubbers risers at steps broken and separating. - AssetCALC ID: 10023125

Uniformat Code: B1080
Recommendation: **Replace in 2026**
