FACILITY CONDITION ASSESSMENT

Montgomery County Public Schools
45 West Gude Drive, Suite 4000
Rockville, MD 20850

Little Bennett Elementary School
23930 Burdette Forest Road
Clarksburg, MD 20871

April 13, 2026

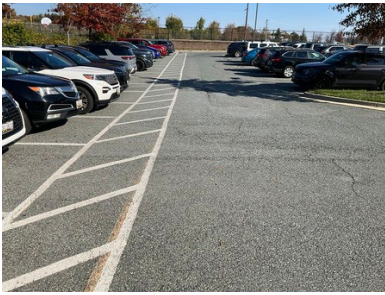
Pavement, Asphalt
Site Little Bennett Elementary School Site

Parking Lots in Poor condition.

Pavement needs to be repaired throughout the parking lot because of wear and tear. - AssetCALC ID: 10025931

Uniformat Code: G2020
Recommendation: **Seal and Stripe in 2026**

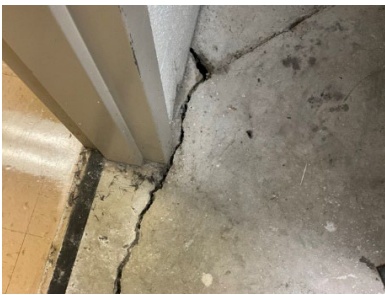
Any Surface, with Paint or Sealant
Main Building Little Bennett Elementary School
Mechanical Room

Flooring in Poor condition.

Cracks throughout the mechanical rooms. - AssetCALC ID: 10025810

Uniformat Code: C2030
Recommendation: **Prep and Paint in 2027**
