FACILITY CONDITION ASSESSMENT

Montgomery County Public Schools

Thurgood Marshall Elementary School
12260 McDonald Chapel Drive
Gaithersburg, MD 20878

April 13, 2026

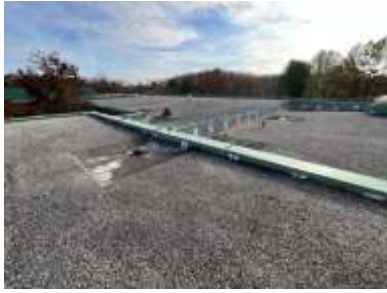
Roofing in Poor condition.

Built-Up
Main Building Thurgood Marshall Elementary School Roof

Roof has a history of recurring leaks and has exceeded its estimate useful life. - AssetCALC ID: 10051336

Uniformat Code: B3010
Recommendation: **Replace in 2027**

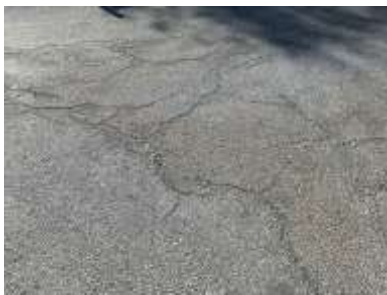
Parking Lots in Poor condition.

Pavement, Asphalt
Site Thurgood Marshall Elementary School Site

Uniformat Code: G2020
Recommendation: **Cut & Patch in 2026**

Full depth repair of excessively cracked area of parking lot. - AssetCALC ID: 10051438

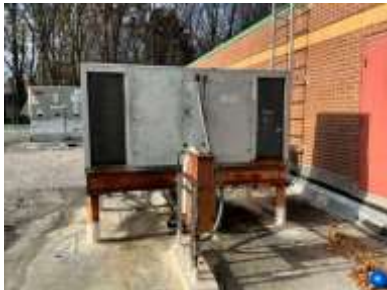
Split System in Poor condition.

Condensing Unit/Heat Pump, 16 to 20 TON
Main Building Thurgood Marshall Elementary School Roof

Unit is exceedingly aged, rust damaged, and uses outdated R-22 refrigerant. - AssetCALC ID: 10051429

Uniformat Code: D3030
Recommendation: **Replace in 2026**

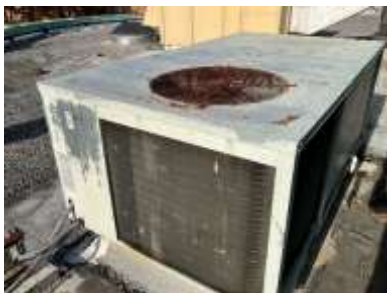
Packaged Unit in Poor condition.

RTU, Pad or Roof-Mounted, 3 TON
Main Building Thurgood Marshall Elementary School Roof

Exceedingly aged and corroded. - AssetCALC ID: 10051395

Uniformat Code: D3050
Recommendation: **Replace in 2026**

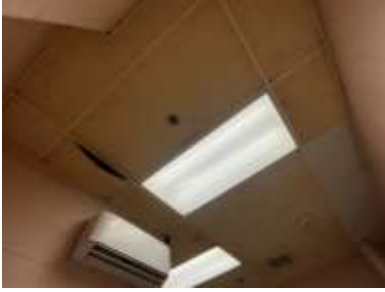
Suspended Ceilings in Poor condition.

Acoustical Tile (ACT)
Main Building Thurgood Marshall Elementary School Throughout Building

Ceilings show age, physical damage, and water stains. - AssetCALC ID: 10051408

Uniformat Code: C1070
Recommendation: **Replace in 2027**
