FACILITY CONDITION ASSESSMENT

Spark M. Matsunaga Elementary School

172559.25R000-075.354

June 3, 2026

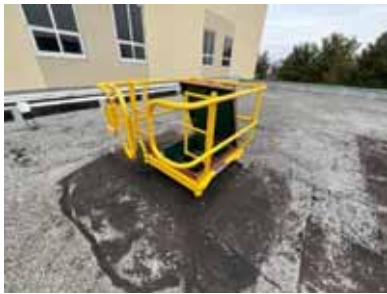
Roofing in Poor condition.

Built-Up
Main Building Spark M. Matsunaga Elementary
School Roof

Roof leaks sometimes and has reached the end of its expected life - AssetCALC ID: 10623891

Uniformat Code: B3010
Recommendation: **Replace in 2026**

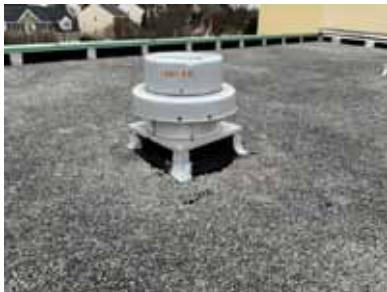
Exhaust Fan in Poor condition.

Centrifugal, 24" Damper
Main Building Spark M. Matsunaga Elementary
School Roof

Unit is at end if it is expected life and scheduled to be replaced this summer - AssetCALC ID: 10596584

Uniformat Code: D3060
Recommendation: **Replace in 2026**

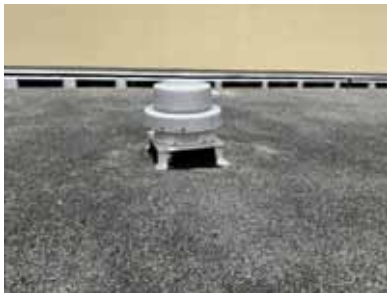
Exhaust Fan in Poor condition.

Centrifugal, 24" Damper
Main Building Spark M. Matsunaga Elementary
School Roof

Unit is at end if it is expected life and scheduled to be replaced this summer - AssetCALC ID: 10596577

Uniformat Code: D3060
Recommendation: **Replace in 2026**

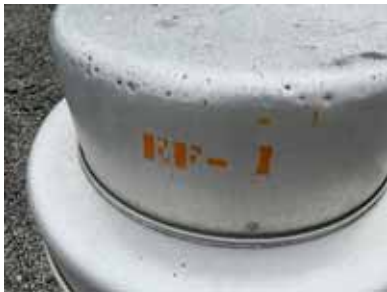
Exhaust Fan in Poor condition.

Centrifugal, 24" Damper
Main Building Spark M. Matsunaga Elementary
School Roof

Unit is at end if it is expected life and scheduled to be replaced this summer - AssetCALC ID: 10596587

Uniformat Code: D3060
Recommendation: **Replace in 2026**

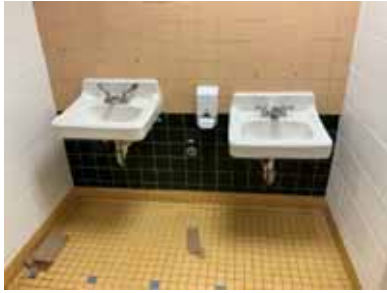
ADA Restrooms

Lavatory, Pipe Wraps/Insulation
Main Building Spark M. Matsunaga Elementary
School Throughout Building

Uniformat Code: Y1050
Recommendation: **Install in 2026**
