# FACILITY CONDITION ASSESSMENT

## **Montgomery County Public Schools**

S. Christa McAuliffe Elementary School  
12500 Wisteria Drive  
Germantown, MD, 20874

May 26, 2026

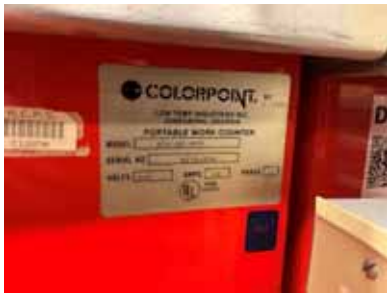
### Food service Equipment in Poor condition.

Refrigerator, 2-Door Reach-In  
S. Christa McAuliffe Elementary School S.  
Christa McAuliffe Elementary School  
Commercial Kitchen

The kitchen equipment was observed to be inefficient and beyond its EUL. - AssetCALC ID: 10383832

Uniformat Code: E1030  
Recommendation: **Replace in 2027**

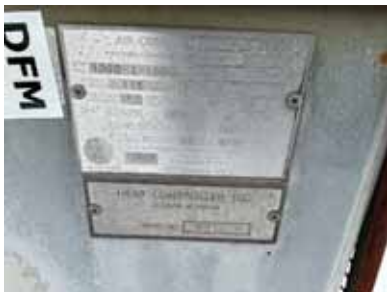
### Food service Equipment in Poor condition.

Walk-In, Condenser for Refrigerator/Freezer  
S. Christa McAuliffe Elementary School S.  
Christa McAuliffe Elementary School Roof

Condensing unit was observed to be deteriorated. - AssetCALC ID: 10383825

Uniformat Code: E1030  
Recommendation: **Replace in 2027**

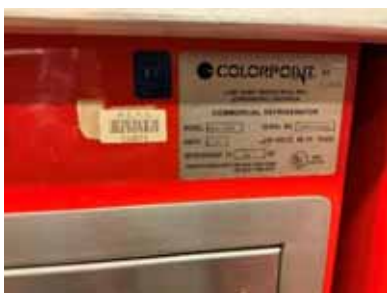
### Food service Equipment in Poor condition.

Prep Table Refrigerated, Salad/Sandwich  
S. Christa McAuliffe Elementary School S.  
Christa McAuliffe Elementary School  
Commercial Kitchen

Kitchen Equipment was observed to be inefficient and beyond its EUL. - AssetCALC ID: 10383811

Uniformat Code: E1030  
Recommendation: **Replace in 2027**

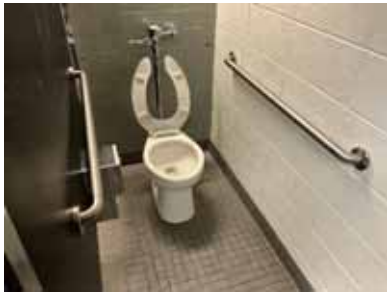
### ADA Restrooms

Toilet Partitions, Location/Clearance  
 S. Christa McAuliffe Elementary School  
 Restrooms - Existing Building

Toilet stalls clearance and path of travel at the existing building restrooms were observed to be non-ADA compliant. - AssetCALC ID: 10512876

Uniformat Code: Y1050  
 Recommendation: **Modify in 2026**

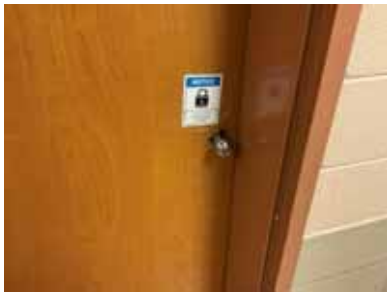
### ADA Entrances and Doors

Hardware, Lever Handle  
 S. Christa McAuliffe Elementary School S.  
 Christa McAuliffe Elementary School Existing  
 Building

Several doors throughout the existing building were observed to have non-ADA compliant hardware. - AssetCALC ID: 10383681

Uniformat Code: Y1030  
 Recommendation: **Install in 2026**

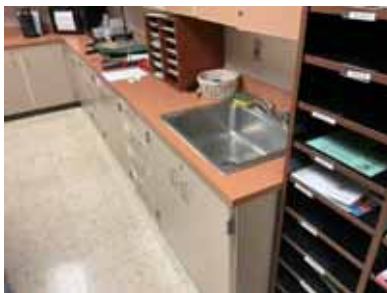
### ADA Kitchen and Laundry Areas

Sink/Counter/Maneuverability, Full  
 Reconfiguration  
 S. Christa McAuliffe Elementary School S.  
 Christa McAuliffe Elementary School Break  
 Room

The sink and counter space at the staff lounge were observed to be non-ADA compliant. - AssetCALC ID: 10383745

Uniformat Code: Y1060  
 Recommendation: **Renovate in 2026**
