# FACILITY CONDITION ASSESSMENT

## **Montgomery County Public Schools**

Dr. Ronald E. McNair Elementary School  
13881 Hopkins Road  
Germantown, MD 20874

*April 13, 2026*

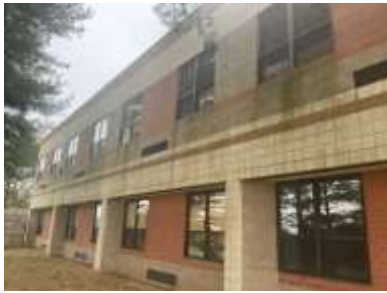
### Exterior Walls in Poor condition.

A portion of the rear building exterior wall has significant areas of moss staining. - AssetCALC ID: 10219378

Uniformat Code: B2010  
Recommendation: **Maintain in 2026**

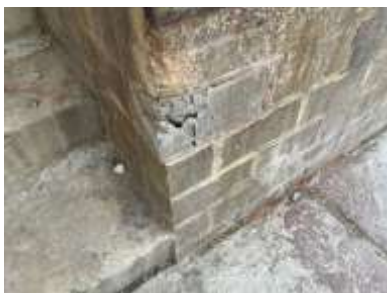
### Exterior Walls in Poor condition.

Areas of cracked brick/mortar joints at the exterior walls at the loading dock. - AssetCALC ID: 10219335

Uniformat Code: B2010  
Recommendation: **Repair in 2026**

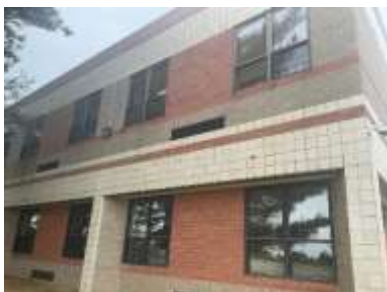
### Glazing in Poor condition.

Original windows have exceeded their EUL and show wear and poor operation. - AssetCALC ID: 10219295

Uniformat Code: B2020  
Recommendation: **Replace in 2027**

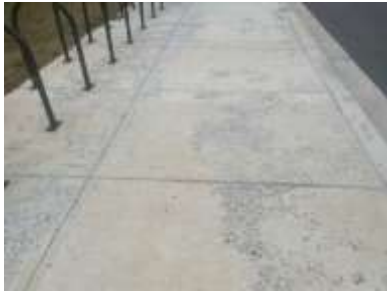
### Sidewalk in Poor condition.

There are significant areas of spalling surface of newly installed concrete sidewalks by the building addition and at the ADA parking spaces. - AssetCALC ID: 10219283

Uniformat Code: G2030  
Recommendation: **Repair in 2026**

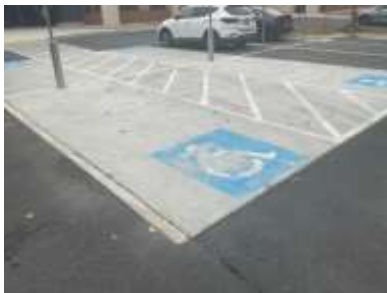
### Parking Lots in Poor condition.

There are significant areas of spalling surface of newly installed concrete sidewalks by the building addition and at the ADA parking spaces. - AssetCALC ID: 10219202

Uniformat Code: G2020  
Recommendation: **Repair in 2026**

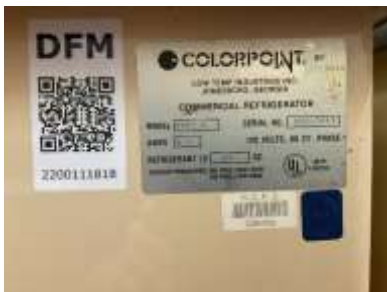
### Foodservice Equipment in Failed condition.

Reportedly the cooler unit is not functional and should be replaced. - AssetCALC ID: 10219394

Uniformat Code: E1030  
Recommendation: **Replace in 2026**

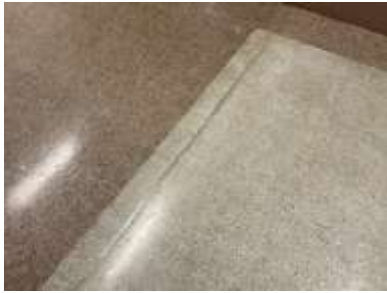
**Recommended Follow-up Study:  
Structural, Superstructure**

There is isolated evidence of deflection and movement reported and observed, as there are areas of cracked terrazzo flooring in the hallways on the 1st & 2nd floors, as well as an isolated area of cracked quarry tile floor in commercial kitchen. In addition, there are numerous areas that have missing or deteriorated sealant around the building exterior along the base of the building exterior walls/foundation. A Professional Engineer with specific expertise in structural design and construction in this geographical area must be retained to evaluate the structure and to provide remedial recommendations consistent with local regulatory and code requirements. The cost of this study is included in the cost tables. Although the estimated cost of repair cannot be accurately determined without the recommended study, a budgetary cost allowance to repair the affected elements is also included. - AssetCALC ID: 10233244

Uniformat Code: P2030  
Recommendation: **Evaluate/Report in 2026**

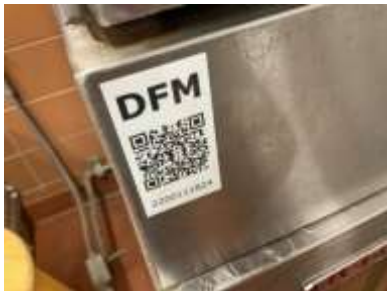
**Foodservice Equipment in Poor  
condition.**

Reportedly the oven does not properly warm or get hot and should be replaced. - AssetCALC ID: 10219327

Uniformat Code: E1030  
Recommendation: **Replace in 2026**

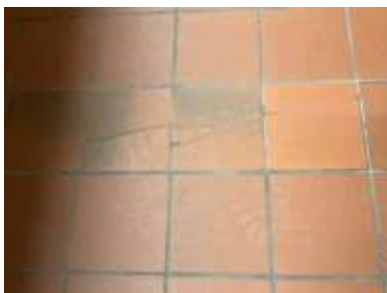
**Flooring in Poor condition.**

There is an isolated area of cracked quarry tile floor in commercial kitchen. - AssetCALC ID: 10219359

Uniformat Code: C2030  
Recommendation: **Repair in 2026**

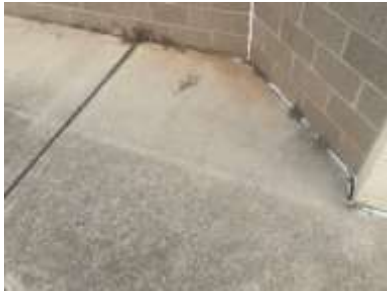
**Caulking in Poor condition.**

There are numerous areas that are either missing caulking or have deteriorated caulking around the building exterior along the base of the building exterior walls/foundation. - AssetCALC ID: 10219432

Uniformat Code: B2010  
 Recommendation: **Replace in 2026**

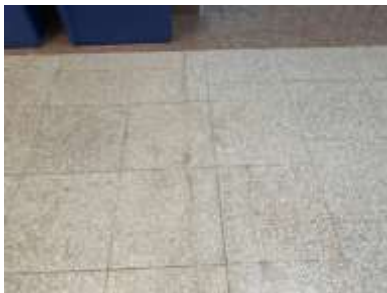
**Flooring in Poor condition.**

There are areas of cracked terrazzo flooring in the hallways on the 1st & 2nd floors of the building. - AssetCALC ID: 10219356

Uniformat Code: C2030  
 Recommendation: **Repair in 2026**

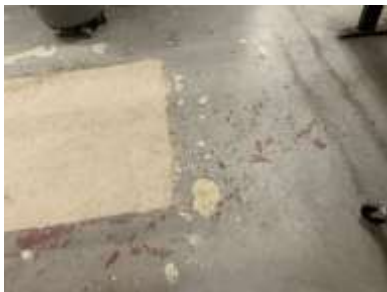
**Flooring in Poor condition.**

Deteriorated painted finishes in the mechanical and electrical rooms. - AssetCALC ID: 10219293

Uniformat Code: C2030  
 Recommendation: **Prep & Paint in 2026**

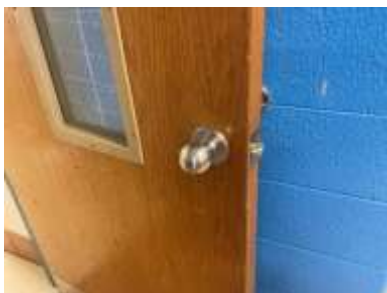
**ADA Entrances & Doors**

Interior doors replace knob handle hardware with lever handles. - AssetCALC ID: 10219227

Uniformat Code: Y1030  
 Recommendation: **Install in 2026**

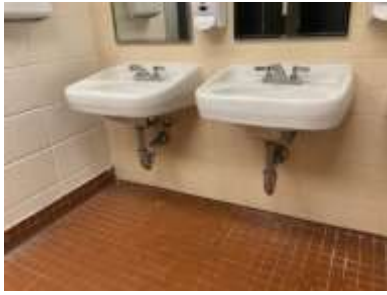
### ADA Restrooms

ADA restroom sinks have some missing pipe wraps - AssetCALC ID: 10219405

Uniformat Code: Y1050  
Recommendation: **Install in 2026**

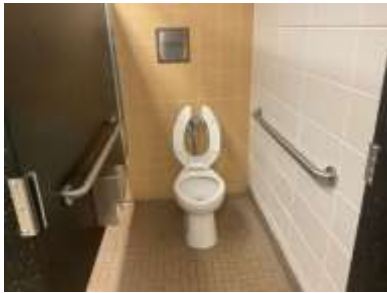
### ADA Restrooms

Uniformat Code: Y1050  
Recommendation: **Modify in 2026**

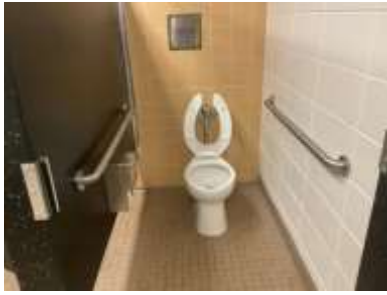
### ADA Restrooms

Uniformat Code: Y1050  
 Recommendation: **Modify in 2026**
