FACILITY CONDITION ASSESSMENT

Montgomery County Public Schools
45 West Gude Drive, Suite 4000
Rockville, MD 20850

Mill Creek Towne Elementary School
17700 Park Mill Drive
Rockville, MD 20855

August 20, 2025

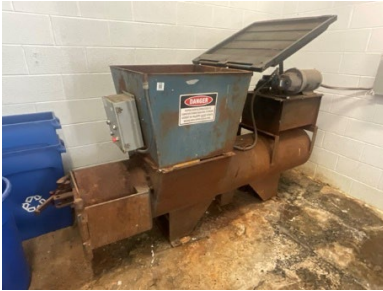
Food Service Equipment in Poor condition.

Trash Compactor, 600 LB
Mill Creek Towne Elementary School Mill
Creek Towne Elementary School Compactor
Room

The trash compactor is excessively aged and shows significant wear. Replacement with a new unit is encouraged. - AssetCALC ID: 9287001

Uniformat Code: E1030
Recommendation: **Replace in 2026**

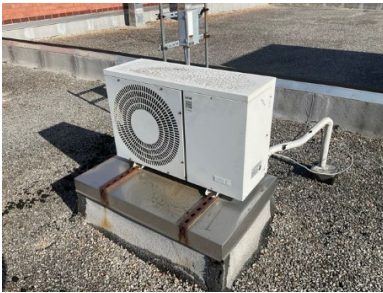
Split System Ductless in Poor condition.

Single Zone, Condenser and Evaporator, 0.75
to 1 TON
Mill Creek Towne Elementary School Mill
Creek Towne Elementary School Roof

The ductless split system has become excessively aged and is due for replacement. - AssetCALC ID: 9287034

Uniformat Code: D3030
Recommendation: **Replace in 2026**

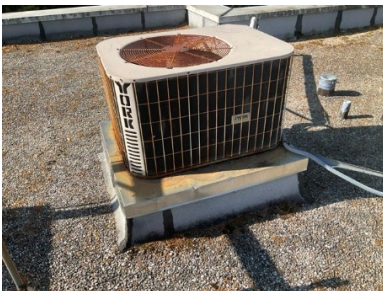
Split System in Poor condition.

Condensing Unit/Heat Pump
Mill Creek Towne Elementary School Mill
Creek Towne Elementary School Roof

The condensing unit is excessively aged and shows significant wear. Replacement with a new unit is encouraged. - AssetCALC ID: 9287056

Uniformat Code: D3030
Recommendation: **Replace in 2026**

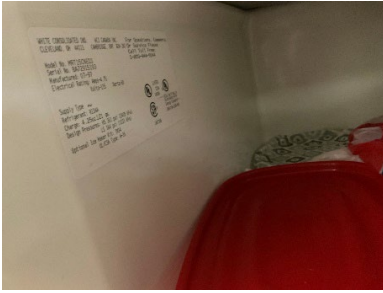
Residential Appliances in Poor condition.

Refrigerator, 14 to 18 CF
Mill Creek Towne Elementary School Mill
Creek Towne Elementary School 115

The refrigerator is excessively aged and shows significant wear. Replacement with a new unit is encouraged. - AssetCALC ID: 9286997

Uniformat Code: E1060
Recommendation: **Replace in 2026**

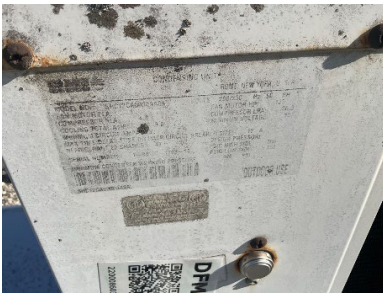
Split System Ductless in Poor condition.

Single Zone
Mill Creek Towne Elementary School Mill
Creek Towne Elementary School Roof

The condensing unit is excessively aged and shows significant wear. Replacement with a new unit is encouraged. - AssetCALC ID: 9286986

Uniformat Code: D3030
Recommendation: **Replace in 2026**

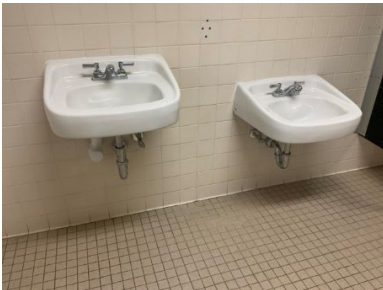
ADA Restrooms

Lavatory, Pipe Wraps/Insulation
Mill Creek Towne Elementary School Mill
Creek Towne Elementary School Restrooms

Uniformat Code: Y1050
Recommendation: **Install in 2025**
