FACILITY CONDITION ASSESSMENT

Montgomery County Public Schools
45 West Gude Drive, Suite 4000
Rockville, MD 20850

North Chevy Chase Elementary School
3700 Jones Bridge Road
Chevy Chase, MD 20815

May 11, 2026

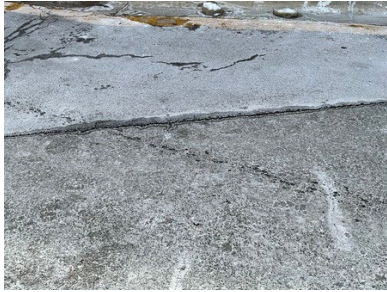
Parking Lots in Poor Condition.

Pavement, Asphalt
 Site North Chevy Chase Elementary School
 Site

Asphalt pavement is in poor condition with significant cracking, surface breakdown, and visible deterioration. The extent of cracking suggests structural fatigue and potential subgrade compromise. Immediate maintenance is recommended, with planning for resurfacing or replacement in the short term. - AssetCALC ID: 10357916

Uniformat Code: G2020
 Recommendation: **Cut & Patch in 2027**

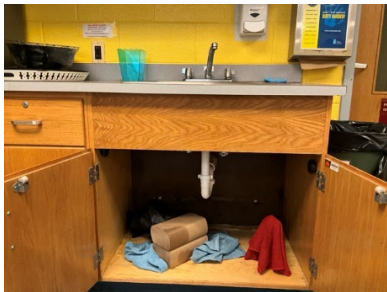
ADA Kitchen & Laundry Areas

Laundry Sink, Height/Location/Clearance
 Main Building North Chevy Chase Elementary
 School Break Room

Uniformat Code: Y1060
 Recommendation: **Modify in 2025**
