FACILITY CONDITION ASSESSMENT

Montgomery County Public Schools
45 West Gude Drive, Suite 4000
Rockville, MD 20850

Oak View Elementary School
400 East Wayne Avenue
Silver Spring, MD 20901

August 20, 2025

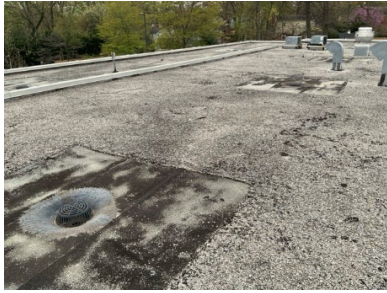
Roofing in Poor condition.

Built-Up
Main Building Oak View Elementary School
Roof

POC reports frequent leaks and aged - AssetCALC ID: 9203940

Uniformat Code: B3010
Recommendation: **Replace in 2026**

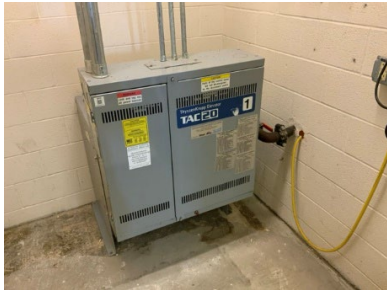
Elevator Controls in Poor condition.

Automatic, 1 Car
Main Building Oak View Elementary School
Elevator Machine Rm 203

Unreliable elevator - AssetCALC ID: 9203867

Uniformat Code: D1010
Recommendation: **Replace in 2026**

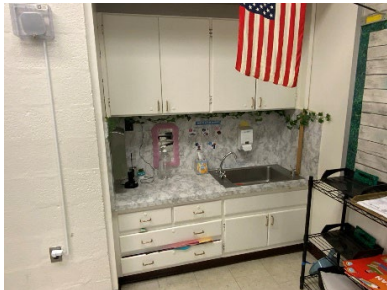
Casework in Poor condition.

Cabinetry, Standard
Main Building Oak View Elementary School
Throughout Building

POC reports some casework in classrooms is in poor condition - AssetCALC ID: 9203809

Uniformat Code: E2010
Recommendation: **Replace in 2027**

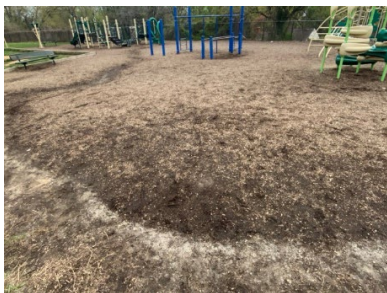
Recommended Follow-up Study: Civil, Site Drainage

Civil, Site Drainage
Site Oak View Elementary School Playground

POC reports that the playground floods - AssetCALC ID: 9361742

Uniformat Code: P2030
Recommendation: **Evaluate/Report in 2025**

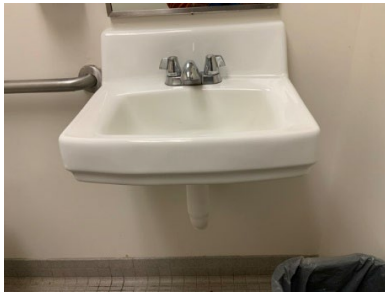
ADA Restrooms

Restrooms, Faucet Hardware
Main Building Oak View Elementary School
Restroom

Uniformat Code: Y1050
Recommendation: **Modify in 2025**
