FACILITY CONDITION ASSESSMENT

Montgomery County Public Schools

Olney Elementary School
3401 Queen Mary Drive
Olney, MD 20832

April 10, 2026

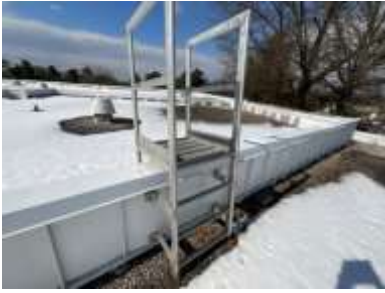
Roof Appurtenances in Failed condition.

Roof Access Ladder, Steel
Main Building Olney Elementary School Roof

The bolts in the ladder are extremely loose and detached from the wall - AssetCALC ID: 10428809

Uniformat Code: B3020
Recommendation: **Replace in 2026**
