FACILITY CONDITION ASSESSMENT

Montgomery County Public Schools

Pine Crest Elementary School
201 Woodmoor Drive
Silver Spring, MD 20901

February 26, 2026

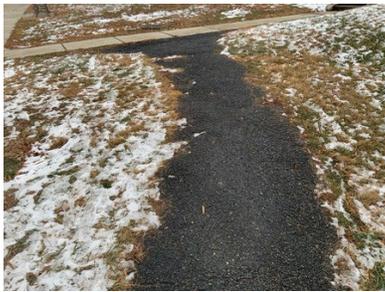
Asphalt
Site Pine Crest Elementary School Site Parking Areas

Sidewalk in Poor condition.

Cracking, heaving and surface degradation of asphalt pavement was observed - AssetCALC ID: 10134186

Uniformat Code: G2030
Recommendation: **Replace in 2026**

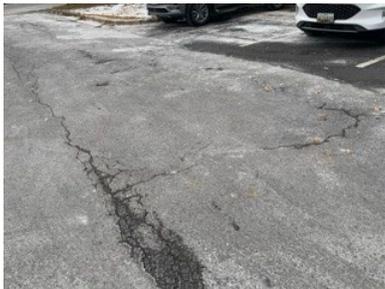
Pavement, Asphalt
Site Pine Crest Elementary School Site Parking Areas

Parking Lots in Poor condition.

Large areas of severe alligator cracking. - AssetCALC ID: 10134194

Uniformat Code: G2020
Recommendation: **Cut and Patch in 2025**

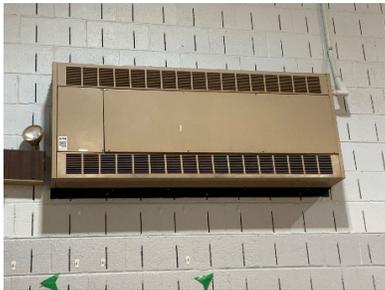
Electric, 8 LF
Main Building Pine Crest Elementary School Gymnasium

Baseboard Heater in Failed condition.

Units in gym do not work - AssetCALC ID: 10134251

Uniformat Code: D3020
Recommendation: **Replace in 2025**

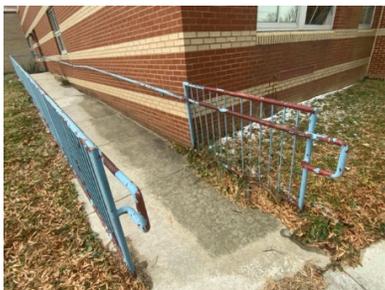
Metal
Site Pine Crest Elementary School Site

Stair/Ramp Rails in Poor condition.

Paint finish is peeling - AssetCALC ID: 10134175

Uniformat Code: B1080
Recommendation: **Refinish in 2026**

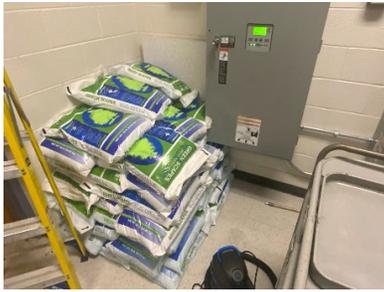
any type, Repairs per Man-Day
Main Building Pine Crest Elementary School
Electrical Room 156A

Electrical System in Poor condition.

Combustibles and flammable materials stored close to electrical equipment - AssetCALC ID: 10134361

Uniformat Code: D5020
Recommendation: **Repair in 2025**

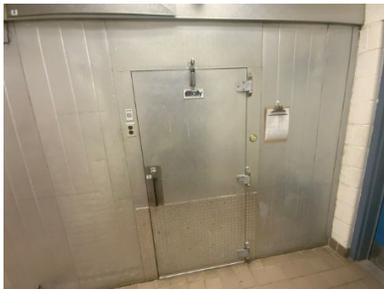
Walk-In, Freezer
Main Building Pine Crest Elementary School
Commercial Kitchen

Foodservice Equipment in Poor condition.

Ice buildup on refrigeration lines - AssetCALC ID: 10134158

Uniformat Code: E1030
Recommendation: **Replace in 2026**

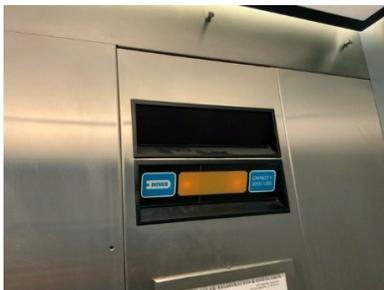
Cabs, AV Cab Position and Arrival Indicators
(per Cab)
Main Building Pine Crest Elementary School
Elevator Shafts/Utility

Accessibility deficiencies were observed at the elevator which did not have working position and arrival indicators. Also, the countertop and sink height in the teacher breakroom cabinets will require reconfiguration to meet ADA requirements.

ADA Elevators

Can indicators missing - AssetCALC ID: 10134347

Uniformat Code: Y1040
Recommendation: **Install in 2025**

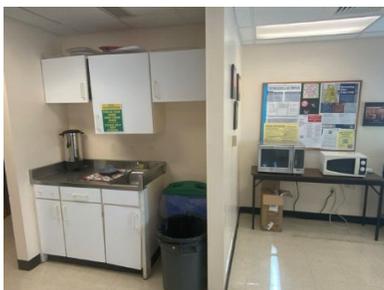
Sink/Counter/Maneuverability, Full
Reconfiguration
Main Building Pine Crest Elementary School
Teacher Breakroom

ADA Kitchen and Laundry Areas

Reconfiguration of counter Ans sink in teacher Breakroom - AssetCALC ID: 10134295

Uniformat Code: Y1060
Recommendation: **Renovate in 2025**

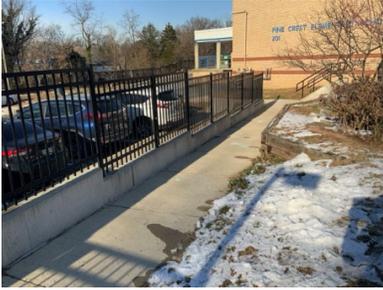
Ramp/Stair Handrails, Extensions
Site Pine Crest Elementary School Exterior Ramp

An accessibility defect was observed at the west side ramp where ADA compliant handrails had not been installed on either side of the travel path.

ADA Paths of Travel

Need ADA compliant handrails on front ramp - AssetCALC ID: 10158838

Uniformat Code: Y1020
Recommendation: **Install in 2025**

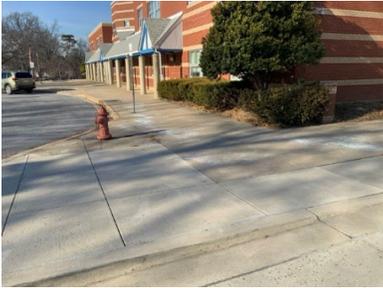
Signage, Directional Wall-Mounted
Main Building Pine Crest Elementary School Parking lot

ADA Paths of Travel

Add directional signage to alternate entrance - AssetCALC ID: 10134297

Uniformat Code: Y1020
Recommendation: **Install in 2025**
