FACILITY CONDITION ASSESSMENT

Montgomery County Public Schools
45 West Gude Drive, Suite 4000
Rockville, MD 20850

Piney Branch Elementary School
7510 Maple Avenue
Takoma Park, MD 20912

August 18, 2025

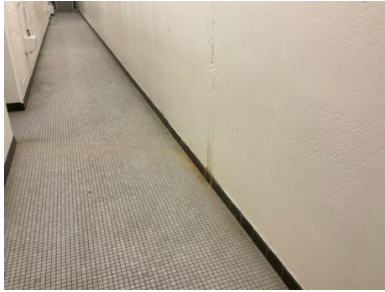
Structural Flooring/Decking in Failed Condition.

Concrete
Piney Branch Elementary School Piney Branch
Elementary School Basement

Leaking water from lower wall - AssetCALC ID: 9321165

Uniformat Code: B1010
Recommendation: **Repair in 2025**

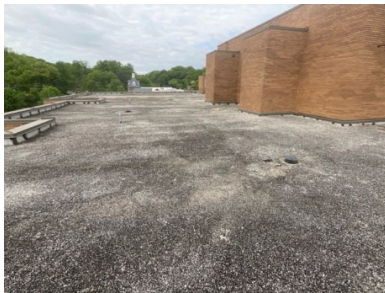
Roofing in Poor Condition.

Single-Ply Membrane, EPDM
Piney Branch Elementary School Piney Branch
Elementary School Roof

Roof leaks in several places - AssetCALC ID: 9321173

Uniformat Code: B3010
Recommendation: **Replace in 2027**

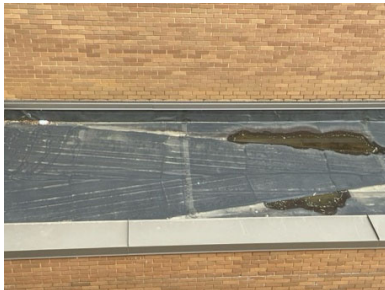
Roofing in Poor Condition.

Single-Ply Membrane, TPO/PVC
Piney Branch Elementary School Piney Branch
Elementary School Roof

Roof leaks evident inside gym - AssetCALC ID: 9321166

Uniformat Code: B3010
Recommendation: **Replace in 2027**

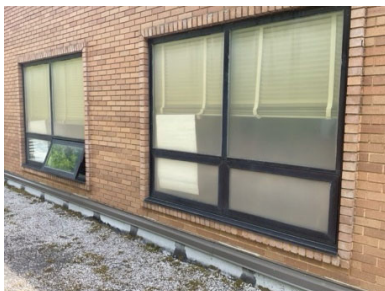
Window in Poor Condition.

Aluminum Double-Glazed, 28-40 SF
Piney Branch Elementary School Piney Branch
Elementary School Building Exterior

Hazed/discolored windows - AssetCALC ID: 9321200

Uniformat Code: B2020
Recommendation: **Replace in 2027**

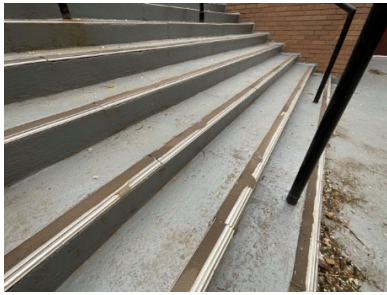
Sidewalk in Poor Condition.

Any pavement type, Sectional Repairs (per Man-Day)
Site Piney Branch Elementary School Back stairs

The steps have eroded leaving a dip towards the front of the stair. - AssetCALC ID: 9302171

Uniformat Code: G2030
Recommendation: **Repair in 2025**

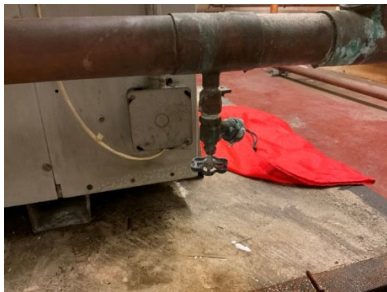
Plumbing System in Poor Condition.

Any type, Repairs per Man-Day
Piney Branch Elementary School Piney Branch Elementary School 9

Leaking. - AssetCALC ID: 9302227

Uniformat Code: D2010
Recommendation: **Repair in 2025**

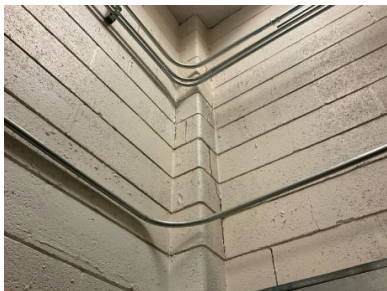
Interior Wall in Poor Condition.

Concrete Block (CMU)
Piney Branch Elementary School Piney Branch Elementary School Penthouse

Peeling paint - AssetCALC ID: 9321162

Uniformat Code: C1010
Recommendation: **Replace in 2026**

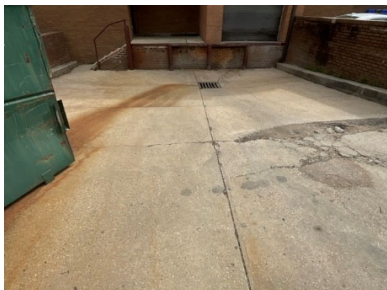
Parking Lots in Poor Condition.

Pavement, Concrete
Site Piney Branch Elementary School Site Parking Areas

Severe cracking - AssetCALC ID: 9302165

Uniformat Code: G2020
Recommendation: **Replace in 2027**

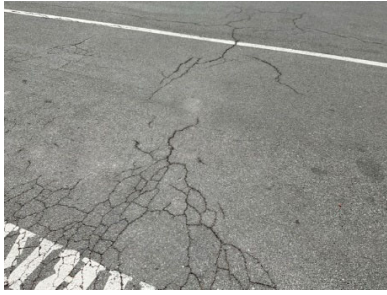
Parking Lots in Poor Condition.

Pavement, Asphalt
Site Piney Branch Elementary School Site
Parking Areas

Sealing is needed - AssetCALC ID: 9302161

Uniformat Code: G2020
Recommendation: **Seal & Stripe in 2027**

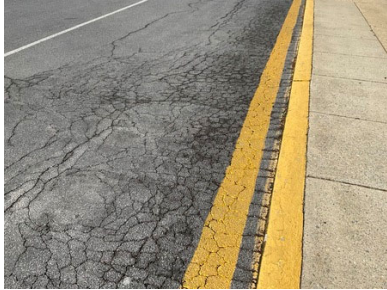
Parking Lots in Poor Condition.

Pavement, Asphalt
Site Piney Branch Elementary School Site
Parking Areas

Cracking throughout - AssetCALC ID: 9302169

Uniformat Code: G2020
Recommendation: **Mill & Overlay in 2027**

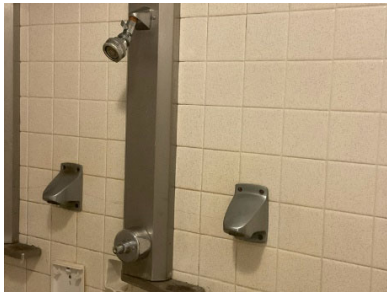
Shower in Failed Condition.

Valve & Showerhead
Piney Branch Elementary School Piney Branch
Elementary School Pool Indoor Area

Leaking shower valve - AssetCALC ID: 9321210

Uniformat Code: D2010
Recommendation: **Replace in 2025**

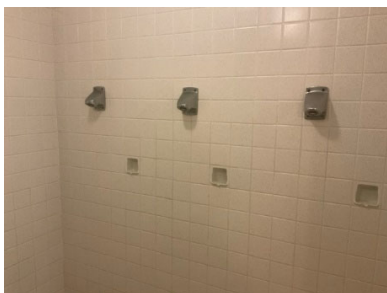
Shower in Failed Condition.

Valve & Showerhead
Piney Branch Elementary School Piney Branch
Elementary School Locker rooms

Uniformat Code: D2010
Recommendation: **Replace in 2026**
