FACILITY CONDITION ASSESSMENT

Montgomery County Public Schools

Poolesville Elementary School
19565 Fisher Avenue
Poolesville, MD 20837

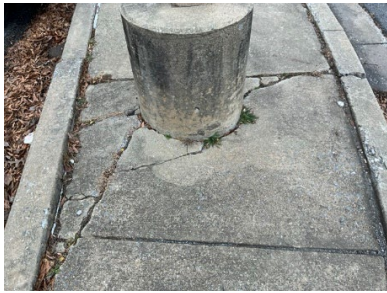
Sidewalk in Poor condition.

Concrete, Small Areas/Sections
Site Earle B. Wood Middle School Site General

Areas of cracked, broken, or missing concrete. Facilities department notes uneven pavement in front of trash room, causing a tripping hazard. - AssetCALC ID: 10292156

Uniformat Code: G2030
Recommendation: **Replace in 2027**

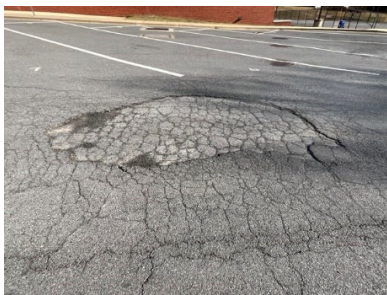
Parking Lots

Pavement, Asphalt
Site Earle B. Wood Middle School Site Parking Areas

Patch areas of failed asphalt. Facilities department notes cracks and water accumulation at front entrance. - AssetCALC ID: 10292161

Uniformat Code: G2020
Recommendation: **Cut & Patch in 2026**

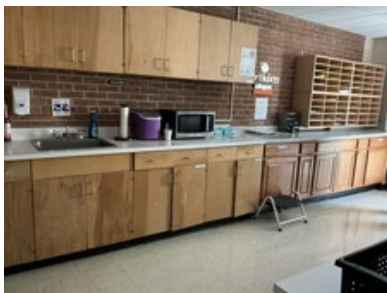
ADA Kitchen & Laundry Areas

Laundry Sink, Height/Location/Clearance
Poolesville Elementary School Break Room

Uniformat Code: Y1060
Recommendation: **Modify in 2026**
