# FACILITY CONDITION ASSESSMENT

Potomac Elementary School  
10311 River Road  
Potomac, MD 20854

*April 10, 2026*

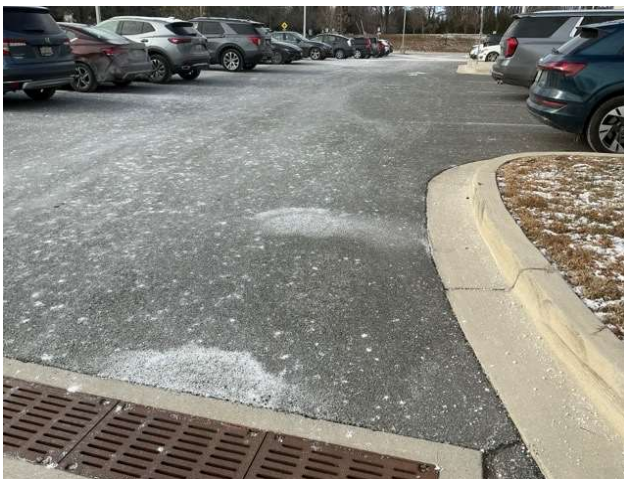
23 - PARKING LOTS

The site is occupied by the school building, playgrounds, ballfields, parking lot and open fields. The sidewalks, parking lots and other site components appeared to be in fair condition.
