# FACILITY CONDITION ASSESSMENT

## Montgomery County Public Schools

Judith A. Resnik Elementary School  
7301 Hadley Farms Drive  
Gaithersburg, MD 20879

April 29, 2026

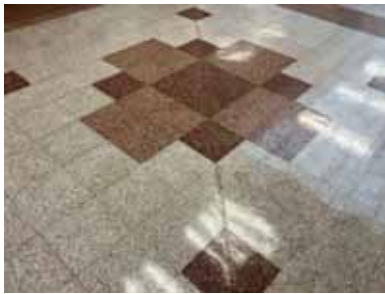
### Recommended Follow-up Study: Structural, General Design

Structural, General Design  
Main Building Judith A. Resnik Elementary  
School Front Entrance and Corridor

Cracks in the substructure were observed in several areas throughout the school. - AssetCALC ID: 10041307

Uniformat Code: P2030  
Recommendation: **Study in 2025**

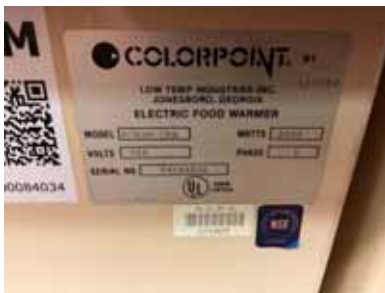
### Foodservice Equipment in Poor condition.

Food Warmer, Tabletop Drawers (Set of 4)  
Main Building Judith A. Resnik Elementary  
School Commercial Kitchen

Kitchen equipment not functioning properly. - AssetCALC ID: 10041301

Uniformat Code: E1030  
Recommendation: **Replace in 2026**

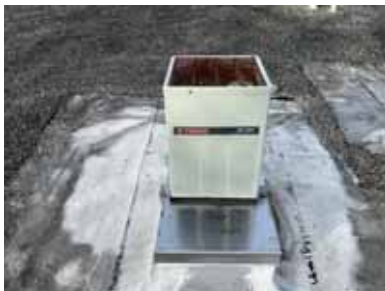
### Split System in Poor condition.

Condensing Unit/Heat Pump, 1 TON  
Main Building Judith A. Resnik Elementary  
School Roof

Condensing unit is exceedingly aged and corrosion deteriorated. - AssetCALC ID: 10041431

Uniformat Code: D3030  
Recommendation: **Replace in 2026**

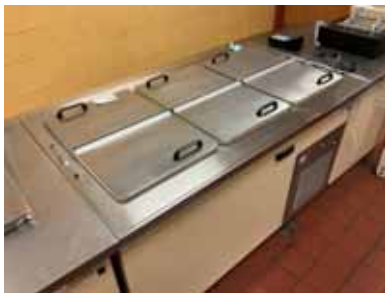
### Foodservice Equipment in Poor condition.

Prep Table Refrigerated, Salad/Sandwich  
Main Building Judith A. Resnik Elementary  
School Commercial Kitchen

Kitchen equipment not functioning properly. - AssetCALC ID: 10041361

Uniformat Code: E1030  
Recommendation: **Replace in 2026**

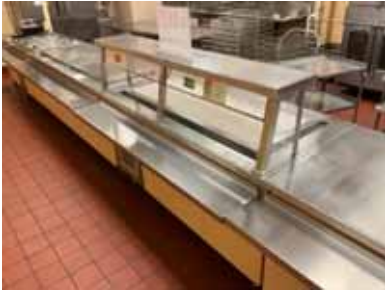
### Foodservice Equipment in Poor condition.

Prep Table Refrigerated, Salad/Sandwich  
Main Building Judith A. Resnik Elementary  
School Commercial Kitchen

Kitchen equipment not functioning properly. - AssetCALC ID: 10041423

Uniformat Code: E1030  
Recommendation: **Replace in 2026**

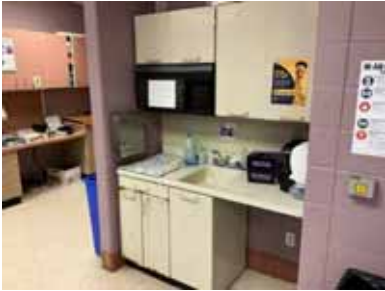
### ADA Kitchen and Laundry Areas

Sink/Counter/Maneuverability, Full  
Reconfiguration  
Main Building Judith A. Resnik Elementary  
School Staff Breakroom

Kitchen area was observed to be deteriorated and lacks accessibility. Replacement is anticipated in the short term. - AssetCALC ID: 10041415

Uniformat Code: Y1060  
Recommendation: **Renovate in 2025**
