# FACILITY CONDITION ASSESSMENT

**Montgomery County Public Schools**  
45 West Gude Drive, Suite 4000  
Rockville, MD 20850

Rock Creek Valley Elementary School  
5121 Russett Road  
Rockville, MD 20853

*April 29, 2026*

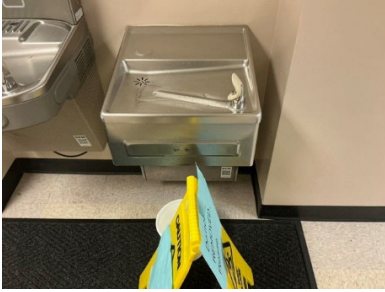
### Drinking Fountain in Poor condition.

Wall-Mounted, Single-Level  
Rock Creek Valley Elementary School Rock  
Creek Valley Elementary School A hallway

Fountain leaking and inoperable - AssetCALC ID: 9997607

Uniformat Code: D2010  
Recommendation: **Replace in 2026**

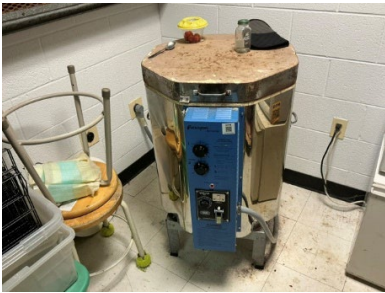
### Ceramics Equipment in Poor condition.

Kiln  
Rock Creek Valley Elementary School Rock  
Creek Valley Elementary School B8

Uniformat Code: E1040  
Recommendation: **Replace in 2026**
