# FACILITY CONDITION ASSESSMENT

## **Montgomery County Public Schools**

Lois P. Rockwell Elementary School  
24555 Cutsail Drive  
Damascus, MD 20872

*May 26, 2026*

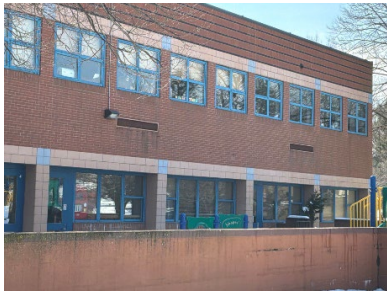
### Exterior Walls in Poor condition.

any surface, 1-2 Story Building  
Main Building Lois P. Rockwell Elementary  
School Building Exterior

Staining and soiling on brick and masonry exteriors. - AssetCALC ID: 10400517

Uniformat Code: B2010  
Recommendation: **Clean in 2026**

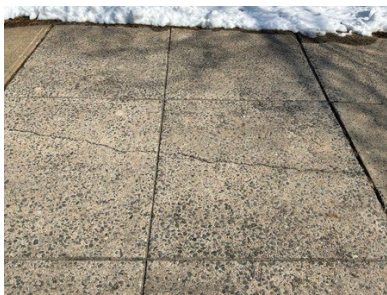
### Sidewalk in Poor condition.

Concrete, Small Areas/Sections  
Site Lois P. Rockwell Elementary School Site  
General

Uneven sidewalks and cracking to concrete in various areas. - AssetCALC ID: 10400393

Uniformat Code: G2030  
Recommendation: **Replace in 2027**

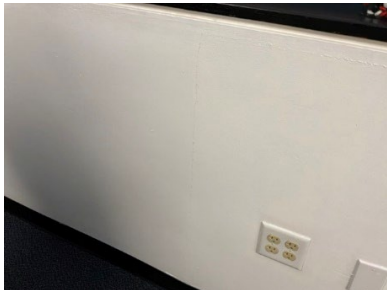
### Interior Wall Construction in Poor condition.

Gypsum Board/Plaster  
Main Building Lois P. Rockwell Elementary  
School Conference Room

Uniformat Code: C1010  
Recommendation: **Repair in 2026**

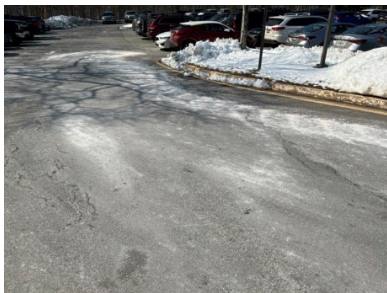
### Parking Lots in Poor condition.

Pavement, Asphalt  
Site Lois P. Rockwell Elementary School Site  
Parking Areas

Transverse cracking through parking lots. - AssetCALC ID: 10400501

Uniformat Code: G2020  
Recommendation: **Seal & Stripe in 2027**

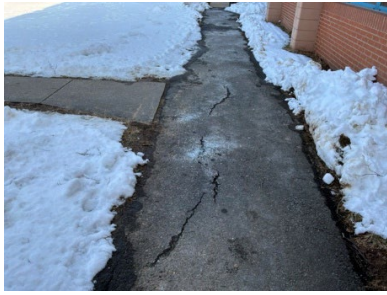
**Trail Surface in Poor condition.**

Asphalt  
 Site Lois P. Rockwell Elementary School Site  
 General

Asphalt trails were observed to be aged with areas of cracks. - AssetCALC ID: 10400349

Uniformat Code: G2050  
 Recommendation: **Overlay in 2027**

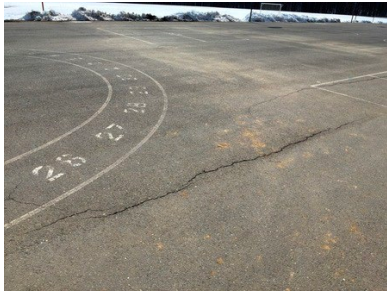
**Athletic Surfaces & Courts in Poor condition.**

Basketball/General, Asphalt Pavement  
 Site Lois P. Rockwell Elementary School Site  
 Sports Fields & Courts

Deep cracks to be sealed on basketball courts. - AssetCALC ID: 10400333

Uniformat Code: G2050  
 Recommendation: **Seal & Stripe in 2027**

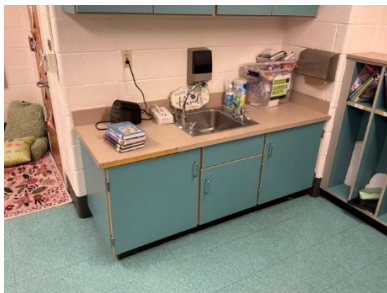
**Casework in Poor condition.**

Countertop, Plastic Laminate  
 Main Building Lois P. Rockwell Elementary  
 School Throughout Building

Laminate countertops were observed to have isolated damage. - AssetCALC ID: 10400520

Uniformat Code: E2010  
 Recommendation: **Replace in 2027**

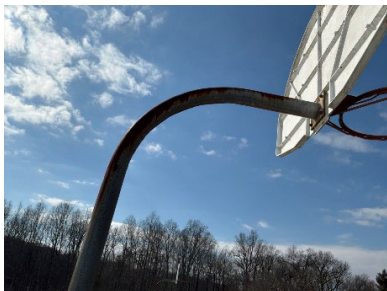
**Sports Apparatus in Poor condition.**

Basketball, Backboard/Rim/Pole  
 Site Lois P. Rockwell Elementary School Site  
 Sports Fields & Courts

Basketball poles are heavily rusted. - AssetCALC ID: 10400357

Uniformat Code: G2050  
 Recommendation: **Replace in 2027**

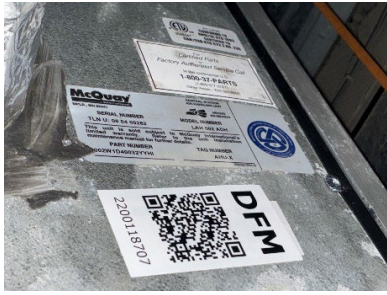
**Split System in Failed condition.**

Fan Coil Unit, DX  
Main Building Lois P. Rockwell Elementary  
School Above Gymnasium Office

Unit is nonfunctional. - AssetCALC ID: 10400542

Uniformat Code: D3030  
Recommendation: **Replace in 2026**

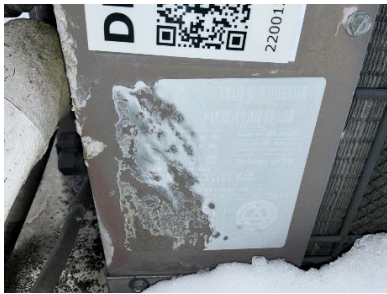
**Split System in Failed condition.**

Condensing Unit/Heat Pump  
Main Building Lois P. Rockwell Elementary  
School Roof

Unit is reportedly nonfunctional. - AssetCALC ID: 10400384

Uniformat Code: D3030  
Recommendation: **Replace in 2026**

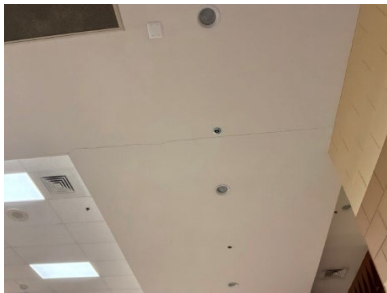
**Ceiling Finishes in Poor condition.**

Gypsum Board/Plaster  
Main Building Lois P. Rockwell Elementary  
School Multipurpose Room

Settlement issues causing cracks in multipurpose room roof and conference room wall. - AssetCALC ID: 10400414

Uniformat Code: C2050  
Recommendation: **Repair in 2026**

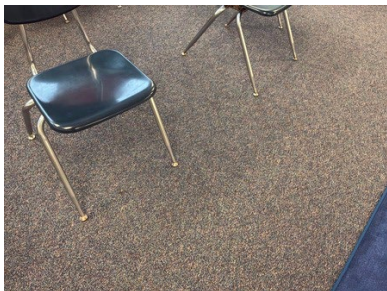
**Flooring in Poor condition.**

Carpet, Commercial Standard  
Main Building Lois P. Rockwell Elementary  
School Throughout Building

Carpet appears aged with isolated areas of deterioration. - AssetCALC ID: 10400495

Uniformat Code: C2030  
Recommendation: **Replace in 2027**
