FACILITY CONDITION ASSESSMENT

Montgomery County Public Schools

Rolling Terrace Elementary School
705 Bayfield Street
Takoma Park, MD 20912

August 15, 2025

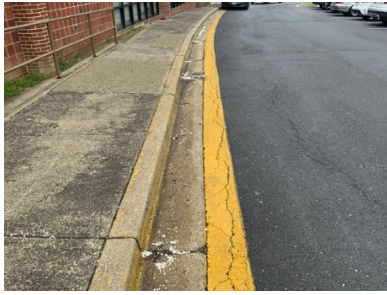
Parking Lots in Poor condition.

Curb and Gutter, Concrete
Site Rolling Terrace Elementary School West
Side Parking Areas

Chipped and cracked gutters - AssetCALC ID: 9195685

Uniformat Code: G2020
Recommendation: **Replace in 2027**

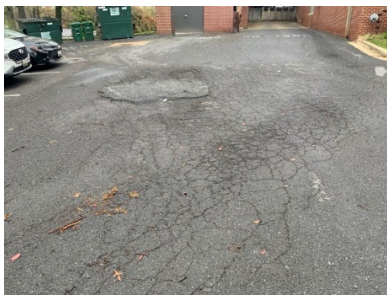
Parking Lots in Failed condition.

Pavement, Asphalt
Site Rolling Terrace Elementary School West
Side Parking Areas

Widespread alligator cracking - AssetCALC ID: 9195689

Uniformat Code: G2020
Recommendation: **Cut and Patch in 2025**

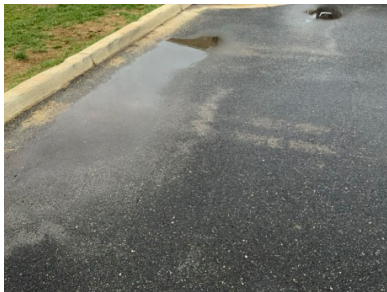
Parking Lots in Poor condition.

Pavement, Asphalt
Site Rolling Terrace Elementary School East
Side Parking Lots

Ponding of rainwater at east end - AssetCALC ID: 9195694

Uniformat Code: G2020
Recommendation: **Cut and Patch in 2025**

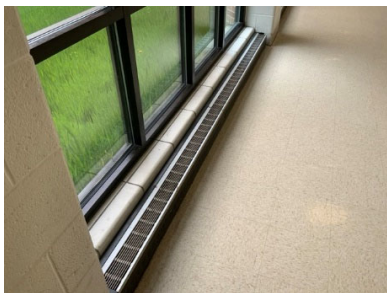
Radiator in Poor condition.

Hydronic, Baseboard (per LF)
Main Building Rolling Terrace Elementary
School Throughout Building

Heaters in cafeteria do not function in a satisfactory manner - AssetCALC ID: 9304611

Uniformat Code: D3020
Recommendation: **Replace in 2026**

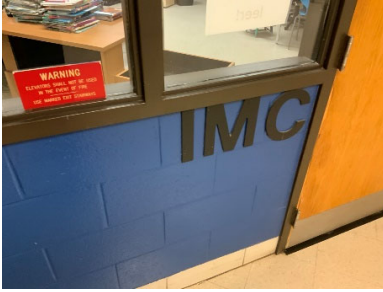
Signage in Poor condition.

Wall-Mounted, Room Identification
Main Building Rolling Terrace Elementary
School Throughout Building

Some of the interior room signage is missing or incorrect. The signage needs to be updated to match the most current FISH drawings. A budgetary cost is included. - AssetCALC ID: 9304521

Uniformat Code: C1090
Recommendation: **Replace in 2027**
