# FACILITY CONDITION ASSESSMENT

**Montgomery County Public Schools**  
45 West Gude Drive, Suite 4000  
Rockville, MD 20850

Bayard Rustin Elementary School  
332 West Edmonston Drive  
Rockville, MD 20852

*May 1, 2026*

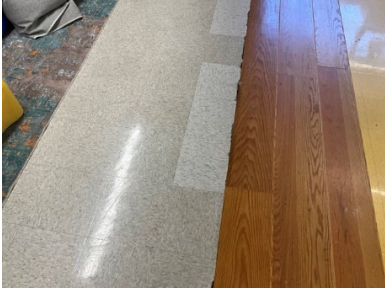
### Interior Construction in Poor Condition.

Any type, Repairs per Man-Day  
Main Building Bayard Rustin Elementary  
School Cafeteria

Cost allowance to repair damage floor tiles - AssetCALC ID: 10054230

Uniformat Code: C1010  
Recommendation: **Repair in 2026**
