# FACILITY CONDITION ASSESSMENT

Sequoyah Elementary School  
17301 Bowie Mill Road  
Derwood, MD 20855

*May 1, 2026*

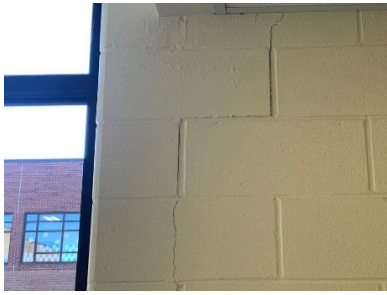
### Recommended Follow-up Study: Structural, Superstructure

Structural, Superstructure  
Main Building Sequoyah Elementary School  
South Stairwell

POC indicated that there is cracking in the walls of the south stairwell. - AssetCALC ID: 10283428

Uniformat Code: P2030  
Recommendation: **Evaluate/Report in 2026**

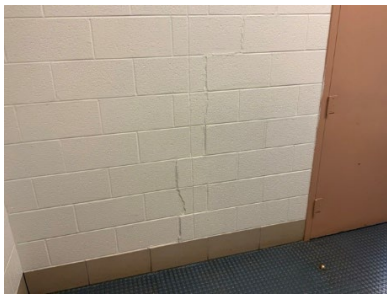
### Exterior Walls in Poor condition.

Concrete Block (CMU)  
Main Building Sequoyah Elementary School  
Stairwells

Cracking in stairway walls. - AssetCALC ID: 10265885

Uniformat Code: B2010  
Recommendation: **Repair/Repoint in 2026**

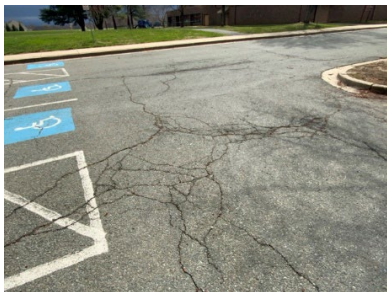
### Parking Lots in Poor condition.

Pavement, Asphalt  
Site Sequoyah Elementary School Site Parking  
Areas

Widespread longitudinal and transverse cracking observed. - AssetCALC ID: 10270045

Uniformat Code: G2020  
Recommendation: **Cut & Patch in 2026**

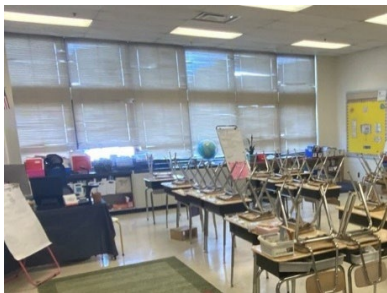
### Recommended Follow-up Study: Building Envelope, Façade

Building Envelope, Façade  
Main Building Sequoyah Elementary School

Uniformat Code: P2030  
Recommendation: **Evaluate/Report in 2026**

An architectural consultant should be retained to investigate cause of water infiltration through the floor of classrooms 12, 13, and 14 when it rains - AssetCALC ID: 10289824

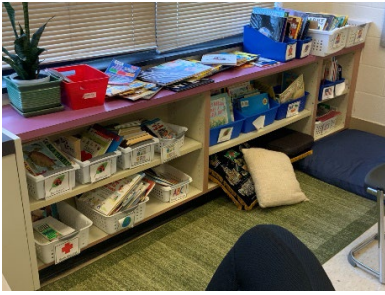
## Pump

Sump, 3 HP  
Main Building Sequoyah Elementary School

POC has indicated that there is water infiltration through the floor of classrooms 12, 13, and 14 when it rains -  
AssetCALC ID: 10289823

Uniformat Code: D2030  
Recommendation: **Install in 2041**

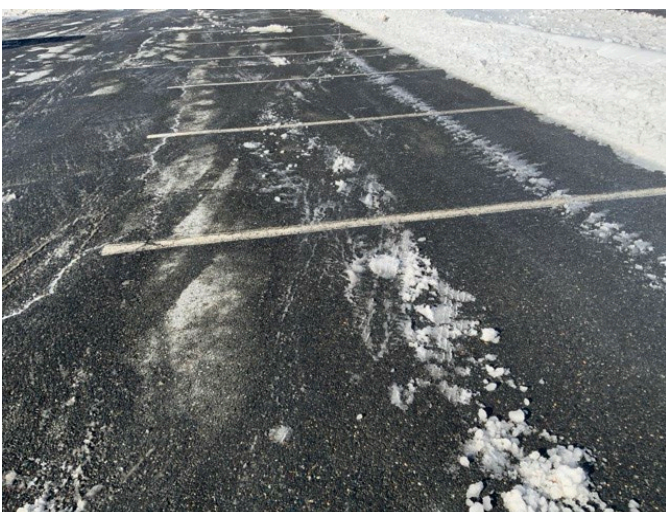
The asphalt parking lots are estimated to be the original installation with widespread alligator, longitudinal, and transverse cracking visible and lifecycle replacement is anticipated for the near term. Pavement striping is also in fair condition although some fading is visible. Visible concrete sidewalk pavement appears in fair condition.

29 - ASPHALT PARKING LOT PAVING
