FACILITY CONDITION ASSESSMENT

Montgomery County Public Schools
45 West Gude Drive, Suite 4000
Rockville, MD 20850

Seven Locks Elementary School
9500 Seven Locks Road
Bethesda, MD 20817

May 26, 2026

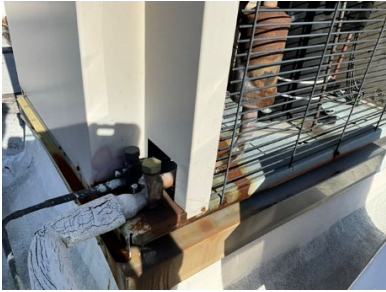
Piping & Valves in Poor Condition.

Unit piping has freezing potential due to insufficient insulation - AssetCALC ID: 10054132

Uniformat Code: D3050
Recommendation: **Replace in 2026**

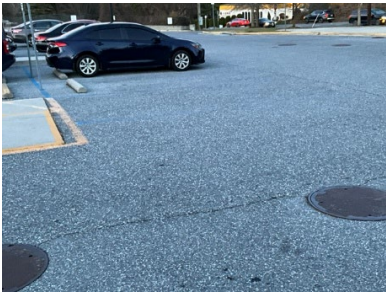
Parking Lots in Poor Condition.

The striping is fading significantly and there are cracks - AssetCALC ID: 10054161

Uniformat Code: G2020
Recommendation: **Seal & Stripe in 2026**

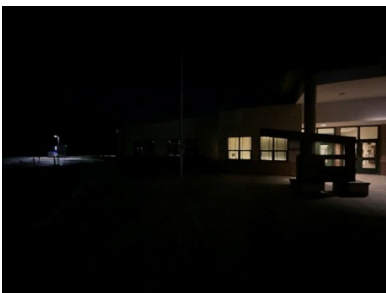
Exterior Light in Poor Condition.

Exterior lights are not present around the exterior of most of the property. It was reported as an issue for children having light at night and for nighttime cleaning. - AssetCALC ID: 10054191

Uniformat Code: D5040
Recommendation: **Replace in 2026**

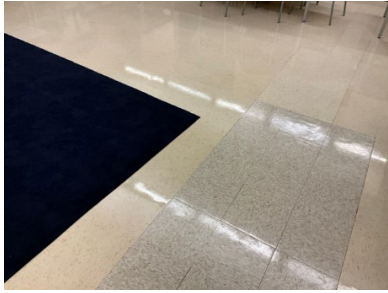
Flooring in Poor Condition.

Classroom VCT throughout is uneven and has had many spot replacements - AssetCALC ID: 10054135

Uniformat Code: C2030
Recommendation: **Replace in 2027**
