# FACILITY CONDITION ASSESSMENT

Snowden Farm Elementary School  
22500 Sweetspire Drive  
Clarksburg, Maryland 20871

May 1, 2026

January 12-13, 2026

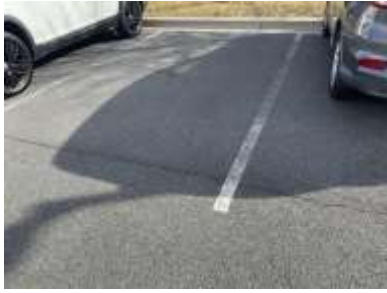
### Parking Lots in Poor condition.

Pavement, Asphalt  
Site Snowden Farm Elementary School Site  
Parking Areas

Striping is faded in some areas - AssetCALC ID: 10224866

Uniformat Code: G2020  
Recommendation: **Seal & Stripe in 2026**

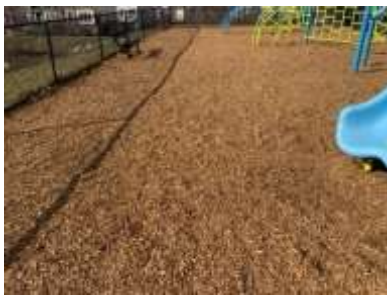
### Playground Surfaces

Rubber, Poured-in-Place  
Site Snowden Farm Elementary School Site  
Playground Areas

The play surface is currently wood chips, requiring frequent maintenance and creating an uneven surface that can be challenging to maneuver. Replacement with rubberized surfacing. - AssetCALC ID: 10224880

Uniformat Code: G2050  
Recommendation: **Replace in 2029**

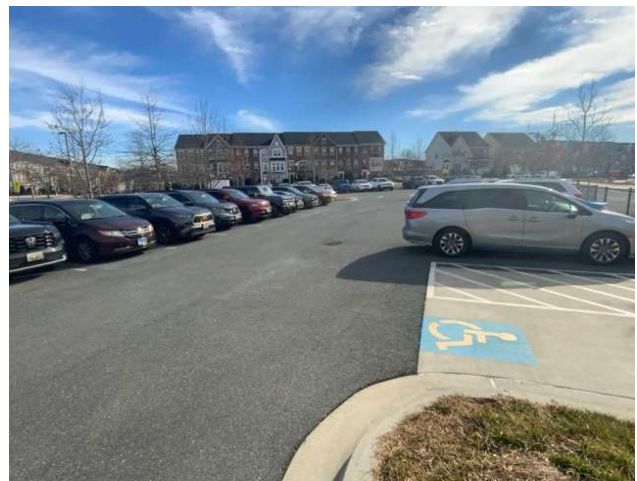
18 - PARKING AREA OVERVIEW

The asphalt parking lots are reported to be original installations from 2019 and are in good condition. Pavement striping is beginning to fade and will require reinstallation within three years. Concrete pavement is generally in good condition throughout the site. Site lighting is with pole-mounted LED for some fixtures and wall packs on the building exterior. Lifecycle replacement is not anticipated within the reserve term.
